**Guidance Note No: 121/2011**

## **Beaching of vessels to perform maintenance**

# Beaching of vessels to perform maintenance

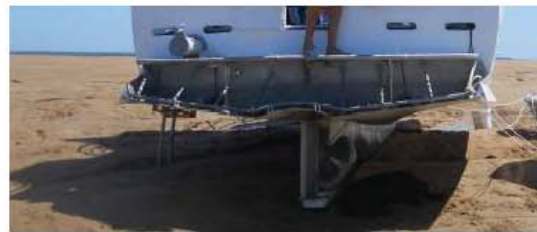
A fishing tour operator received fatal crush injuries after beaching his vessel on its keel to perform maintenance. The vessel was balanced on its keel allowing access to both sides of the vessel. The deceased was underneath the vessel when it rolled onto its side crushing him.

- The vessel was beached in an upright position balanced on the keel.
- The vessel was not stabilised whilst it was beached.
- People were allowed onboard the vessel whilst the maintenance work was being performed.

Beached vessel resting on keel without support.

- Carry out a risk assessment to identify the risks and appropriate control measures to mitigate the risks.
- Consider employing a suitably qualified person who has the appropriate facilities, equipment and experience to carry out the work.
