INDEPENDENT MONITOR'S AUDIT OF THE MCARTHUR RIVER MINE FOR THE 2010 OPERATIONAL PERIOD

ENVIRONMENTAL EARTH SCIENCES VIC

**REPORT TO THE MINISTER FOR PRIMARY INDUSTRY FISHERIES AND
RESOURCES**

OCTOBER 2011

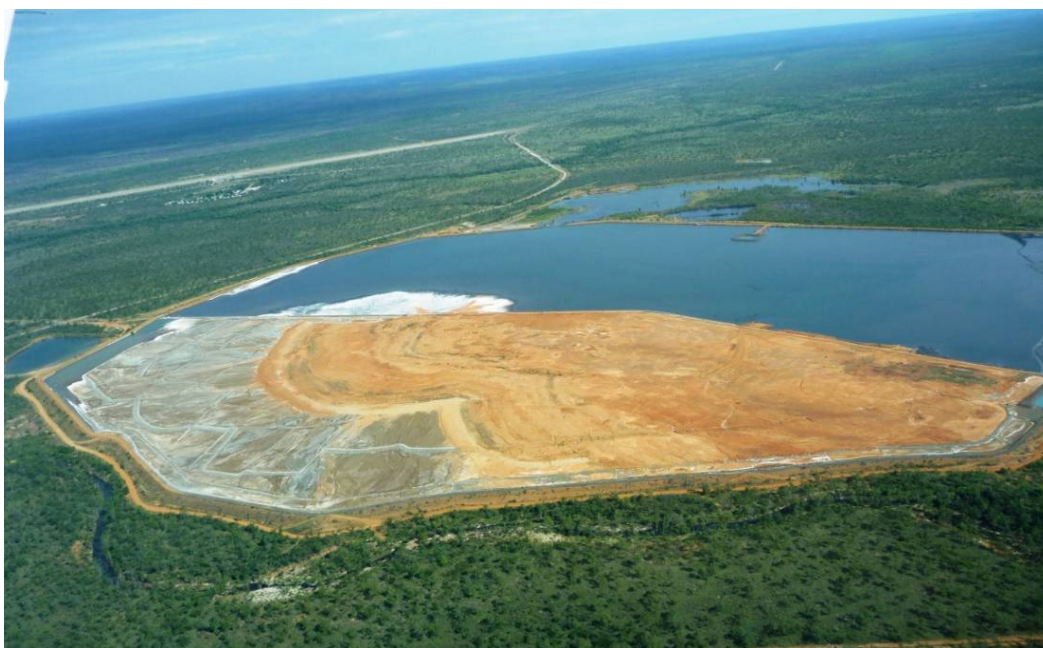
Significant Issue last audit	2011 Update
Excess water storage in the tailings storage facility which poses the risk of overtopping and embankment failure due to spillways being under-designed for a flood event.	Excess water in the TSF Cell 2 is still an issue. Based on the 2010 Dam Safety Audit, the available capacity is less than the storage capacity required to contain a 1 in 200 year event. As such, the facility does not have sufficient capacity and this will need to be increased by the start of the 2011/2012 wet season. See Plate 1 and Plate 2.
Seepage migration from the tailings storage facility to Surprise Creek and the hazard classification of tailings in Cell 1 and Cell 2.	Seepage migration from the TSF into Surprise Creek remains an issue (See Plate 3). However, an investigation into the geochemical nature of the tailings and water levels in TSF Cell 1 has been undertaken since last audit. This investigation, though compliant with the written instruction, is inadequate at a technical level, moreover it has confirmed that acid drainage will occur.

Plate 1 Excess water stored in the TSF Cell 2 in 2010. Note clay cap of TSF Cell1 was approximately 60% complete at the time. Photo: Independent Monitor, May 2010.

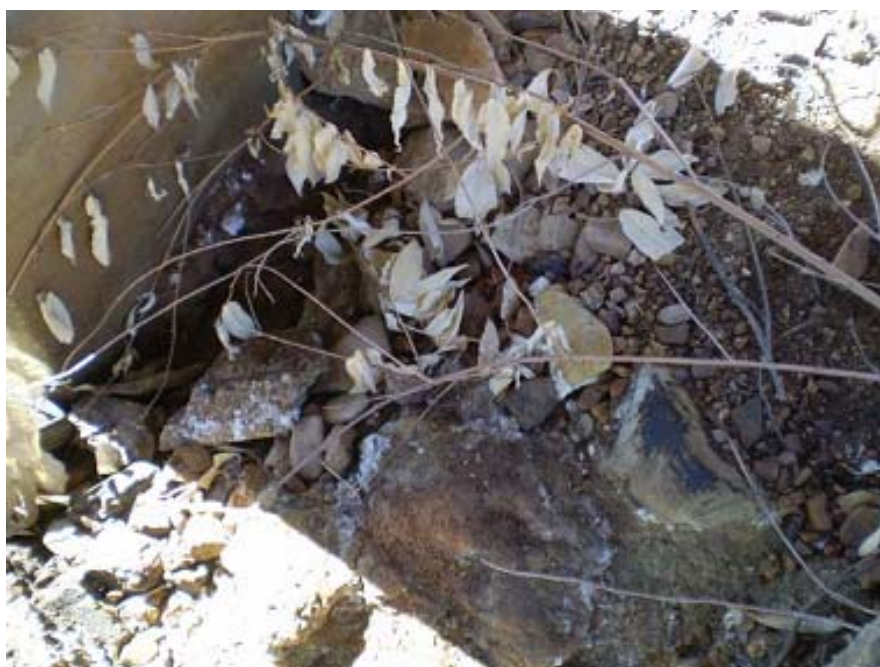
Plate 5 Photo of minor salt on rocks along Surprise Creek at the bridge crossing along Carpentaria Highway as observed by the DoR. Photo: DoR.

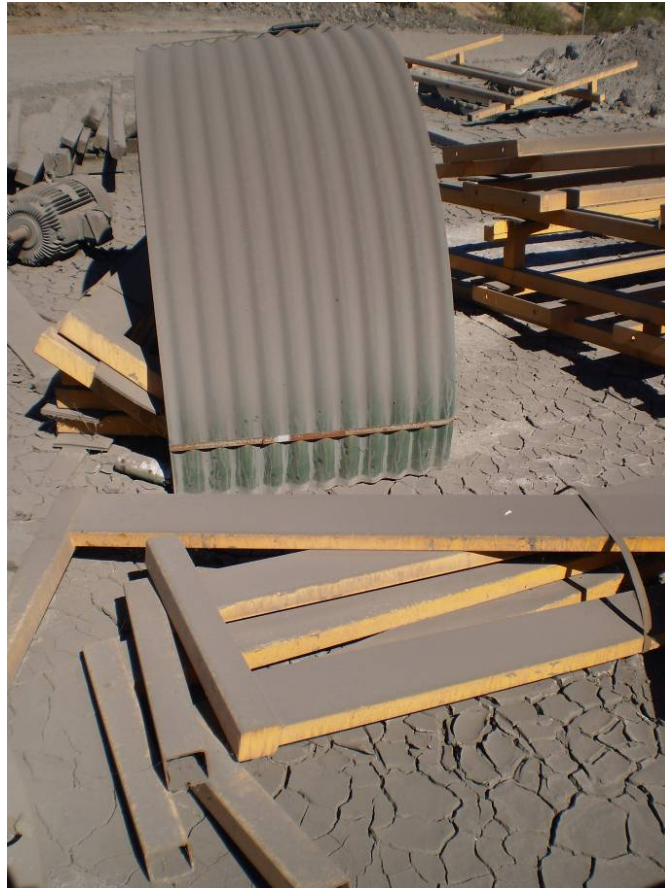
Plate 7 Likely concentrate dust accumulating on objects in the PACRIM yard

- explore the use of different water sprays in the concentrate shed to continually keep the concentrate moist;
- where possible consider reducing concentrate stockpiles around the plant;
- use water trucks or water sprays to aid in dust suppression of worked stockpiles; and
- consider implementing an ongoing program to remove spilt concentrate from crushing plant and conveyors.

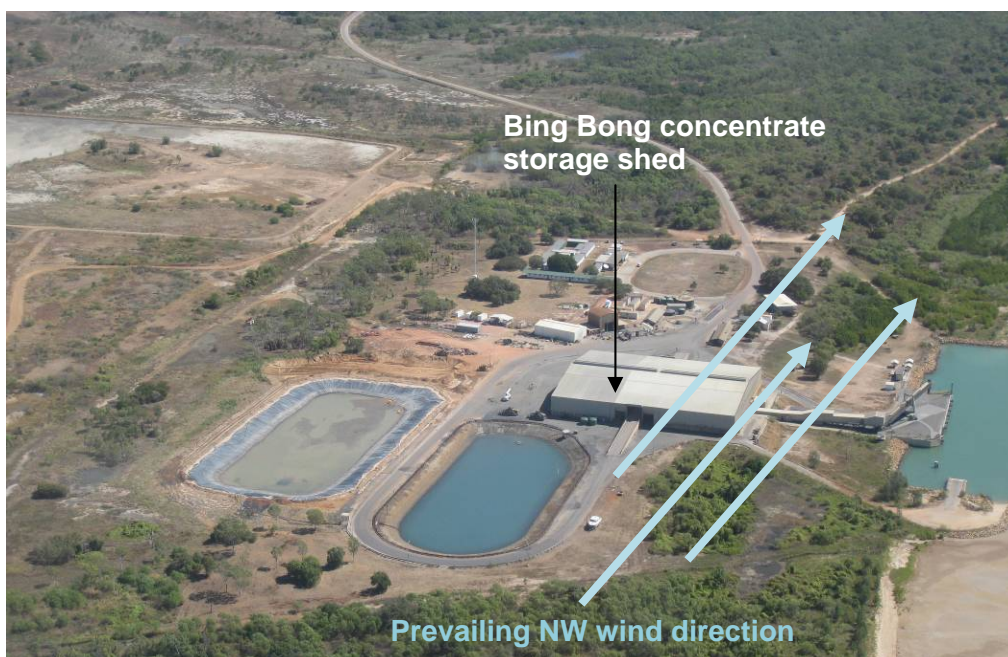
- although monitoring location BB1 at Bing Bong Port recorded dust lead concentrations of up to $600\,000 \text{ mg/kg}$ (or 60%), the TIM at this location has decreased since the last monitoring period; this finding highlights the fact that, although total dust collected at this site may have decreased, the dust that was collected is contaminated with a high proportion of lead, which is likely to have originated from concentrate stored at Bing Bong Port (see Plate 9).

Plate 9 Aerial photograph showing the position of the Bing Bong concentrate storage shed in relation to the prevailing North West wind direction. Photo: Independent Monitor 2011.

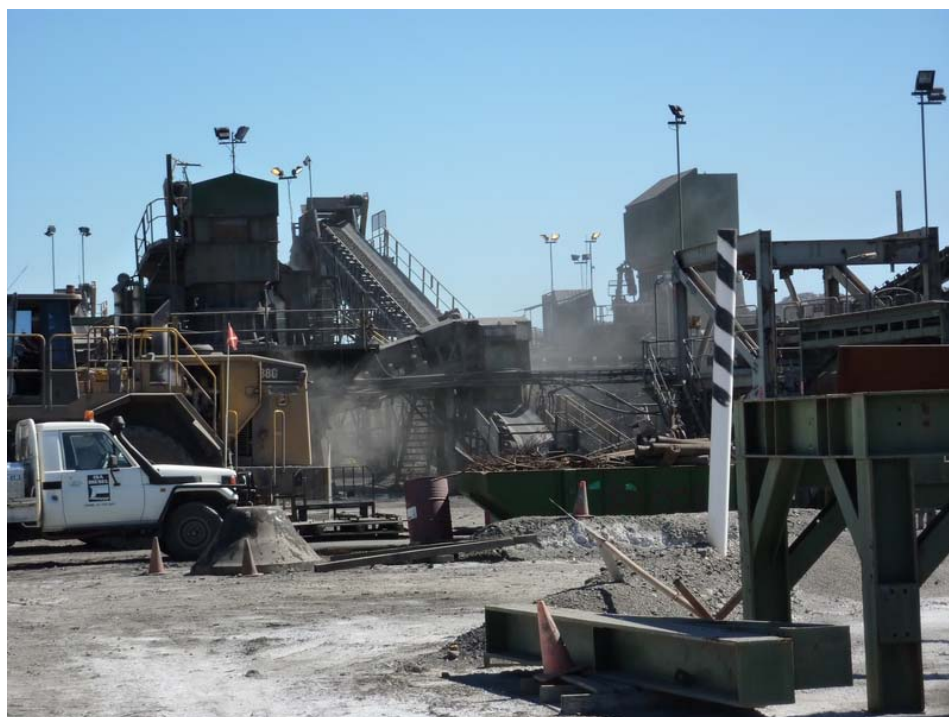
Fugitive dust emissions from the mine site ROM pad/PACRIM crushing facilities.	This issue has not been significantly improved since the previous audit. During the May 2011 site inspection, dust was still observed emanating from the PACRIM crusher. The IM notes that water sprays are being used more often at the ROM pad than last year, however, few upgrades to dust suppression on the PACRIM plant were observed. It is further noted that contaminated dust monitoring results have not improved in this area between 2009 and 2010.
Fugitive dust emissions from the Bing Bong Port concentrate storage shed.	The primary source of contaminated dust at Bing Bong Port comes from the concentrate storage shed. This year it was observed that the doors to the shed still remain open, which provides an opportunity for lead/zinc/silver dust to escape. As such, this issue continues to be of concern. MRM have indicated that capital expenditures have been approved for updates to the shed which will allow the doors to remain shut while avoiding gas build up.

Plate 10 PACRIM area. Note fugitive dust in the centre of the photo. We note that MRM have advised that limiting dust emissions completely from this plant may not be possible. Photo: Independent Monitor 2011.

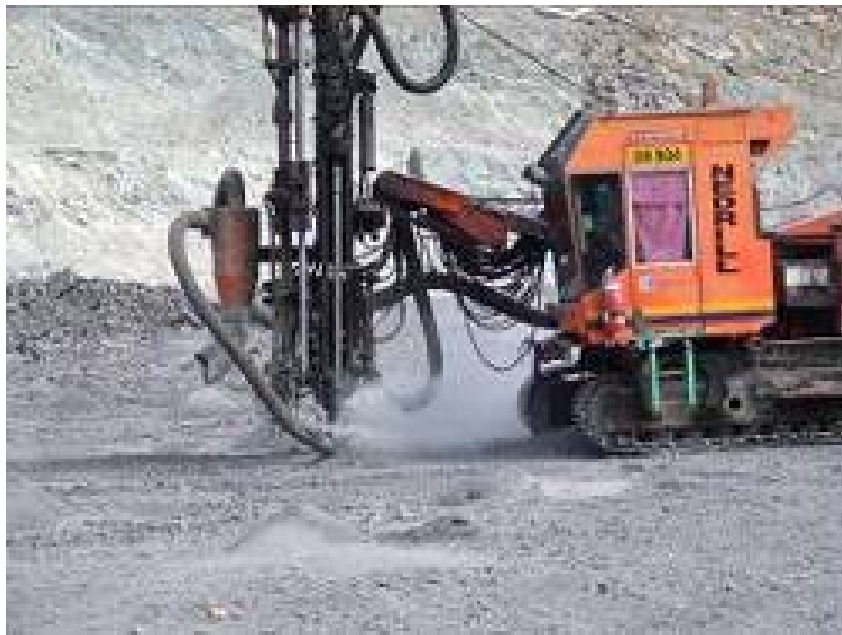
Plate 11 Dust generated by working drill rig. Photo sourced from Simtars (2010) assessment

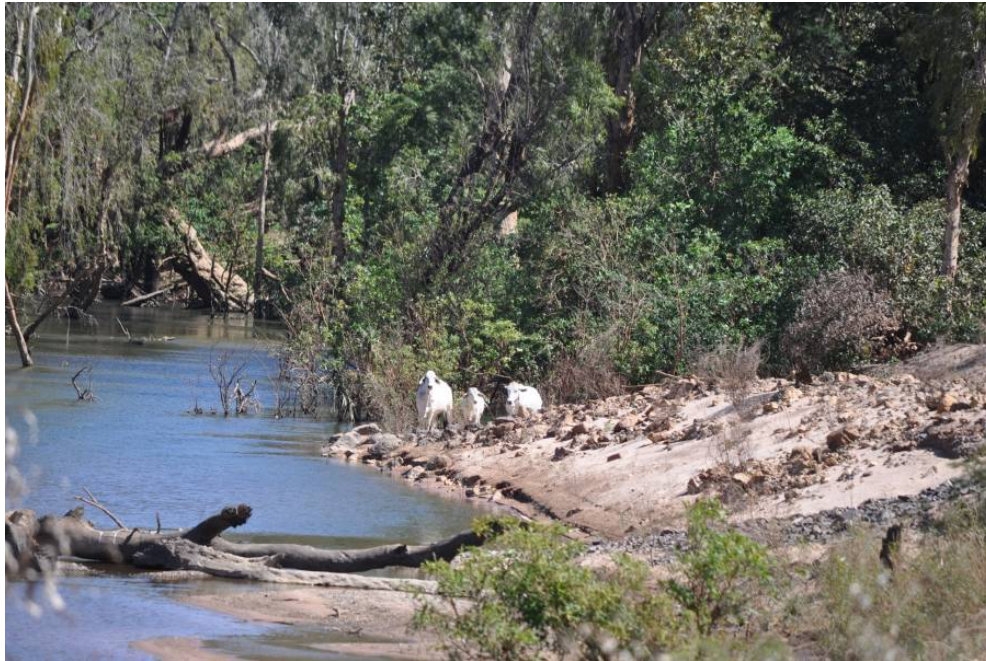
Plate 19 Cattle at the upstream start of the McArthur River diversion at the location where the original McArthur River is met by the diversion channel. Photo: Independent Monitor.

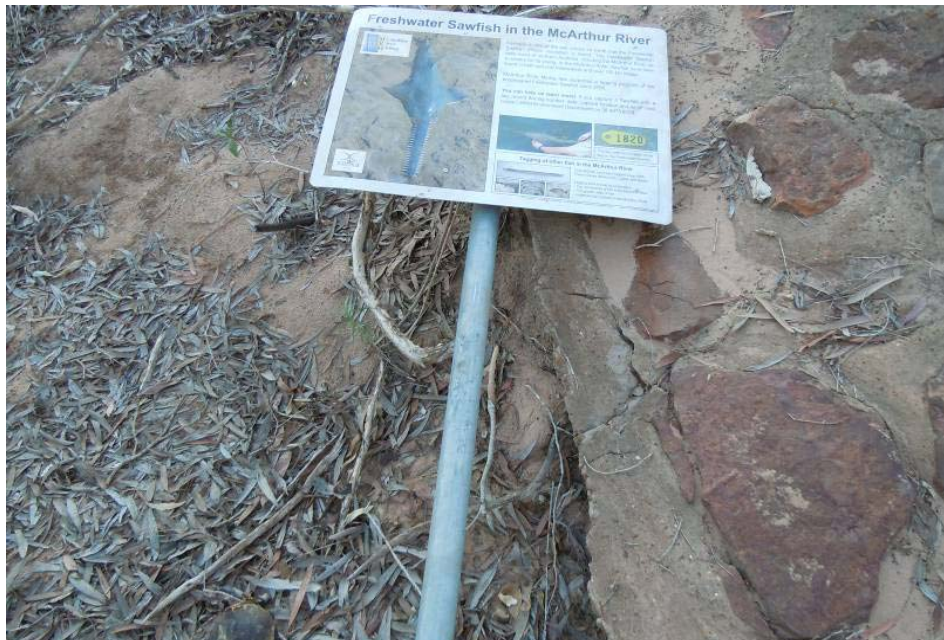
Plate 22 MRM Sawfish monitoring sign requiring maintenance at the Borroloola boat ramp.

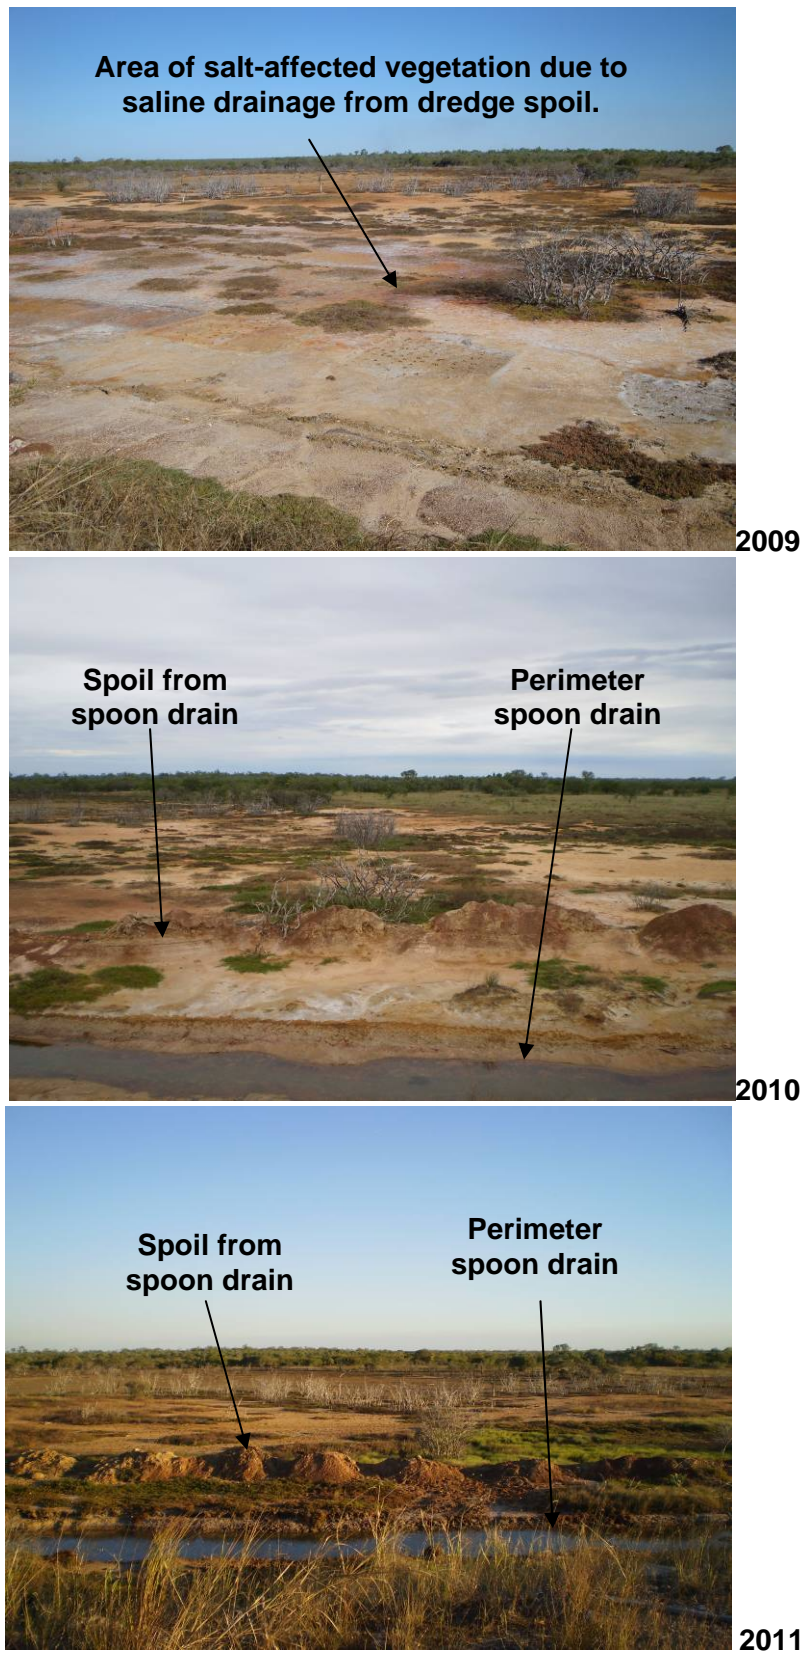
Plate 25 Area of vegetation dieback outside the dredge spoil ponds as photographed in 2009, 2010 and 2011. With the addition of the spoon drain to redirect saline seepage out to sea, vegetation growth has slightly improved since 2009. Photos: Independent Monitor.

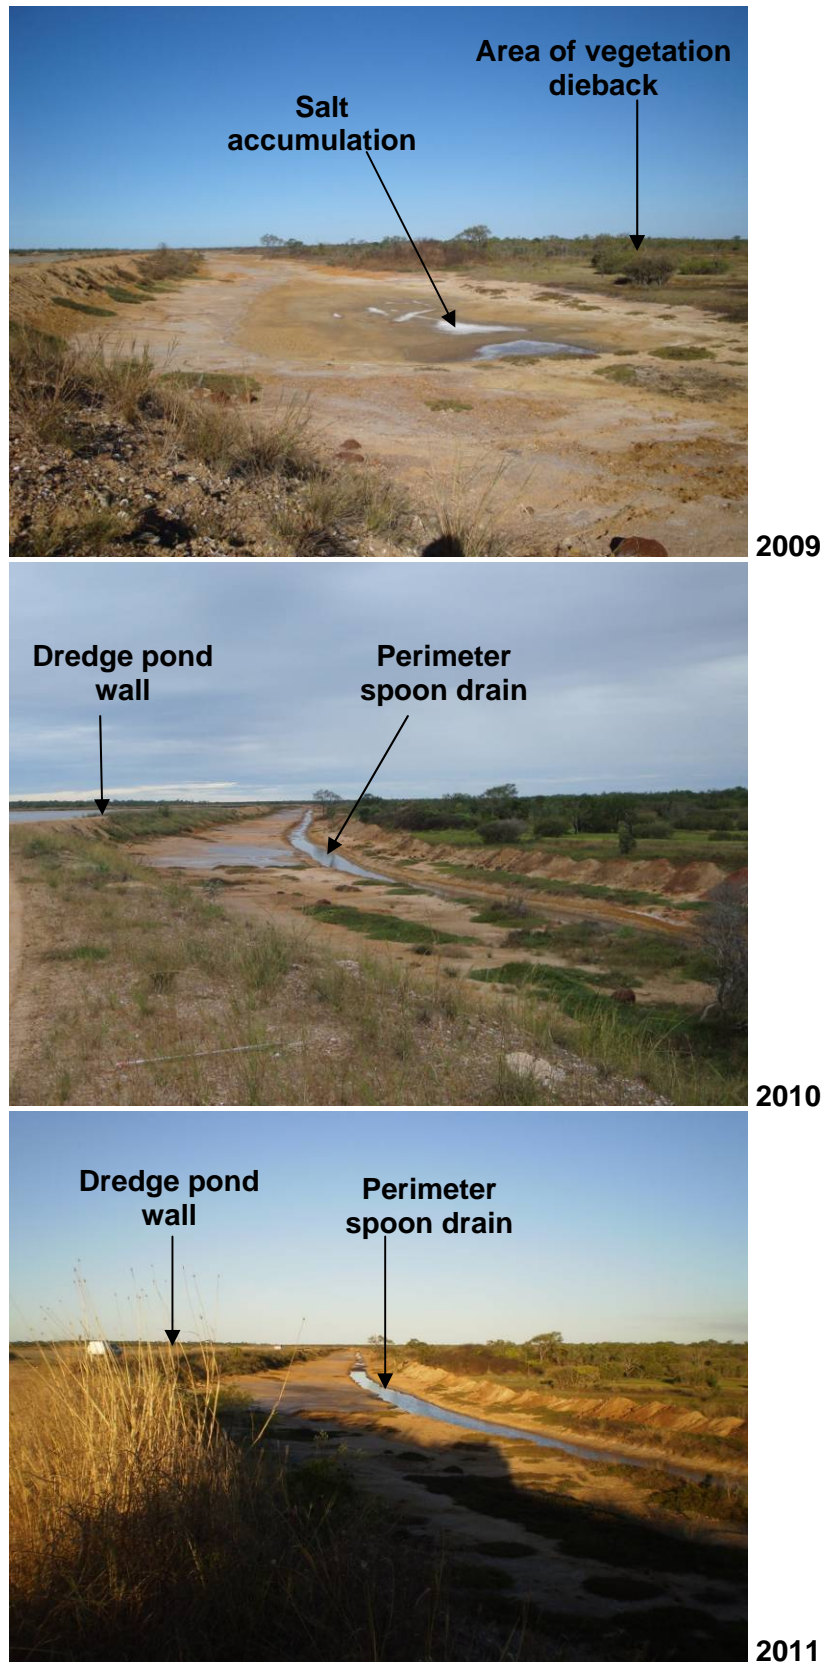
Plate 26 Series of photographs taken in 2009 (top) 2010 (middle) and 2011 (bottom), showing the outer toe of the spoil ponds, with the spoon drain subsequently installed to redirect saline seepage. Photos: Independent Monitor.

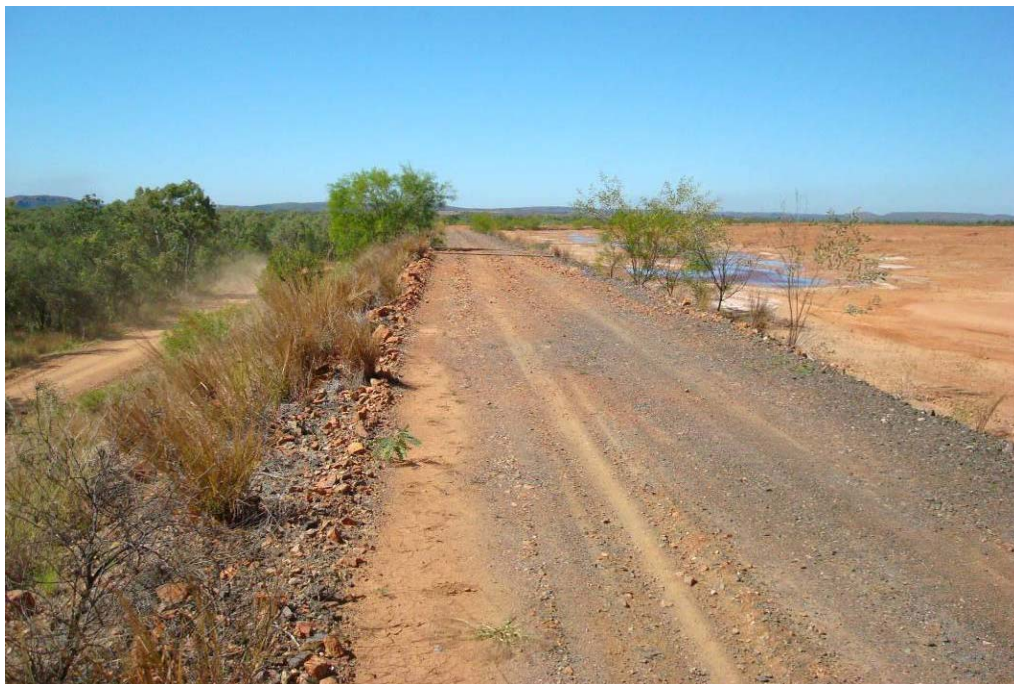
Plate 30 General view of embankment crest of TSF Cell 1 showing the embankment crest generally in good condition. Photo: Independent Monitor.

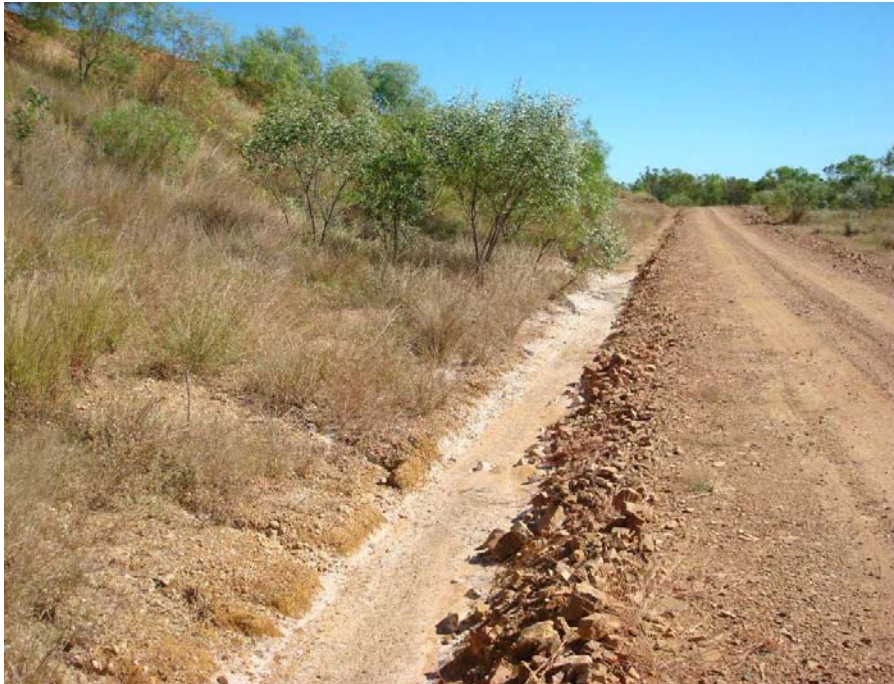
Plate 31 Salt precipitation and seepage on TSF Cell 1 Embankment toe adjacent to Surprise Creek. Photo: Independent Monitor.

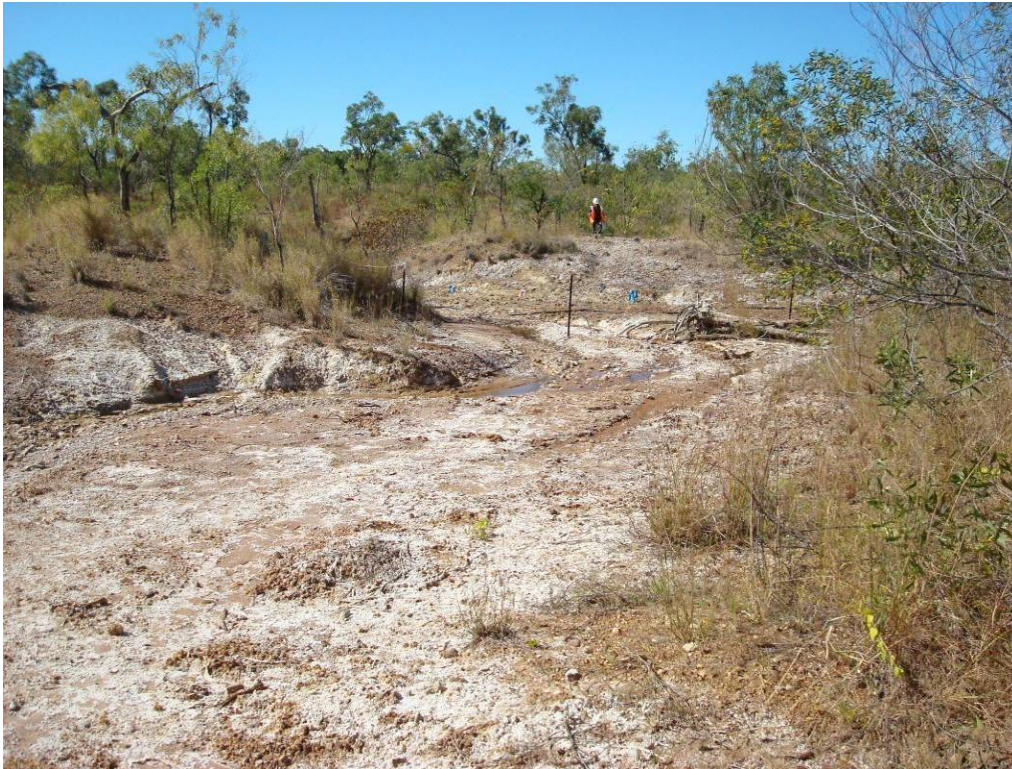
Plate 32 Extensive salt precipitation and active seepage zone downstream of TSF Cell 1 embankment toe adjacent to Surprise Creek. Photo: Independent Monitor.

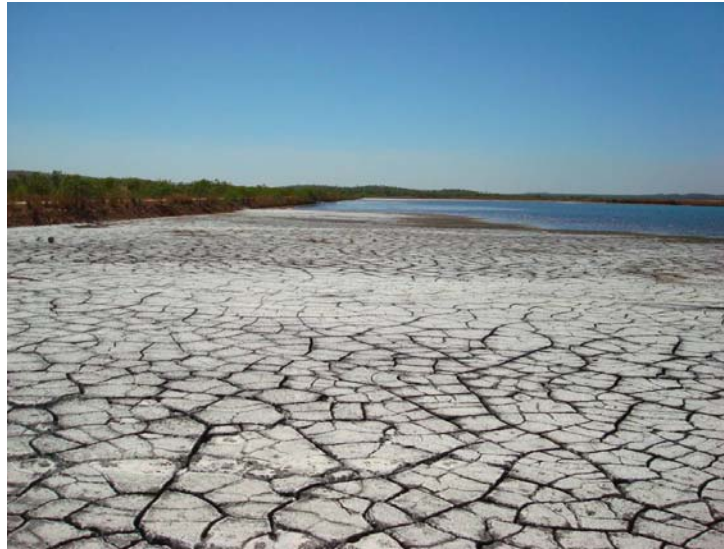
Plate 34 Desiccation of deposited tailings on beaches in TSF Cell 2. Photo: Independent Monitor.

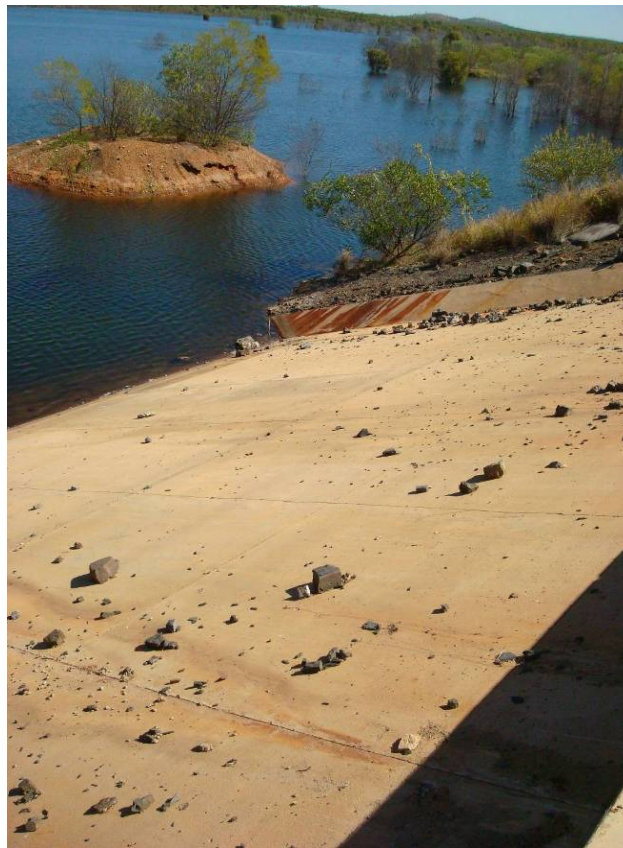
Plate 35 Concrete spillway apron where seepage was noted during previous audit. No seepage was visible during the inspection. Photo: Independent Monitor.

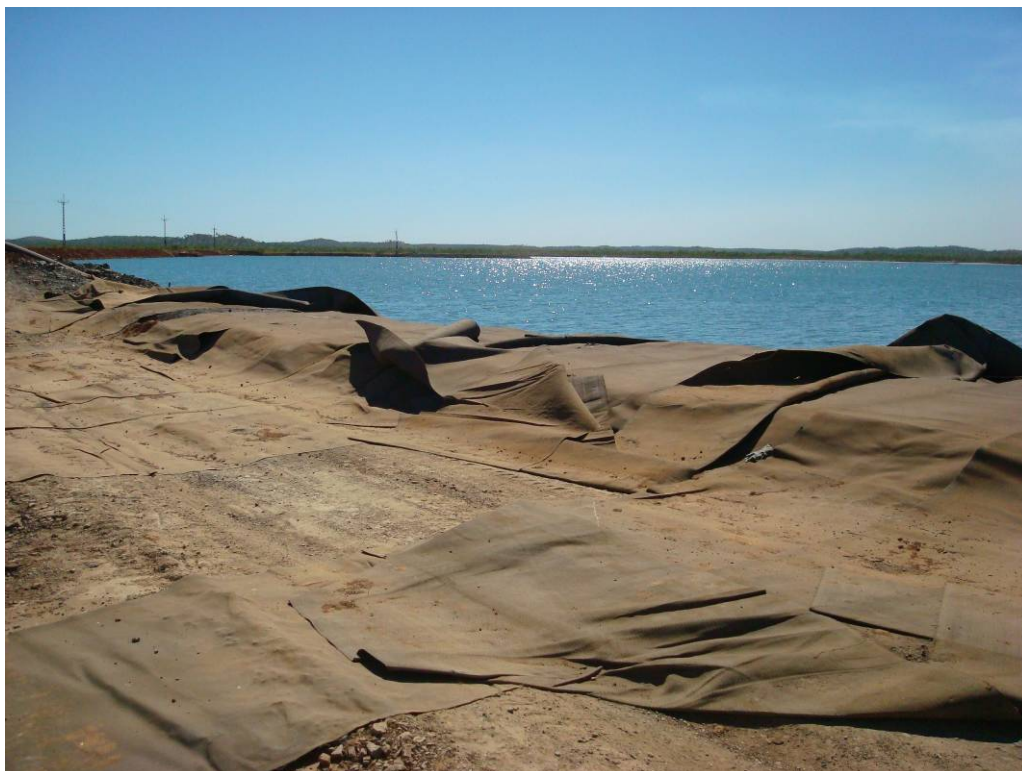
Plate 36 Temporary bund in spillway constructed of soil covered in geofabric. Photo: Independent Monitor.

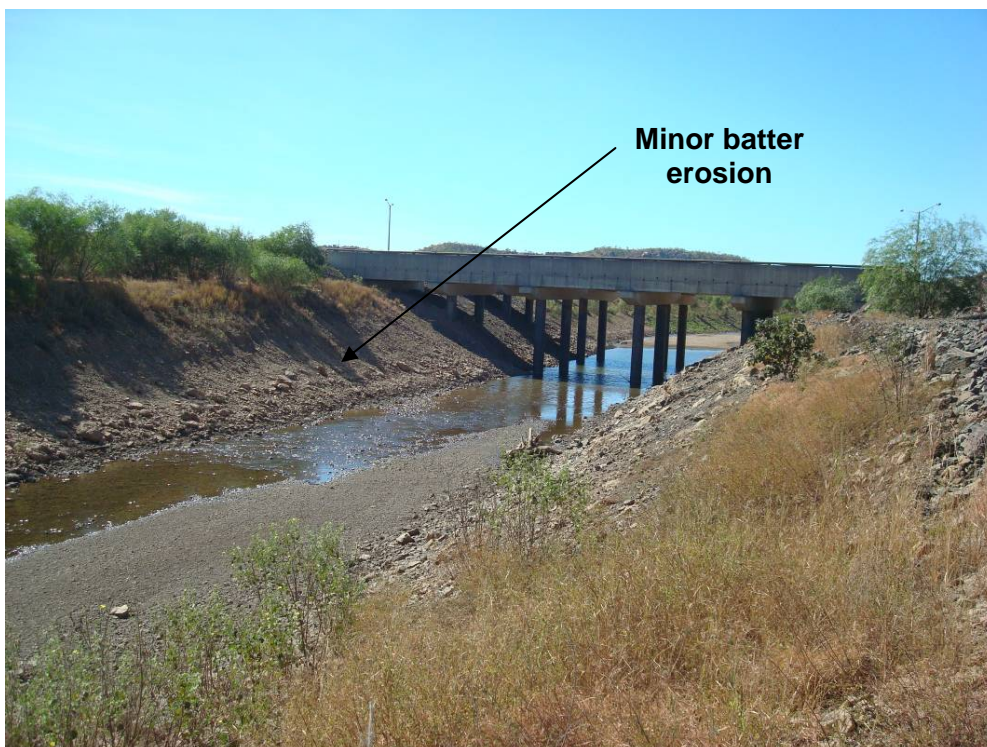
Plate 46 Barney Creek diversion channel upstream of bridge to OEF; note minor erosion of the batters. Photo: Independent Monitor

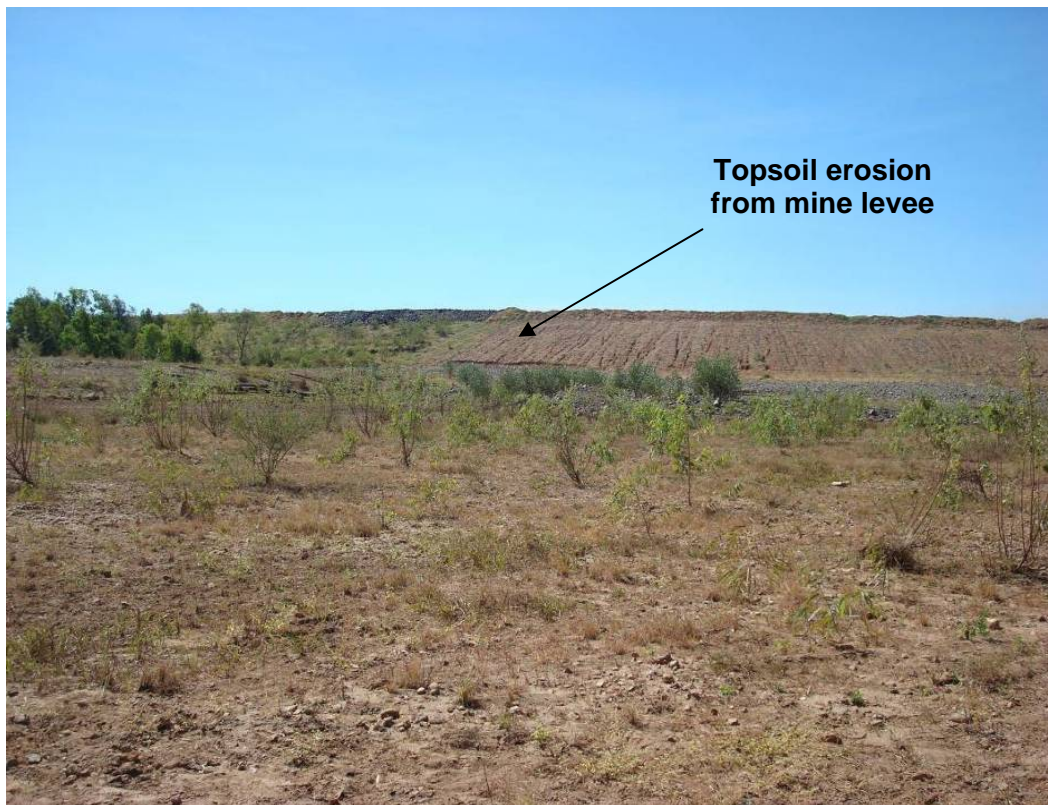
Plate 49 View of mine levee showing erosion of topsoil along base. Photo: Independent Monitor

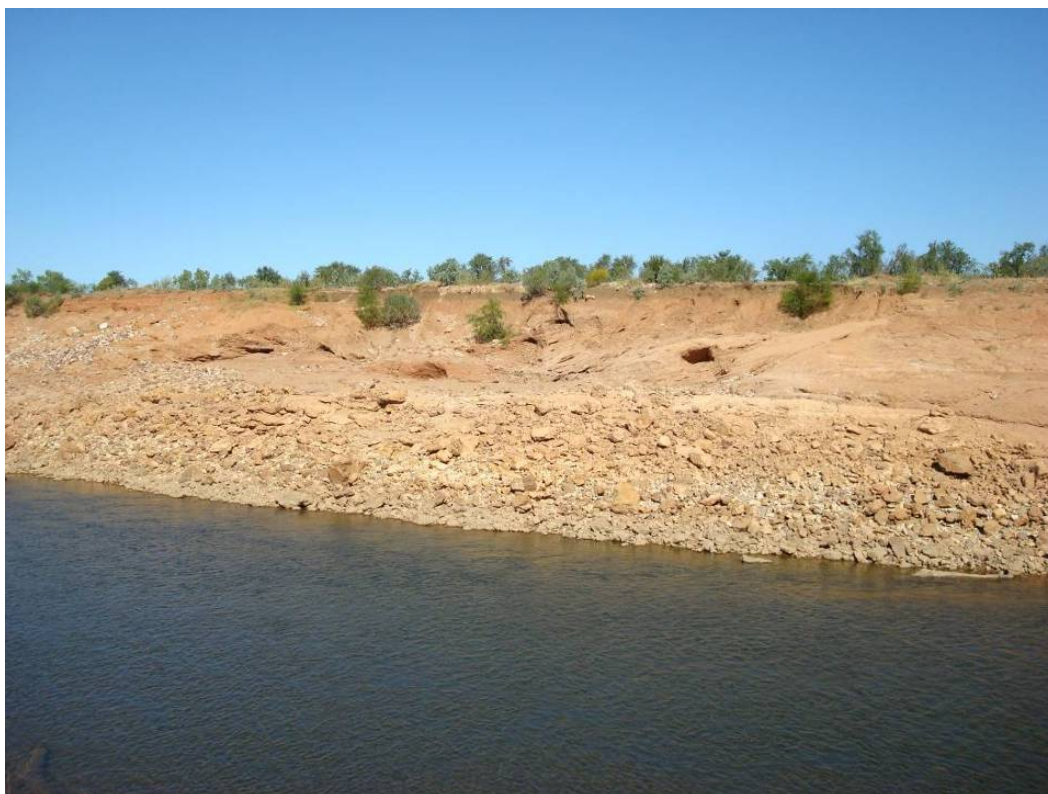
Plate 50 Minor erosion of McArthur diversion batter. Photo: Independent Monitor

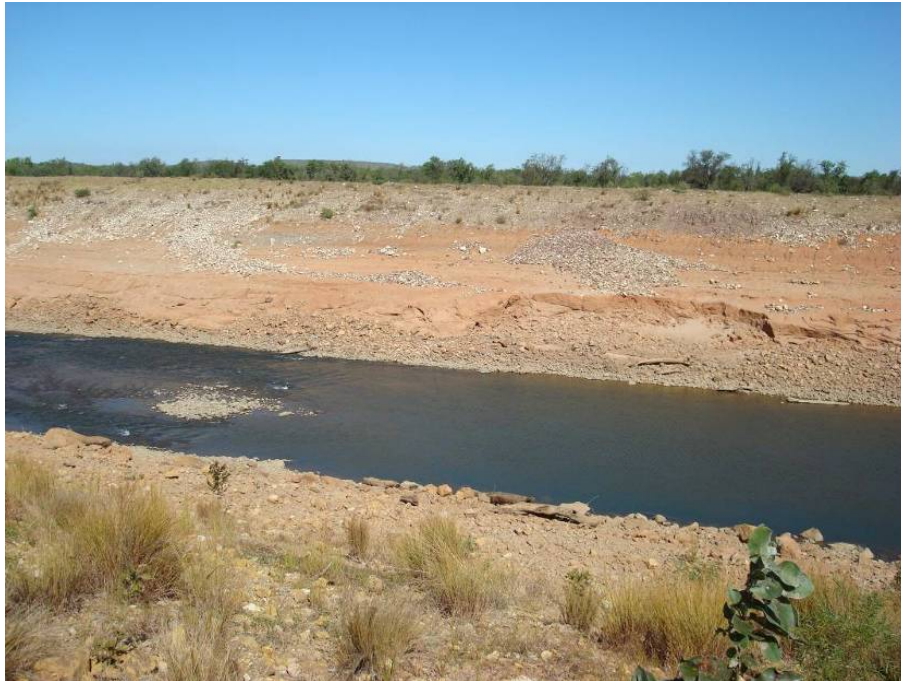
Plate 51 Minor erosion of McArthur diversion batter. Photo: Independent Monitor

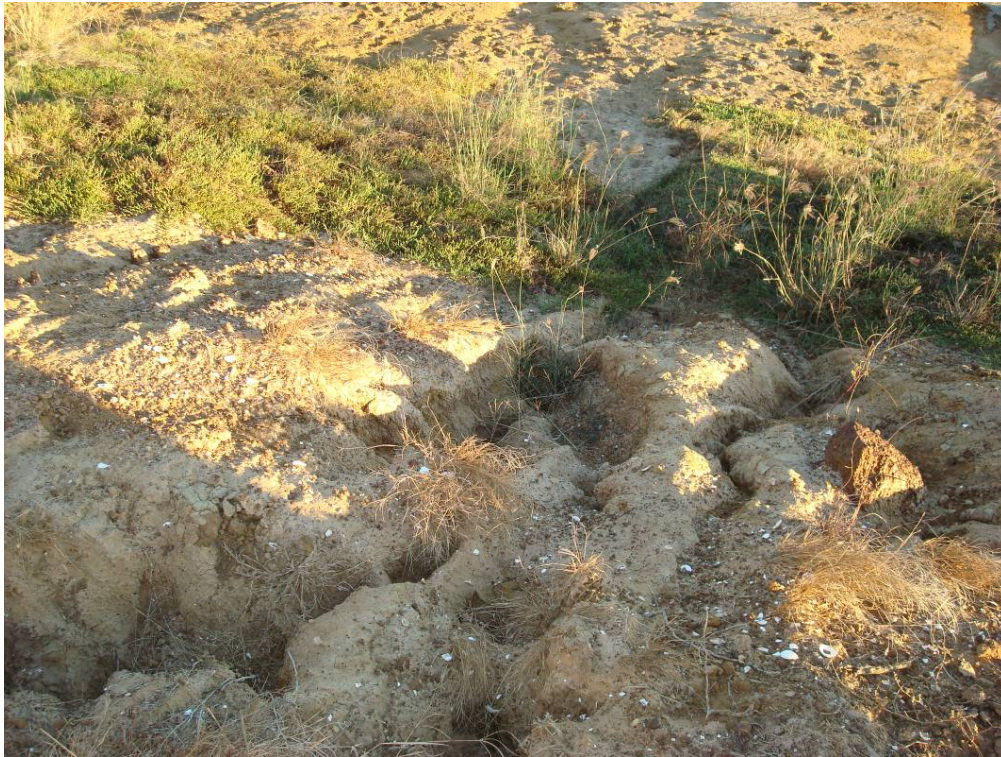
Plate 54 Erosion of dispersive embankment fill at the dredge spoil cells. Photo: Independent Monitor

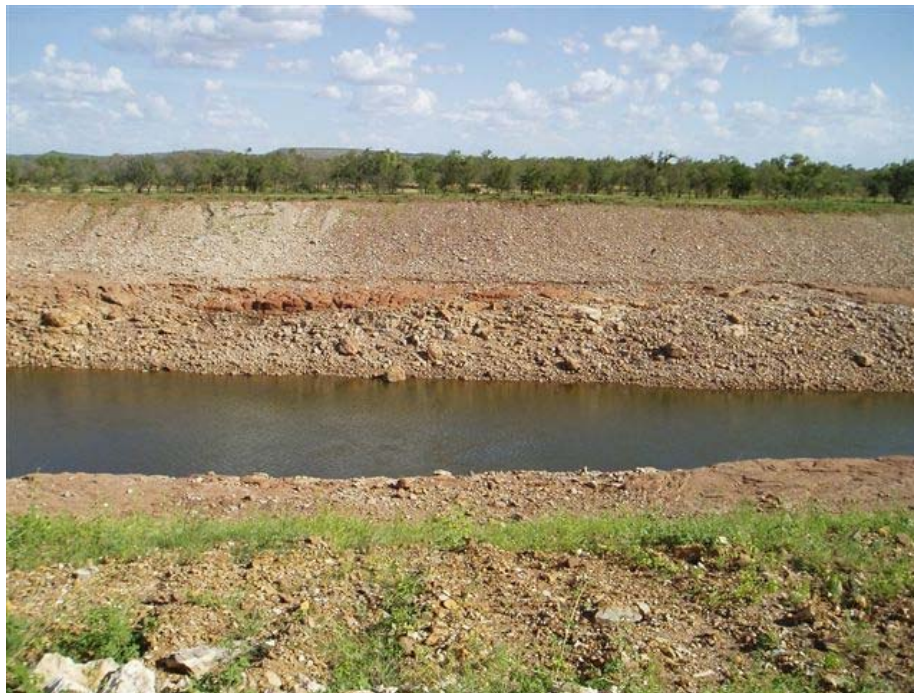
Plate 56 View of eastern batter slope scour at river channel chainage 1750m; taken March 2009. Photo: Independent Monitor

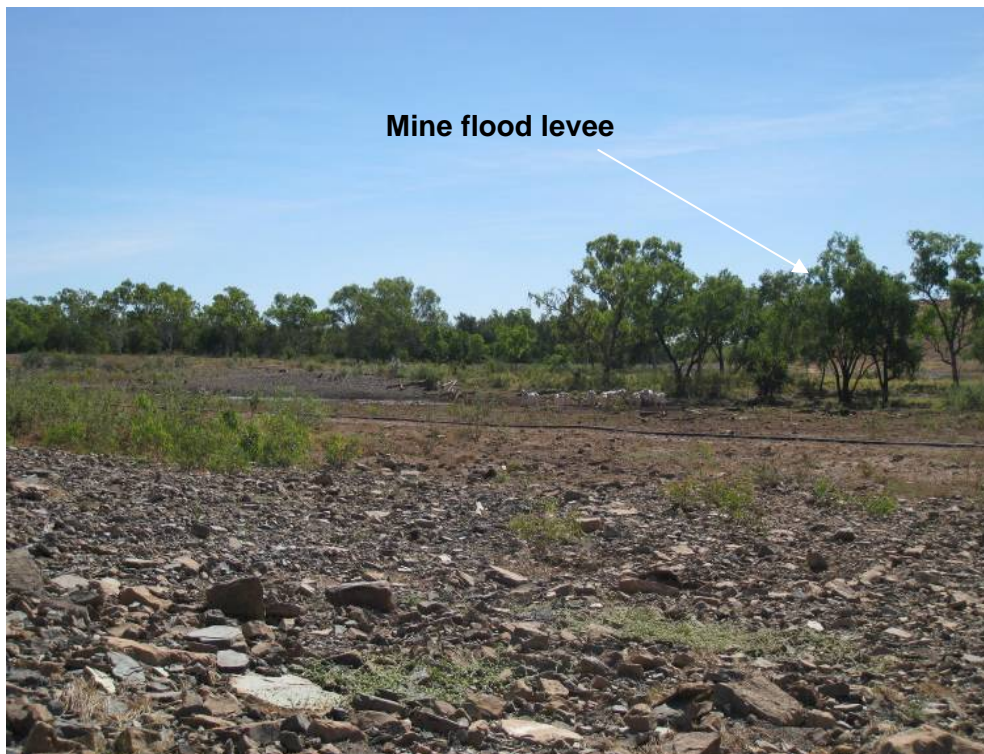
Plate 61 View of rock work placed in the foreground and background in 2010 to address scour along the overland flow path from the old McArthur River channel to the diversion channel. Photo is taken looking towards the old channel alignment. The mine levee wall can be seen behind the trees to the right. Photo: Independent Monitor

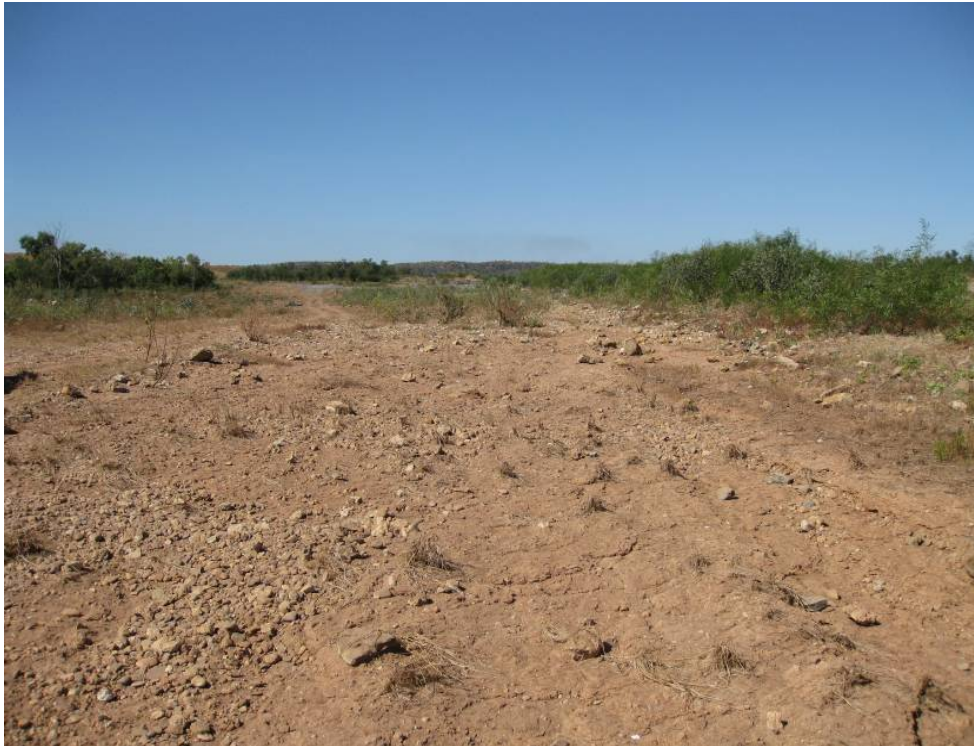
Plate 63 Evidence of scour associated with the 2010/2011 wet season overland flow from the old McArthur River channel about to spill into the diversion channel, located just to the right out of the photo. The photograph location is just south of scour repair works placed along the flow path in 2010. Photo: Independent Monitor

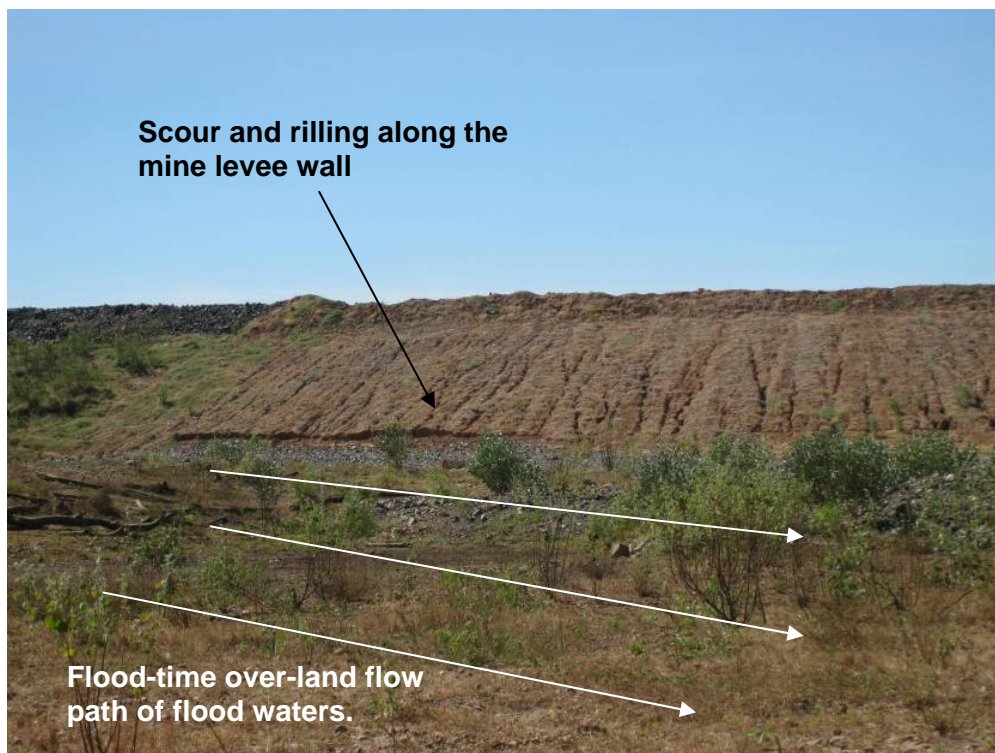
Plate 64 Minor erosion at the toe of the mine levee wall due to flood flow from original McArthur River channel being conveyed overland towards the diversion channel. Photo: Independent Monitor

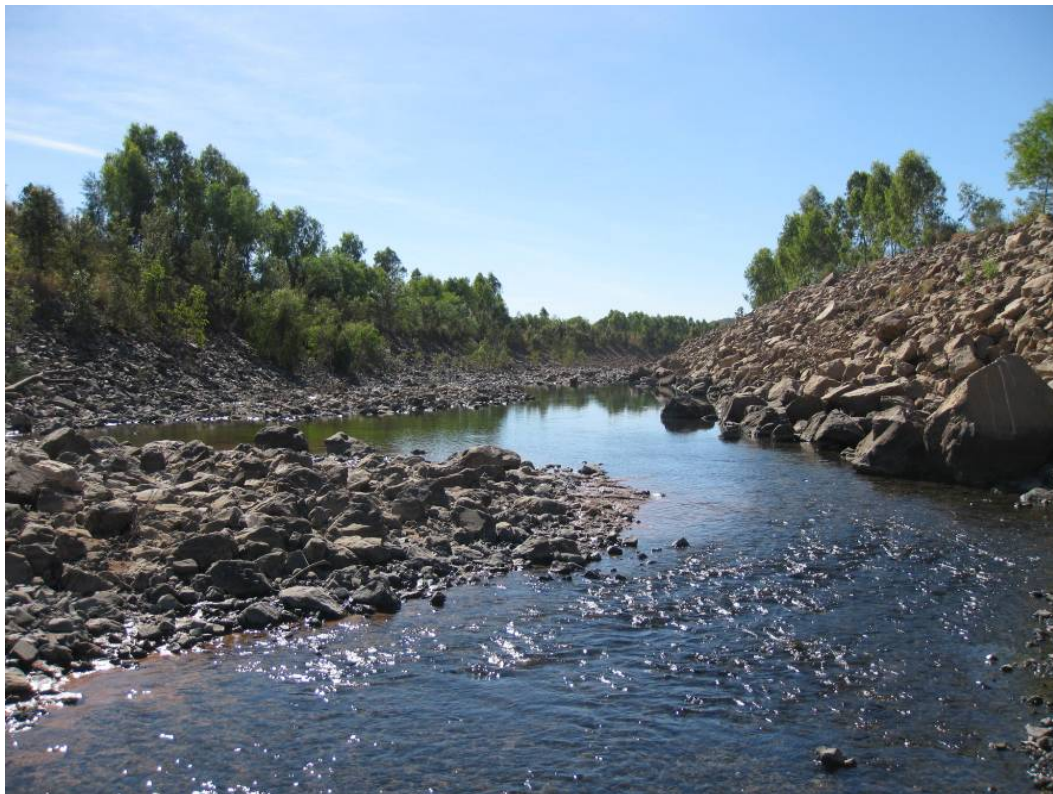
Plate 66 Looking downstream along Barney Creek diversion channel at Surprise Creek confluence. 2010 rock armouring of channel batter slope opposite Surprise Creek entry (to address 2009/2010 wet season scour) is shown in right hand portion of photo. Photo: Independent Monitor

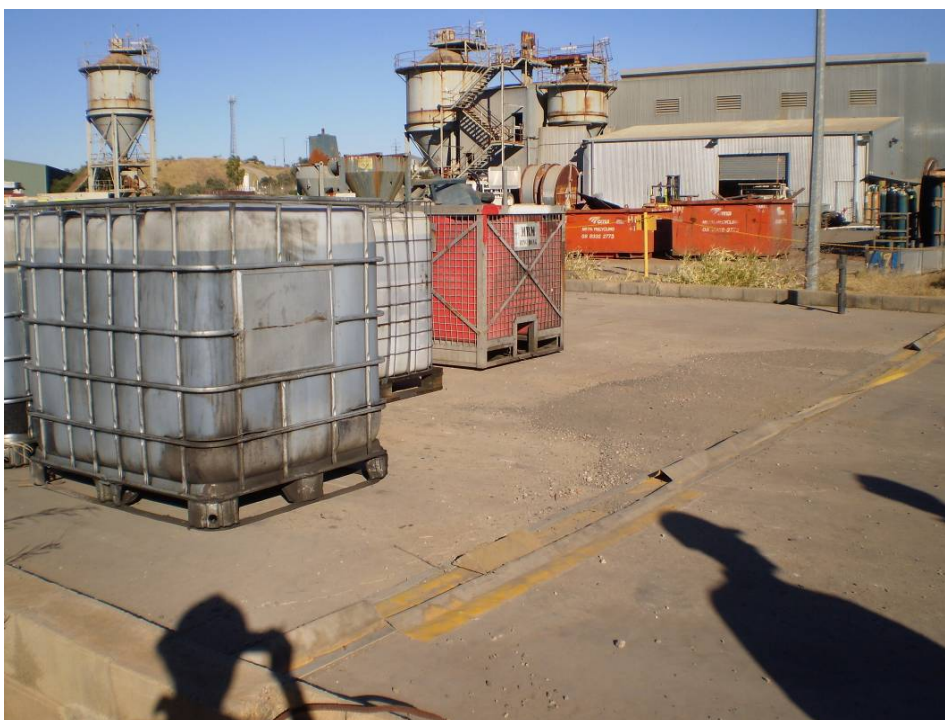
Plate 67 Waste oil stored in IBCs in the store yard. The collapsible bunding shown in the foreground is in need of replacement, and no sump exists in the concrete containment pad. Photo: Independent Monitor

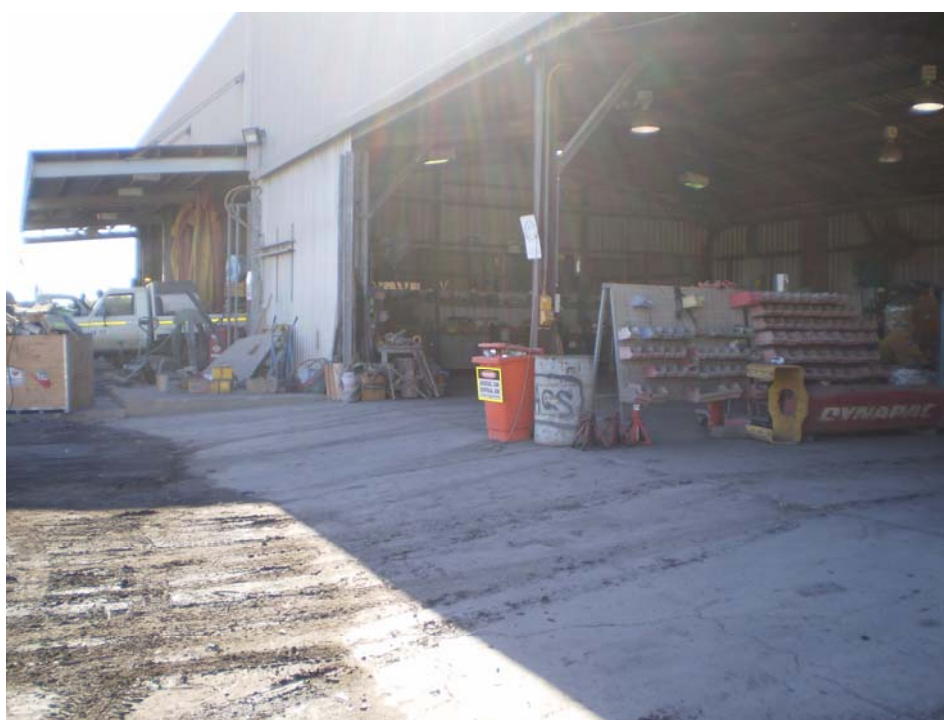
Plate 68 Vehicle workshop area with possibly impacted soil at the front entrance. Photo: Independent Monitor.
