INDEPENDENT MONITOR AUDIT OF THE MCARTHUR RIVER MINE FOR THE 2011 OPERATIONAL PERIOD

ENVIRONMENTAL EARTH SCIENCES VIC
REPORT TO THE MINISTER FOR MINES AND ENERGY
1 OCTOBER 2012
VERSION 1

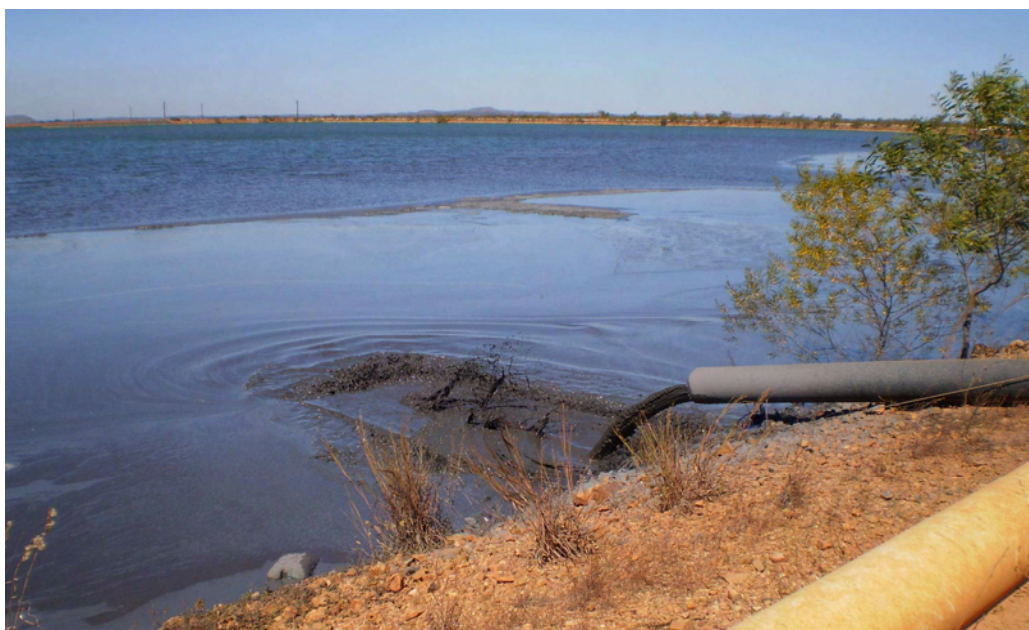
Plate 1 Aqueous deposition of tailings observed by the IM during the May 2011 site inspection.

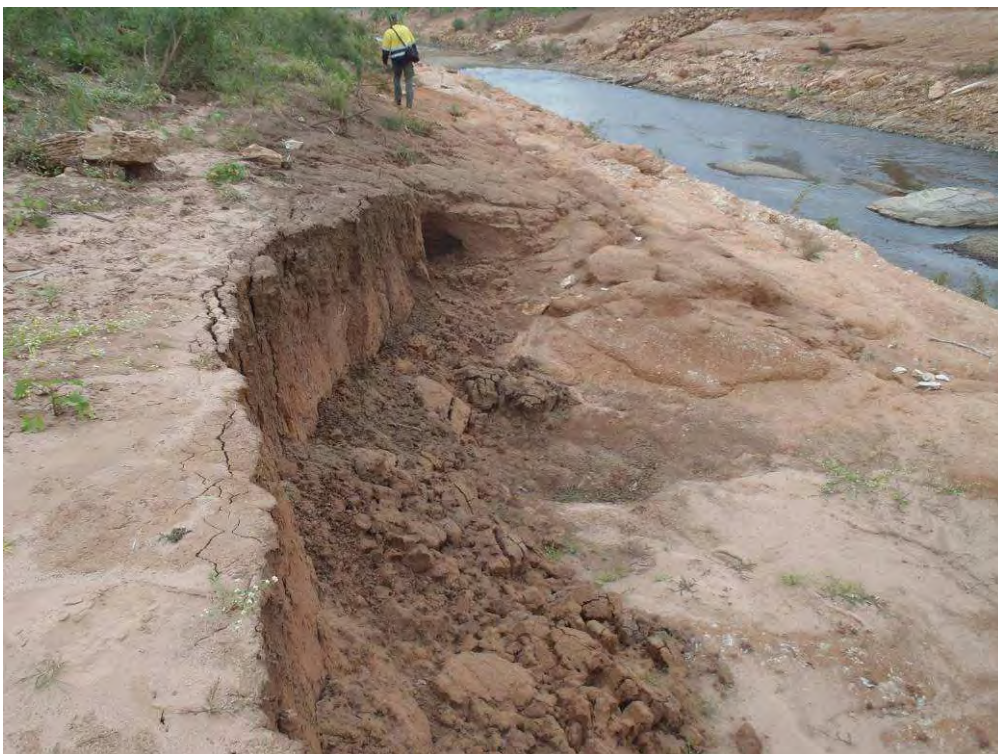
Plate 10 Erosion on mine side of McArthur River diversion. Photograph: Independent monitor.

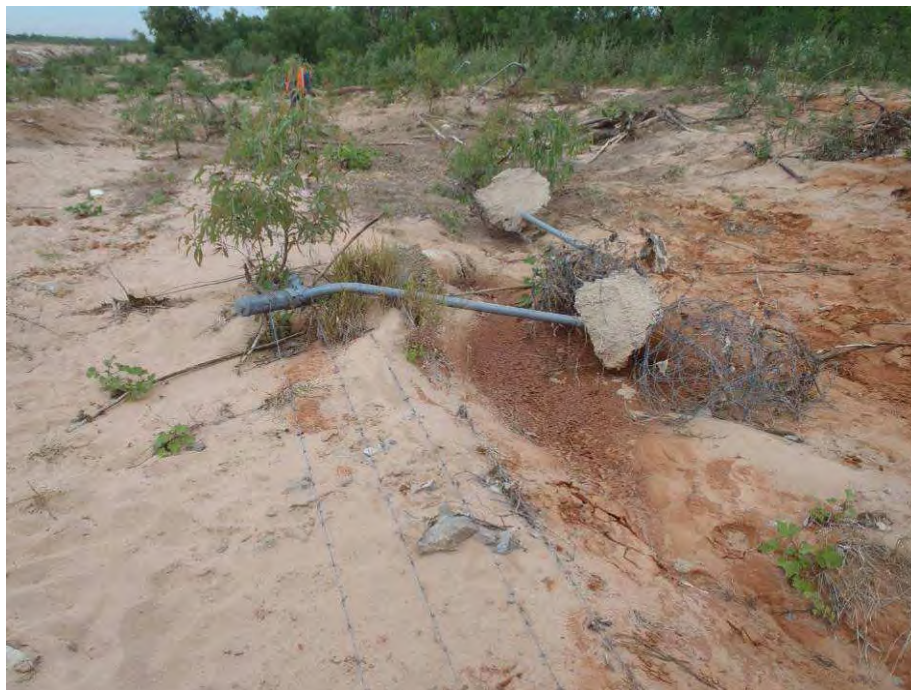
Plate 17 Old cattle exclusion fence along McArthur river diversion which may be a hazard to fauna and staff.

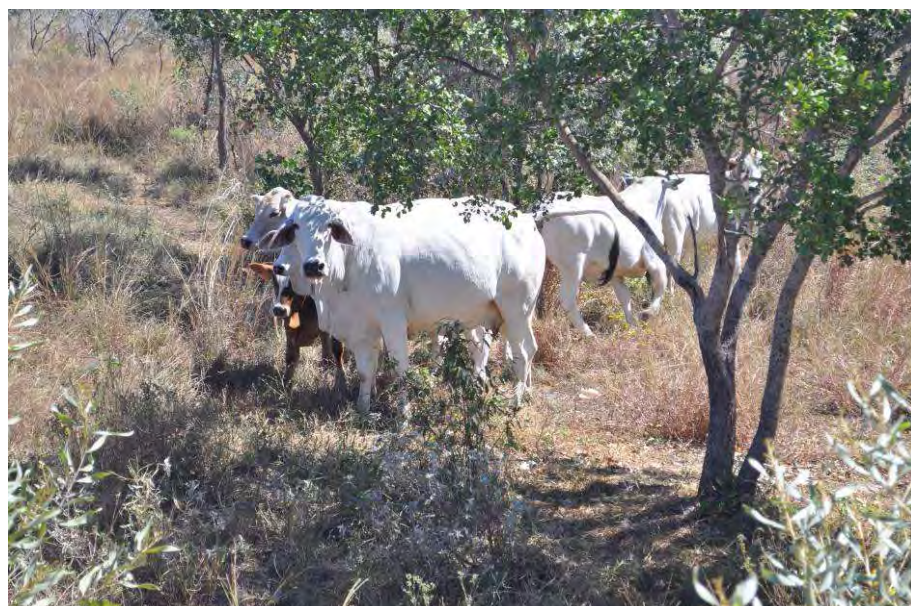
Plate 18 Cattle observed near Water Storage Dam during the IM 2012 site inspection.

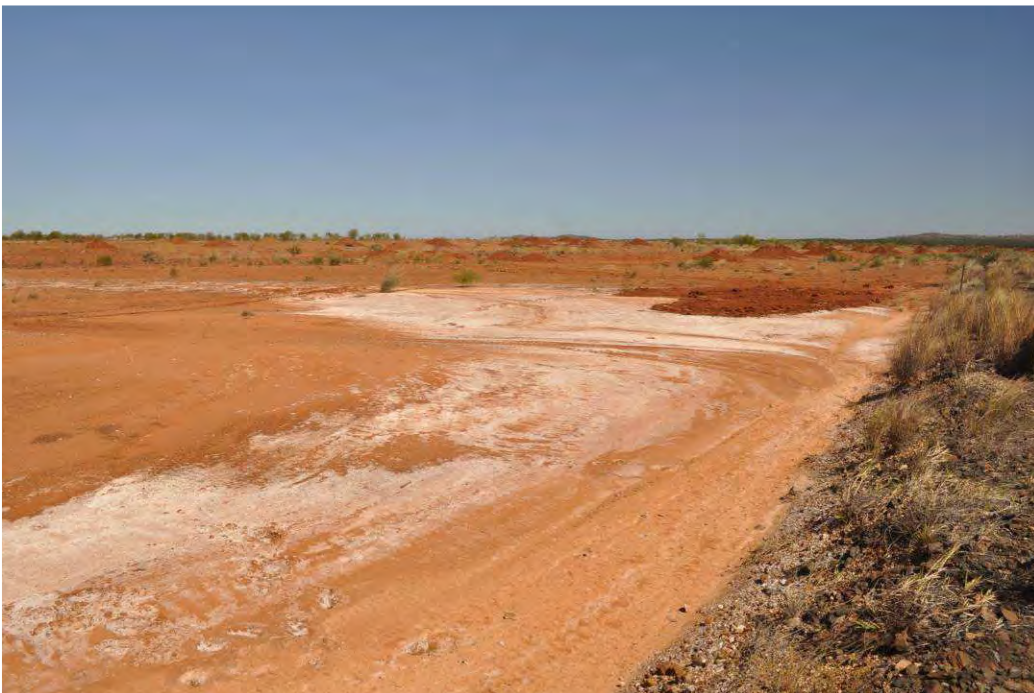
Plate 20 Sparse natural revegetation of areas of TSF cell 1 with no topsoil observed during 2012 site inspection. This area allows run-off to flow around the edge of the TSF to a collection point for pumping to TSF cell 2. Clay top soil piles will be dispersed to control area of erosion on the surface of TSF cell 1.

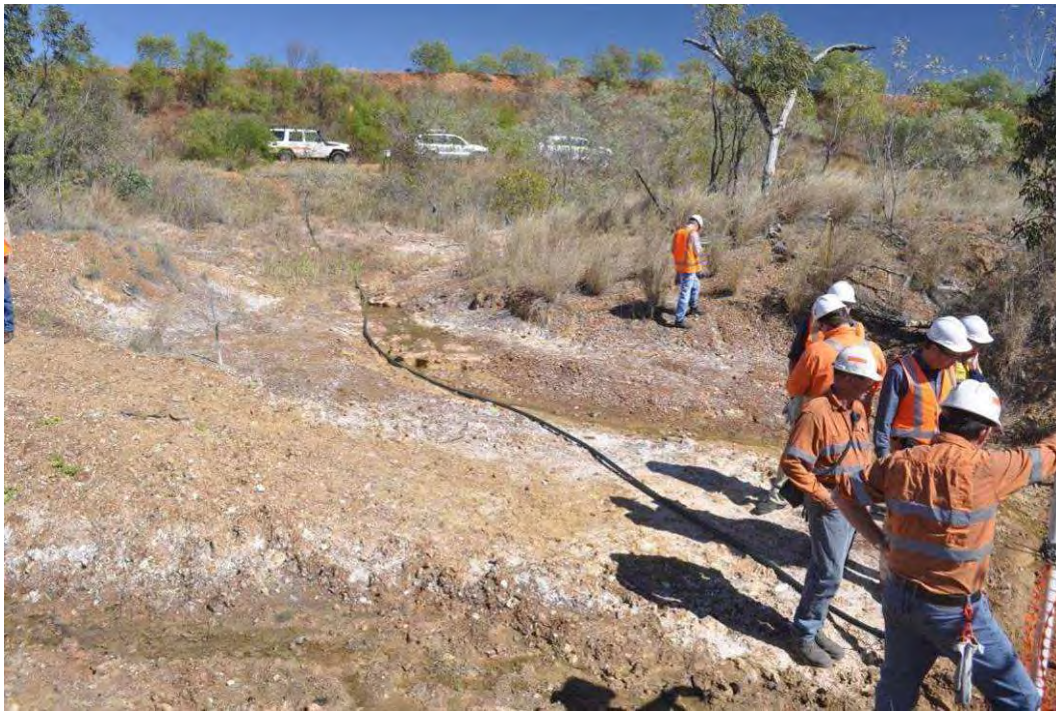
Plate 21 Salt accumulation from tailings seepage at Surprise Creek observed during May 2012. The water quality of seepage appeared to improved since the previous year, perhaps due to reduced water levels in the TSF or from fresher water travelling subsurface from the WMD.

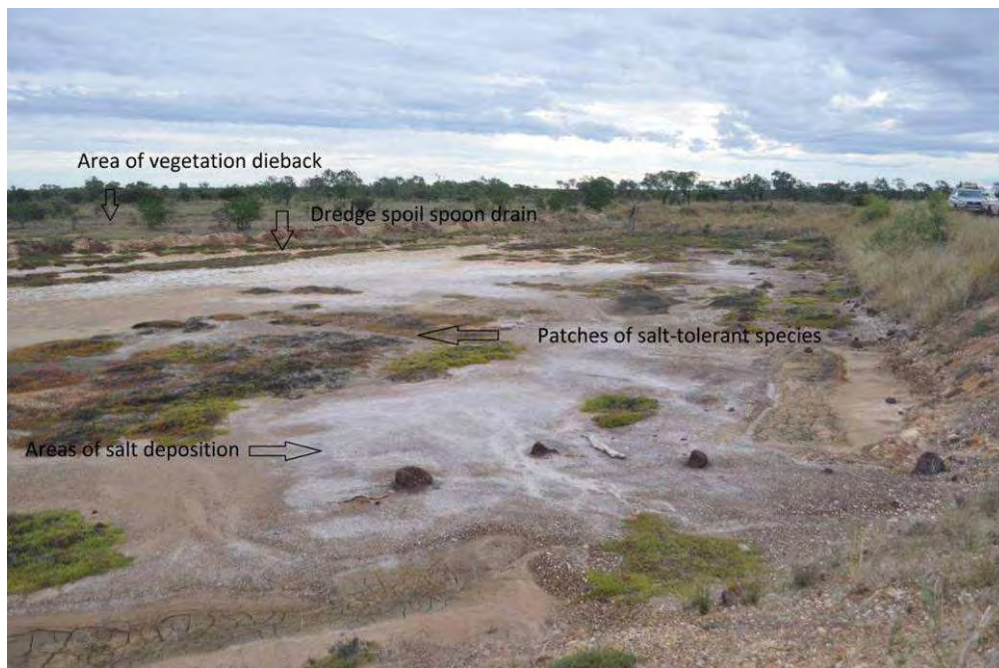
Plate 27 Photograph taken during May 2012 site inspection showing salt deposition and salt-tolerant species between dredge spoil ponds and spoon drain and area of vegetation dieback in the background. Photograph: Independent Monitor.

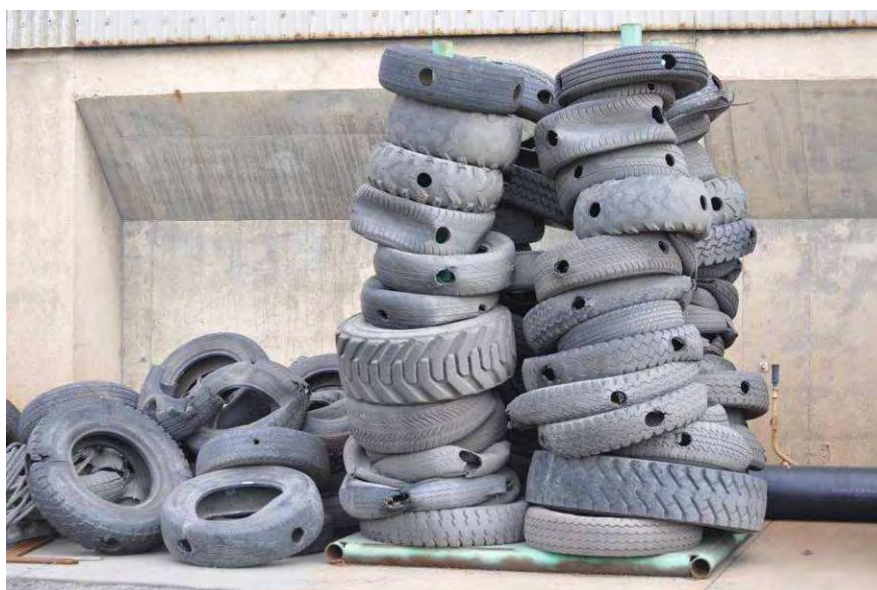
Plate 28 Tyres observed at Bing Bong port in May 2012. Most with holes bored into them. Photograph: Independent monitor.

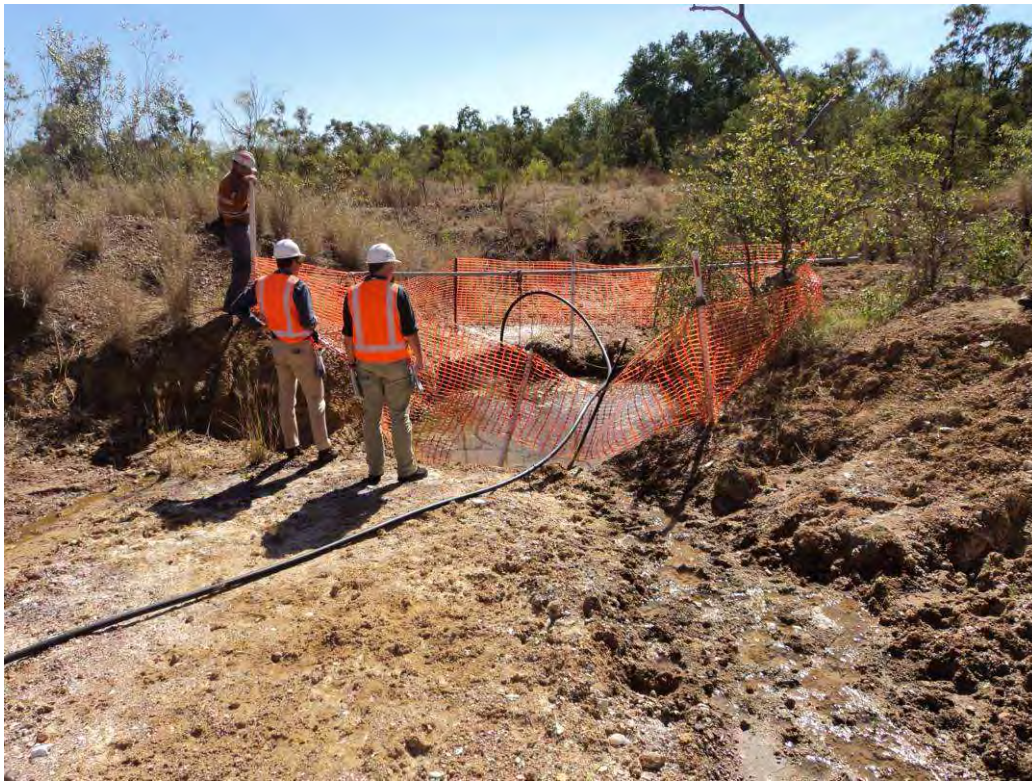
Plate 29 Seepage flowing from the toe of TSF Cell1 embankment towards Surprise Creek is captured within a sump, shown above.

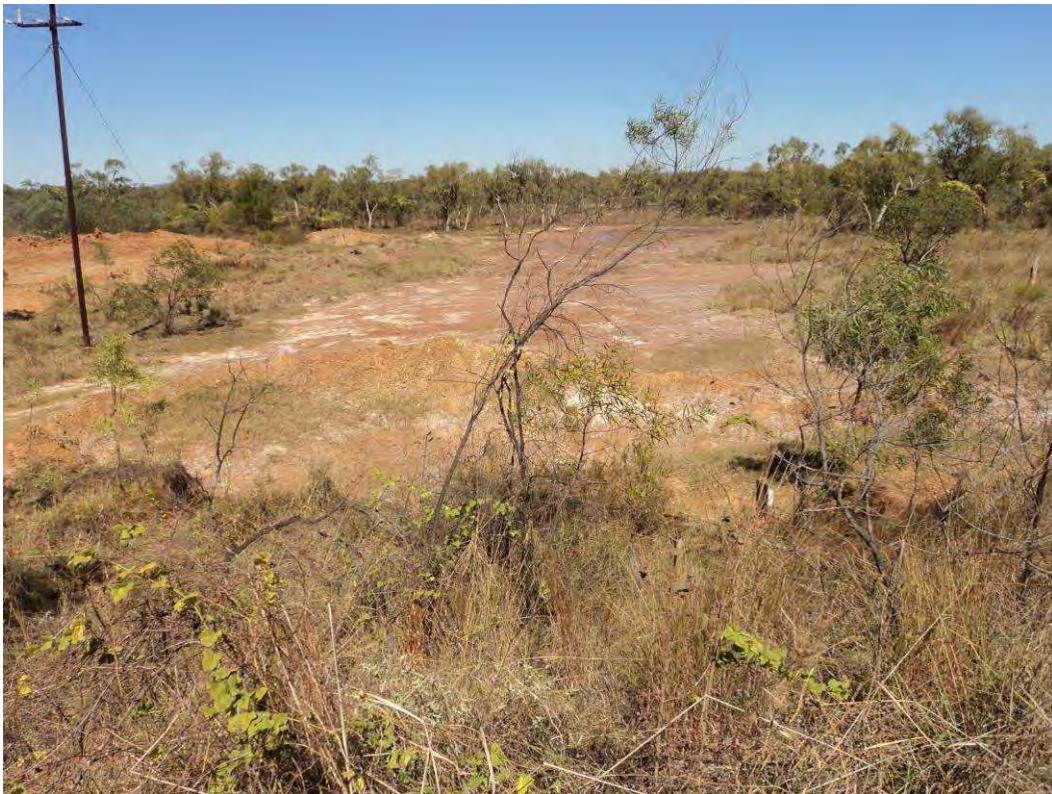
Plate 30 Seepage causing salt precipitation in an area south of the TSF Cell2, downstream from the 'contaminated waste area' of the WMD.

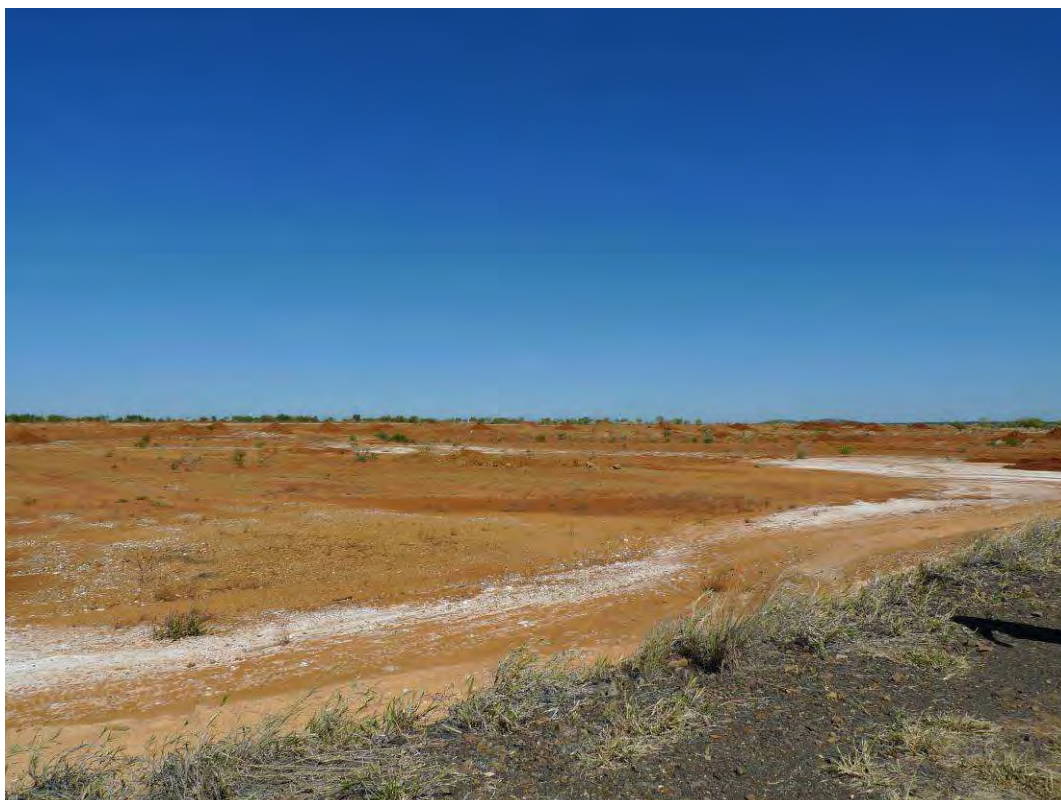
Plate 31 Salt Precipitation on clay capping of Cell 1, May 2012.

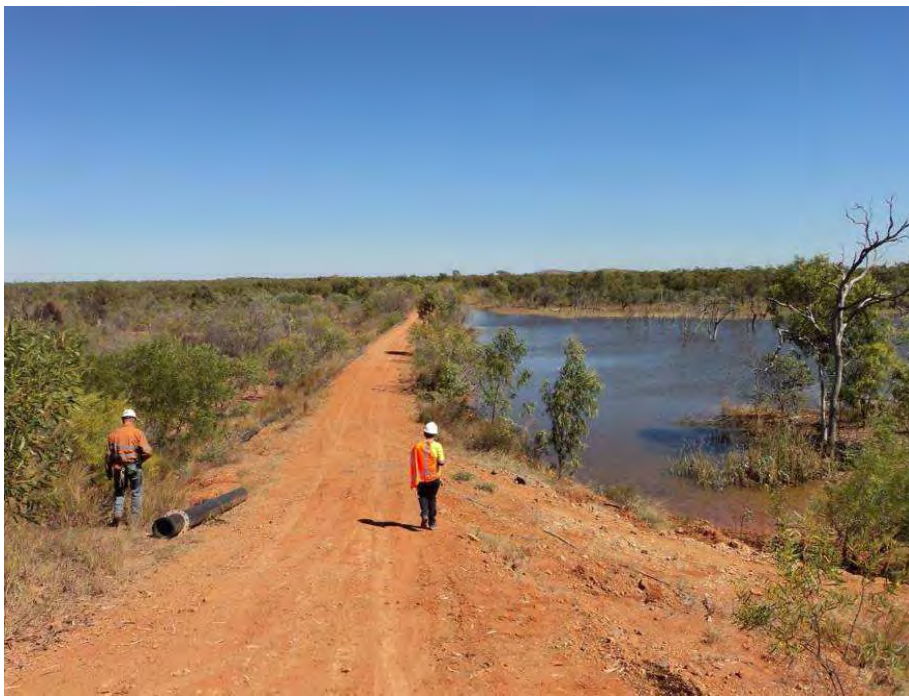
Plate 37 Poned water from Little Barney Creek, which has pooled to the east of TSF Cell 2, and north of the WMD.

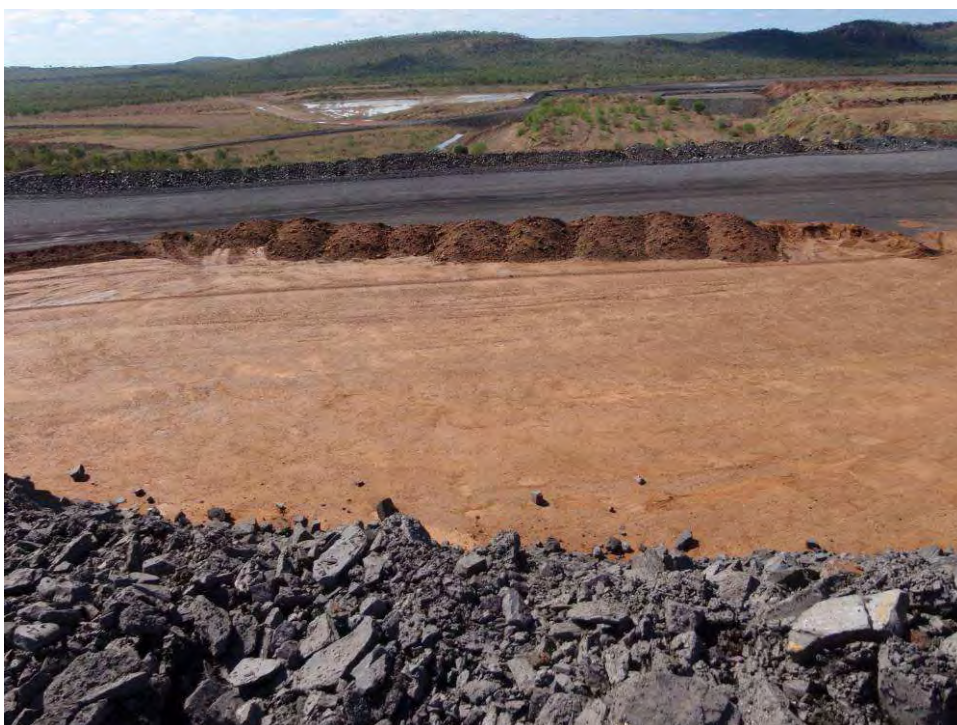
Plate 38 Area of exposed clay liner has been reduced when compared to previous years, which is a positive improvement.

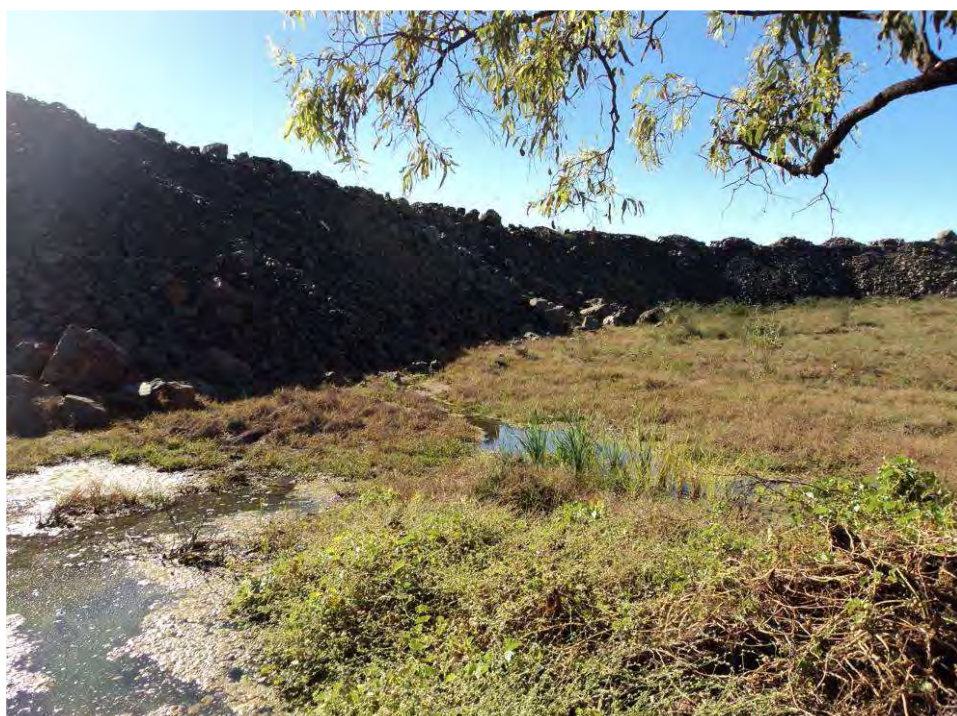
Plate 39 Area of seepage observed from the north eastern toe of the OEF. This seepage is collected in a downstream pump.

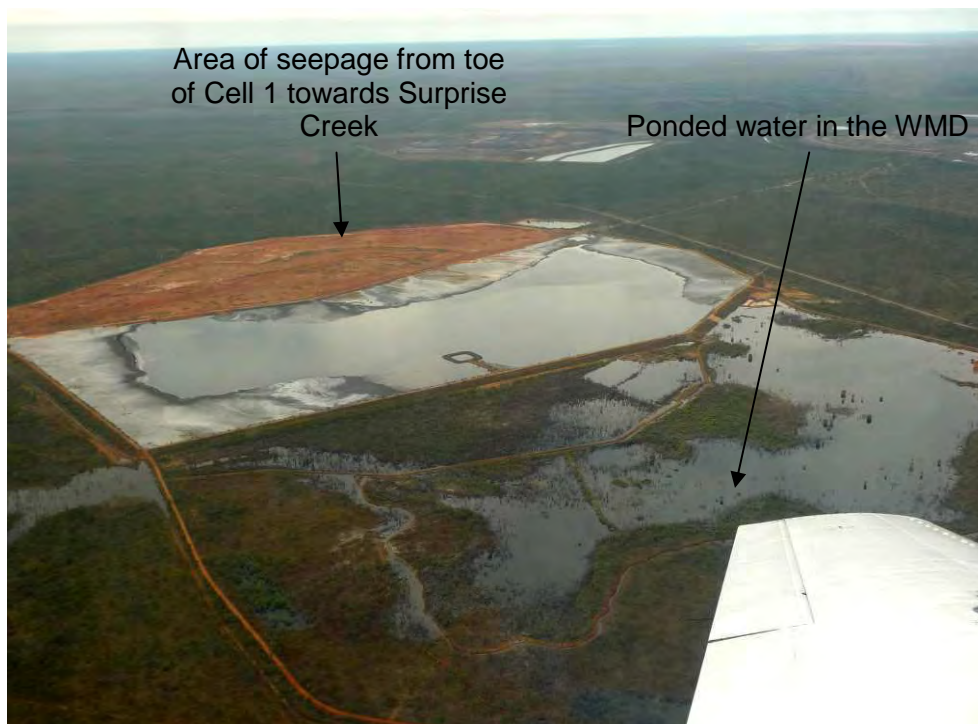
Plate 43 Ponded water within the WMD during the May 2012 site inspection.
