# McArthur River Mine Independent Monitor

## Mine Rehabilitation Audit

03 December 2025

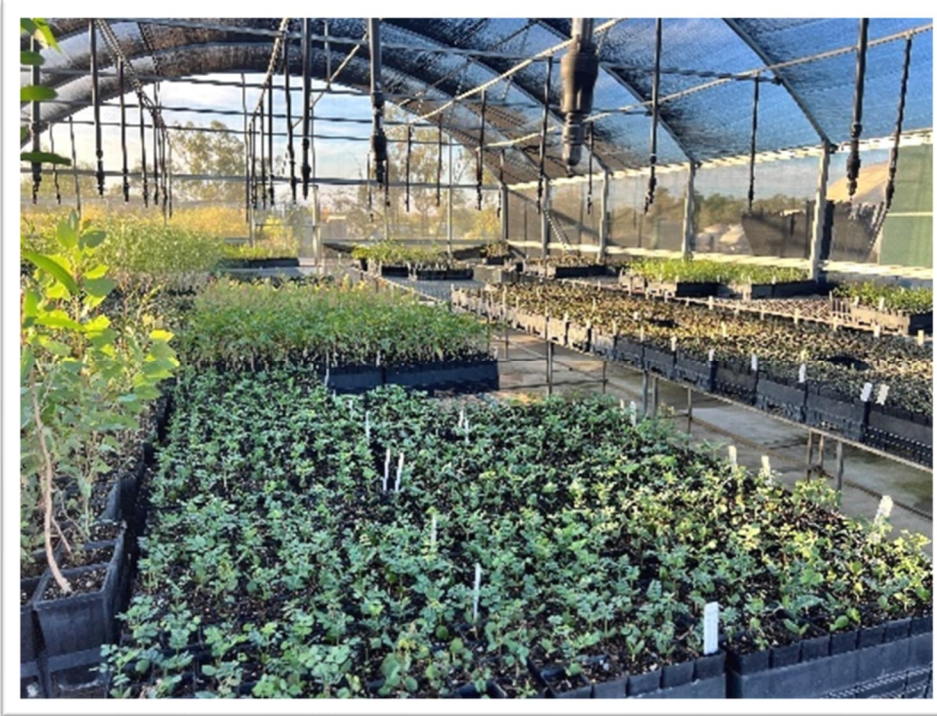
| Aspect | Item | Observation | Opportunity |
|---|---|---|---|
| Plant Nursery | 1 | <p>The Mine nursery had excellent facilities, appeared organised and effective for the needs of providing local, acclimatised plants for revegetation activities, refer photos 1 and 2. This included:</p> <ul style="list-style-type: none"> <li>• A climate-controlled seed storeroom,</li> <li>• Soil mixing bays,</li> <li>• Dedicated propagation and potting-up areas,</li> <li>• Multiple greenhouses with variable shade-cloth covers (providing different light conditions),</li> <li>• Unshaded hardening-off areas,</li> <li>• Automated irrigation and drainage systems, and</li> <li>• Effective plant, pest and disease procedures.</li> </ul> <p>The nursery has achieved annual production volumes of more than 100,000 tube stock.</p> <p>80% of the nursery tube stock is produced from seed collected by the Mine's Rehabilitation Team harvested from the local area.</p> | Nil |

| Aspect | Item | Observation | Opportunity |
|---|---|--|---|
| | | <p data-bbox="504 1093 1310 1125">Photo 1: Plants and tube stock seedlings growing in one of the nursery greenhouses</p> | |

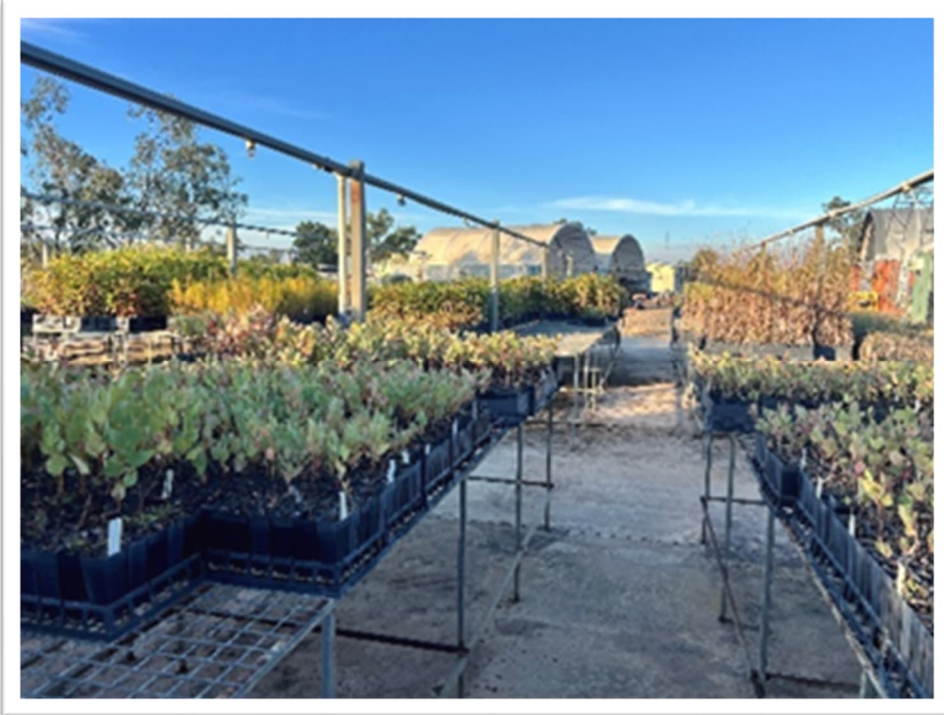
| Aspect | Item | Observation | Opportunity |
|---|---|--|---|
| | | <p data-bbox="504 1109 996 1133">Photo 2: 'Hardening-off' area at the Mine's nursery</p> | |

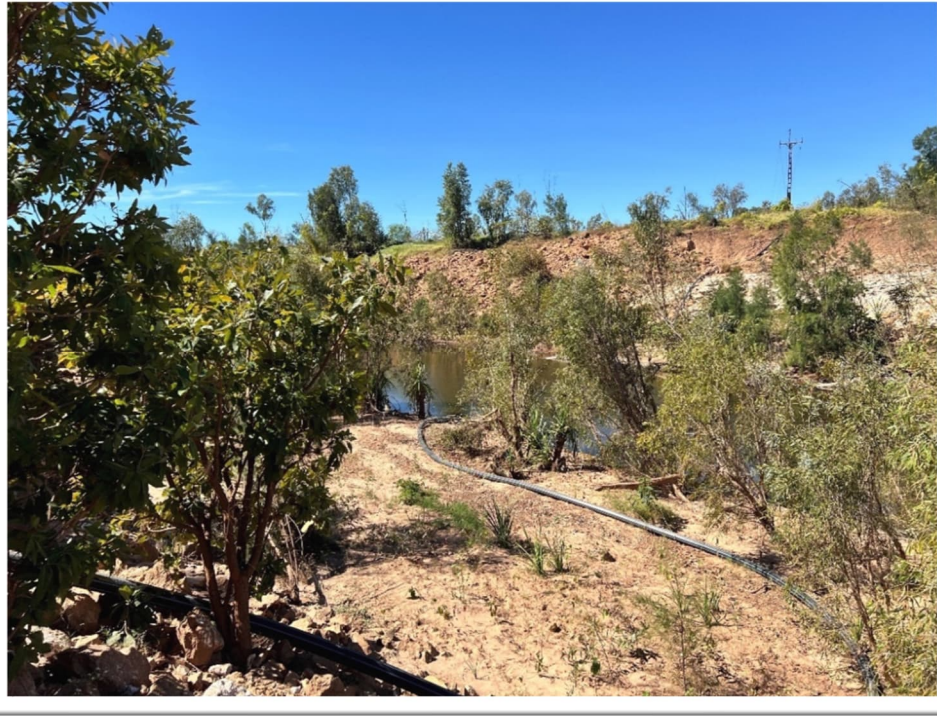
| Aspect | Item | Observation | Opportunity |
|---|---|---|---|
| Revegetation – McArthur River Diversion Channel (Lower section) | 5 | <p>Staged revegetation in the downstream section of the McArthur River Diversion Channel is progressing well (e.g., SW16 and SW17). High plant diversity, structural complexity and establishment success (maintained over multiple wet seasons) are evident. This area has relatively gentle-sloping sides, which likely reduces water velocity and erosion, supporting improved substrate conditions for growth and establishment, as well as the retention of plantings during the wet season, refer photos 3 and 4. An irrigation system is used to support establishment of recently planted areas during the extreme dry season conditions.</p> <p>In a typical year around 80,000 plants are planted by the Mine Rehabilitation Team. Unfortunately, survivability success is poor due to annual river flooding that strip the seedlings and topsoil in erosion-prone locations, such as rocky outcrops and near-vertical sides. In past years, the focus of revegetation has been on achieving high numbers of plantings.</p> | OFI: Shift the focus of revegetation activities from high numbers of plantings to targeted planting in specific areas with higher likelihood of survival success, such as high banks and adjacent flats, and areas with more gradual slopes and soil retention. |

| Aspect | Item | Observation | Opportunity |
|---|---|--|---|
| | | <p data-bbox="504 1109 1473 1136">Photo 3: McArthur River Diversion Channel, lower section, lower bank plantings and irrigation pipeline</p> | |

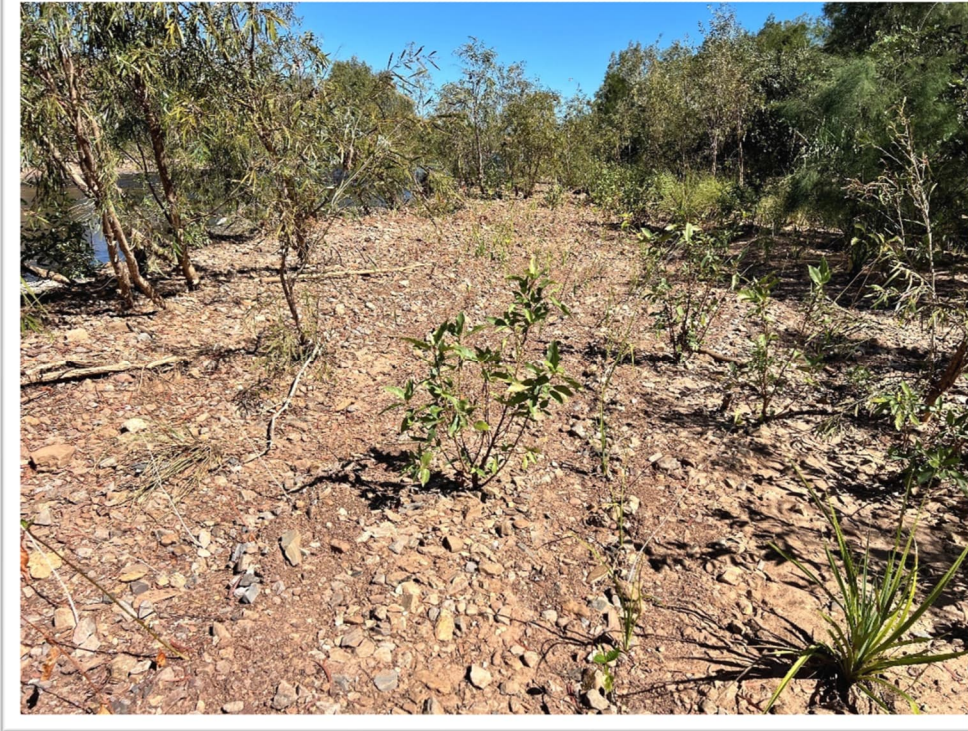
| Aspect | Item | Observation | Opportunity |
|--|---|---|---|
| | | <p data-bbox="504 1141 1444 1197">Photo 4: McArthur River Diversion Channel, lower bank 2024 plantings that survived the wet season flooding.</p> | |

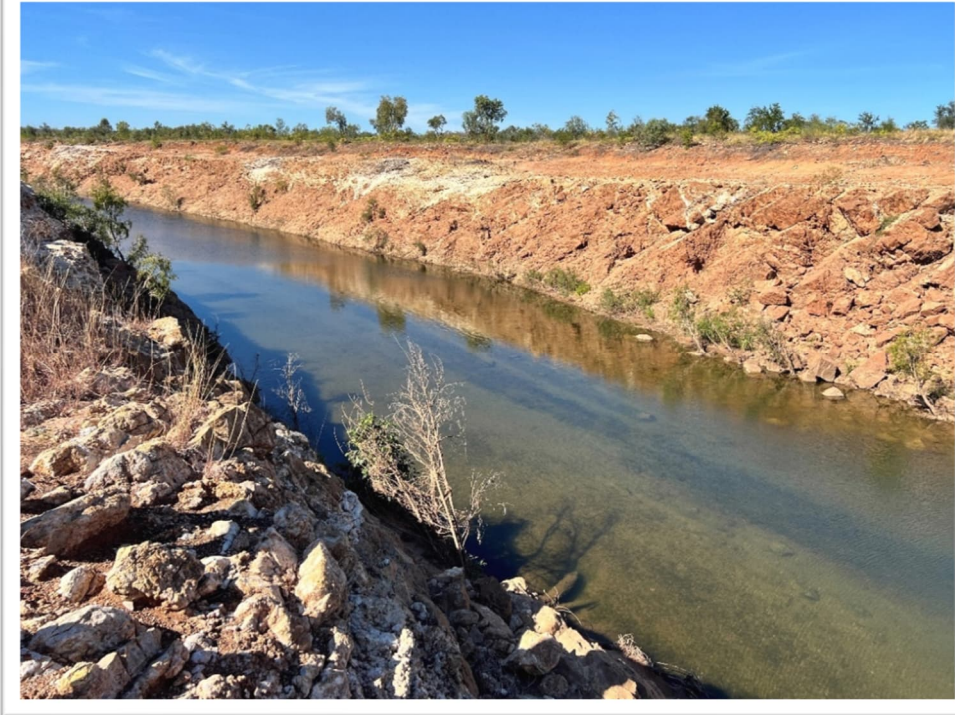
| Aspect | Item | Observation | Opportunity |
|--|---|---|---|
| Revegetation – McArthur River Diversion Channel (Middle Section) | 6 | The middle section area of the McArthur River Diversion Channel, around SW14 and SW15, is steep sided with limited vegetation and soil substrate due to the high volume and velocity of water during the wet season (up to 26 m above dry season river height), refer photos 5 and 6. | OBS: Given the challenges associated with the diversion design at the middle section location – particularly high water volume and velocity during the wet season, which hinder riparian vegetation establishment – it is recommended that revegetation efforts focus on the upper banks and adjacent flats. This approach would help achieve connectivity for fauna and establish source plant |

| Aspect | Item | Observation | Opportunity |
|---|---|---|---|
| | | <p data-bbox="504 1114 1456 1165">Photo 5: McArthur River Diversion Channel, trapezoidal middle section, rocky outcrops and annual high velocity river flows that strip topsoil and seedlings make middle bank revegetation unattainable.</p> | <p data-bbox="1505 308 2016 387">populations (i.e., seeds banks) to support natural regeneration as the river channel evolves over coming decades and centuries.</p> <p data-bbox="1505 411 2027 550">OFI: In the middle section area of the McArthur River Diversion Channel, revegetation efforts should focus on the upper banks and adjacent flats to help achieve connectivity for fauna and establish source plant populations.</p> <p data-bbox="1505 574 2049 798">While additional earthworks (recontouring and realignment of the channel) to the rock structure in this area were considered, such intervention is likely to negatively impact aquatic fauna and flora throughout the diversion. Potential consequences include altered downstream flow conditions and quality, and restricted upstream fish movement, which could undermine the ecological improvements observed in recent years.</p> |

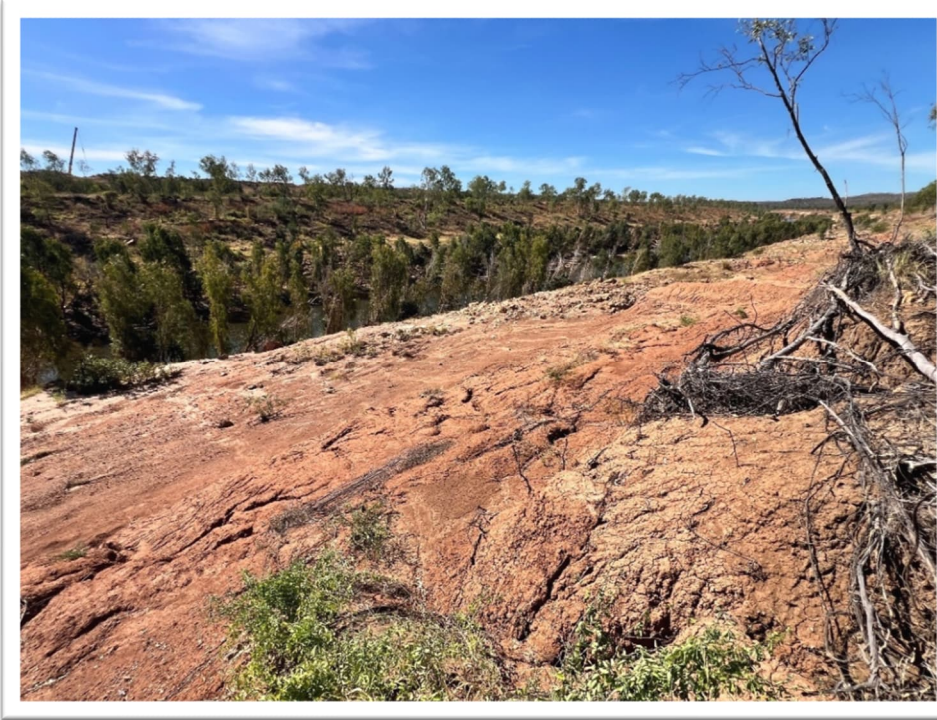
| Aspect | Item | Observation | Opportunity |
|---|---|---|---|
| Revegetation – McArthur River Diversion Channel (Middle Sections) | 7 | Both up- and down-stream of the steep-sided channel area, limited vegetation has established on the more gently sloped exposed rock middle banks due to water erosion during the wet season scalping soil and planted vegetation, refer photo 6. | OBS: Similar to the approach recommended in the middle section area, revegetation should focus on the upper banks, as well as continue to establish vegetation along the waterline margins. Establishing vegetation at these locations will enhance ecological connectivity and support the development of sustainable, self-regenerating plant populations. This strategy also reduces continued plant losses along the more erosion-prone middle bank. |

| Aspect | Item | Observation | Opportunity |
|---|---|--|--|
| | | <p data-bbox="504 1098 1460 1181">Photo 6: McArthur River Diversion, middle section, more gently sloped wider middle bank with exposed rock and no ability to retain topsoil or plantings due to flow volumes and velocity of annual river flooding</p> | |

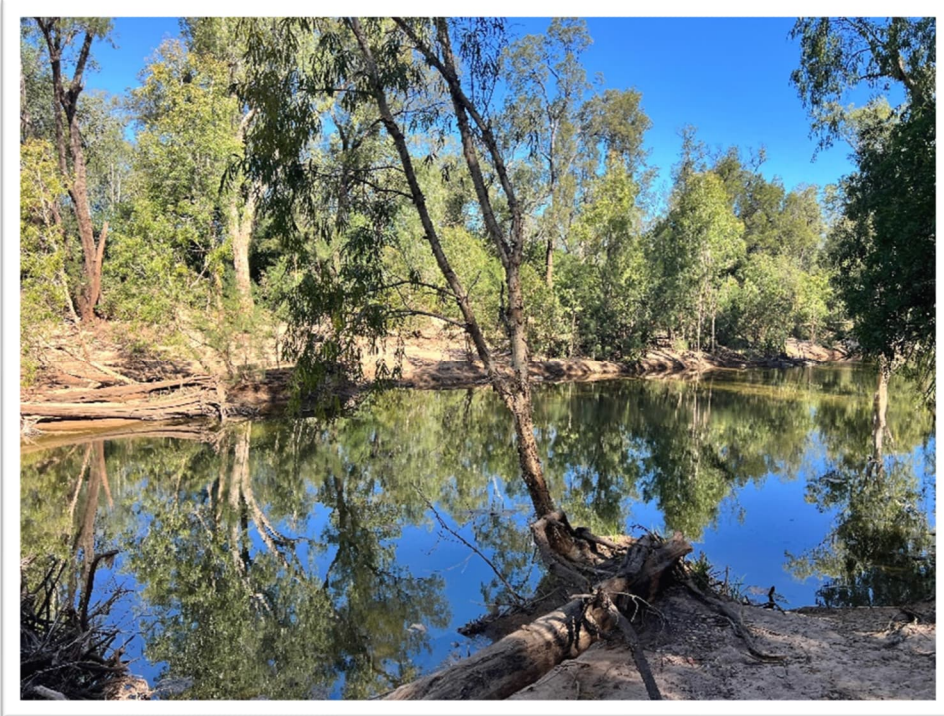
| Aspect | Item | Observation | Opportunity |
|---|---|--|---|
| Revegetation – McArthur River Diversion Channel – Control Sites | 9 | <p>One upstream and one downstream control site were inspected during the site visit and appeared appropriate comparison with the McArthur River Diversion Channel. Their proximity to the diversion and presence of remnant vegetation and representative ecosystems supports their use as appropriate reference conditions for assessing rehabilitation success, refer photo10. However, further evaluation of suitability was not undertaken due to the brevity of inspection and no additional analysis of potential</p> | Nil |

| Aspect | Item | Observation | Opportunity |
|---|---|---|---|
| | | <p>control sites and conditions.</p> <p>Photo 8: McArthur River, control site, upstream of SW10, characterised by diverse species and vertical structural complexity.</p> | |

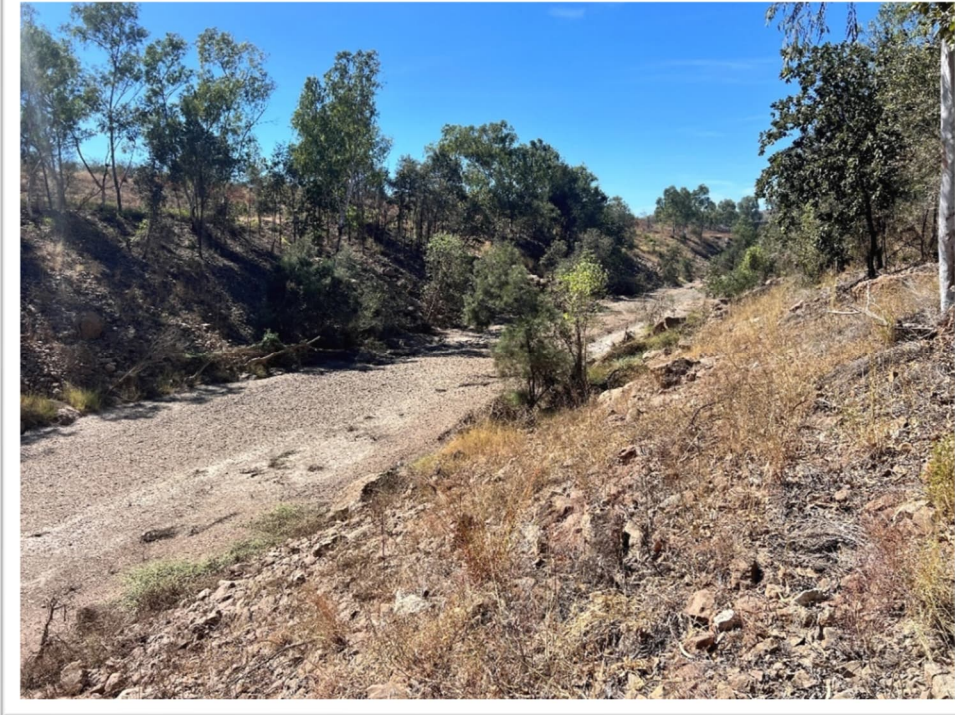
| Aspect | Item | Observation | Opportunity |
|---|---|---|---|
| Revegetation – Barney Creek Diversion Channel | 12 | <p>The revegetation in the Barney Creek Diversion Channel is advancing well, with improvements in both flora species diversity and vertical structure development. This diversion appears to be more ecologically progressed than the McArthur River Diversion Channel middle section, likely due to several factors: minimal native vegetation clearing during construction, more stable bank gradients and substrate composition, and limited high water flow duration – typically around two weeks annually – reducing erosion risk and allowing vegetation to establish for most of the year, refer photo 9. These conditions collectively create a more favourable environment for long-term revegetation success.</p> | Nil - |

| Aspect | Item | Observation | Opportunity |
|---|---|--|---|
| | | <p data-bbox="504 1125 1422 1204">Photo 9: Barney Creek Diversion Channel, middle section (upstream of haul bridge), revegetation established along the upper bank, with approximately 15-year-old eucalypts, but some limitations relating to revegetation on the rocky middle and lower bank</p> | |

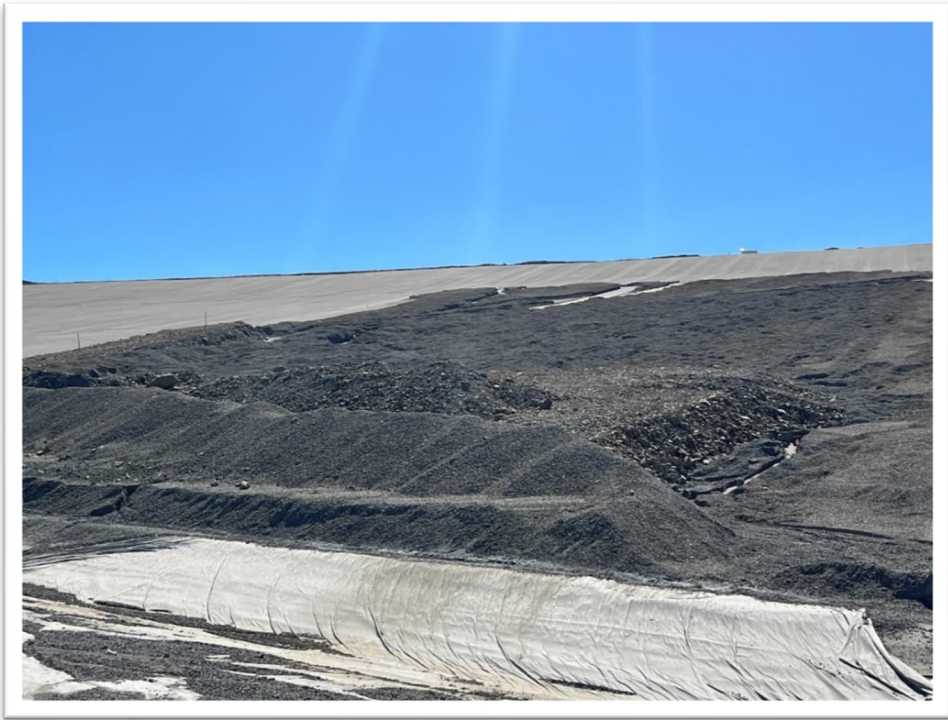
| Aspect | Item | Observation | Opportunity |
|---|---|--|---|
| North Overburden | 14 | An area approximately 10 hectares in size on the southern side of the NOEF has been designated for revegetation trials, using species composition and methods aligned with those applied successfully in | OFI: Revegetation trials should be initiated on the NOEF as soon as possible, with recognition that they will need to |

| Aspect | Item | Observation | Opportunity |
|---|---|---|--|
| Emplacement Facility | | <p>the Northern Clean Water Drain, refer photo 11. Although such trials have been proposed for several years (e.g., outlined in the RMP), implementation has not commenced, refer photo 10.</p> <p>An irrigation trial for the NOEF was planned for 2021 but has not commenced.</p> <p>Given the extensive area requiring rehabilitation (total footprint area &gt;400 ha) and the variability in substrate, slope and site conditions across the NOEF and compared to the Northern Clean Water Drain, further delays in trial initiation increase the risk of inefficiencies in identifying and implementing effective revegetation techniques.</p> <div data-bbox="524 576 1469 1299" data-label="Image"> </div> <p>Photo 10: NOEF southern face with BGM liner visible in the upper sections. Rock has been positioned (dark coloured material) on top of the BGM awaiting placement of a final growth media top layer</p> | <p>occur in phases over multiple years, and that unsuccessful outcomes are an expected and valuable part of developing robust, site-specific rehabilitation solutions.</p> |

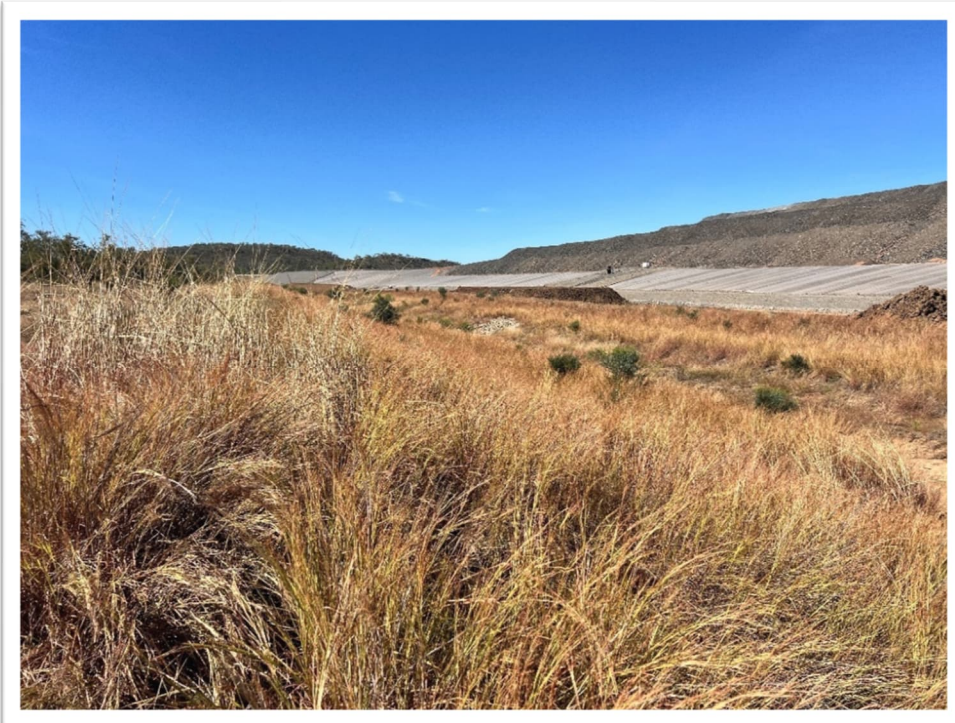
| Aspect | Item | Observation | Opportunity |
|---|---|--|---|
| Revegetation – Northern Clean Water Drain | 15 | <p>(topsoil with hydroseeding) to commence NOEF revegetation trials.</p> <p>Revegetation of the Northern Clean Water Drain, hydro-seeded in late 2022, has been successful, with multiple mature grass species effectively stabilising the banks, refer photo 11. Additionally, natural encroachment of shrubs species is contributing to further structural stability and ecological development of the area.</p> <p>Photo 11: Northern Clean Water Drain view east from the top bank, note natural encroachment of shrub species</p> | Nil |

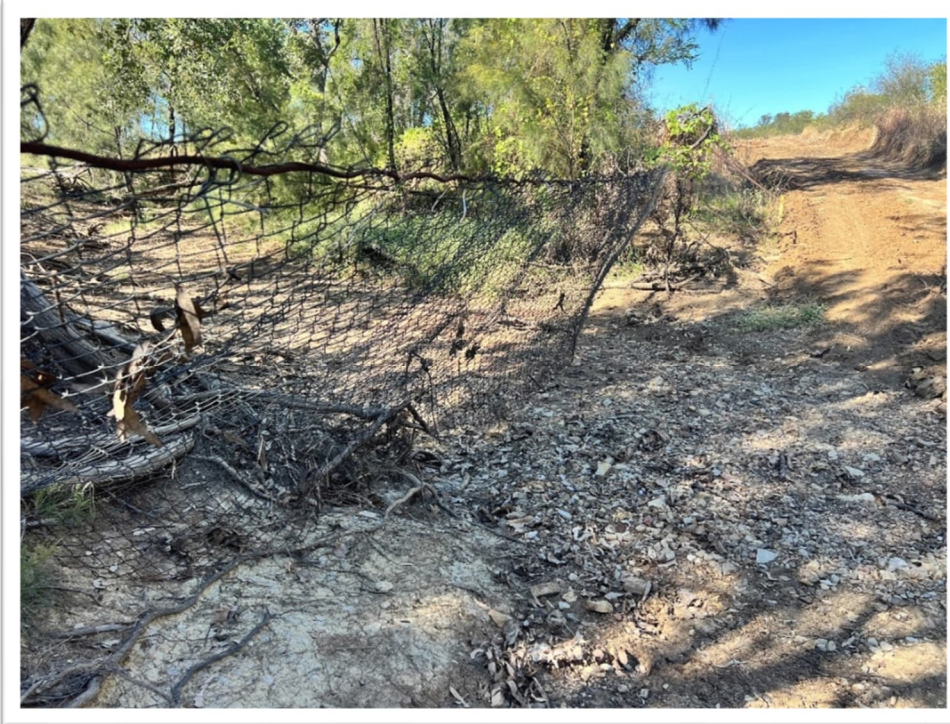
| Aspect | Item | Observation | Opportunity |
|---|---|---|---|
| Weed and Pest Animal Management - Livestock | 17 | <p>Livestock management practices continue to improve at the Mine, to minimise adverse impacts on revegetation from grazing and/or habitat degradation. Notably, several pivoting cattle floodgates have been installed at key waterway entry and exit points, typically access track fords across the waterway. These structures restrict cattle access while allowing unimpeded water, fish passage and debris flow during high-flow events, refer photo 12.</p> <p>The cattle floodgate in Barney Creek was first trialled in 2023 and since that time, a further five (5 installed and 2 more planned ) have been installed at selected waterways across the mining lease. The floodgate appeared effective during inspection, with no cattle observed within operational or rehabilitation areas of the Mine, although some cattle tracks were present in the Northern Clean Water Drain and along the McArthur River Diversion Channel, indicating occasional incursion.</p> <p>Under MRM Cattle Management Plan , any cattle observed within the lease area must be removed through a muster within four days of detection. These measures ensure proactive management of grazing pressure and protection of sensitive revegetation areas, particularly those supporting cane grass and Purple-crowned Fairy-wren habitat.</p> | <p>OBS: Ongoing maintenance, monitoring and targeted improvements are essential to enhance the effectiveness of cattle management measures. Given the higher palatability and ecological sensitivity of cane grass, areas supporting or intended to support this species should be prioritised for the continuation of regular inspections-to help detect early signs of grazing pressure and allow for timely intervention to protect critical habitat for target riparian fauna.</p> <p>OFI: Continue regular inspection, weekly during the dry season, to help detect early signs of grazing pressure and allow for timely intervention to protect critical habitat for target bird species, namely Purple-crowned Fairy-wren.</p> |

| Aspect | Item | Observation | Opportunity |
|---|---|---|---|
| | | <p data-bbox="504 1109 1249 1133">Photo 12: Cattle floodgate on Barney Creek, located near Carpentaria Highway</p> | |
