# Independent Monitor Community Report 2008 Operational Period

Community Report by the Independent Monitor for the Period  
October 2007 to September 2008

Welcome to the second Annual Community Report by the Independent Monitor of the McArthur River Mine (for the period from October 2007 to September 2008)

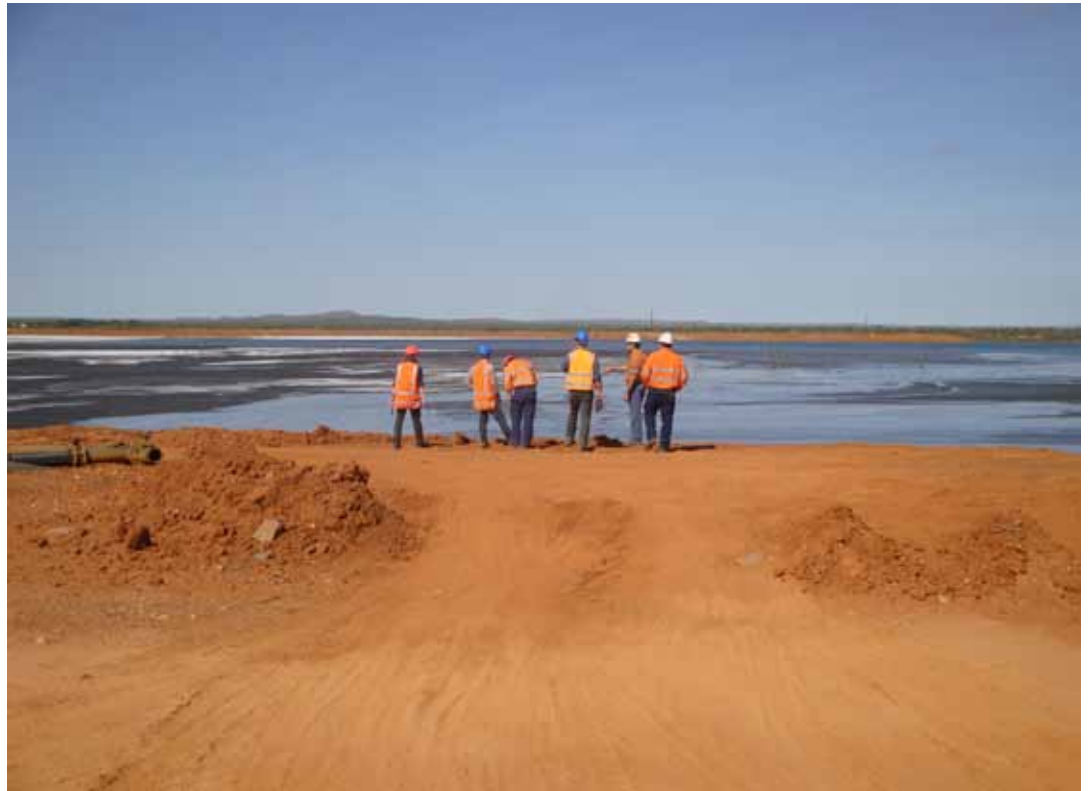
The Independent Monitor and MRM inspecting the clay layer covering the Tailings Storage Facility (foreground) with fresh tailings in the distance. (Photo by Independent monitor, June 2009)

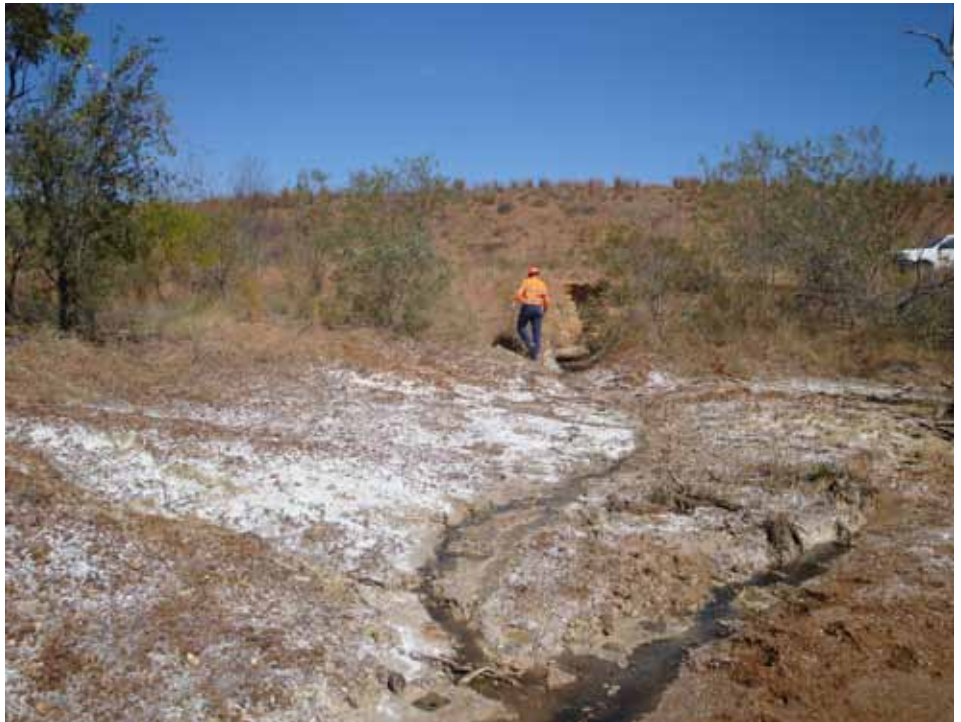
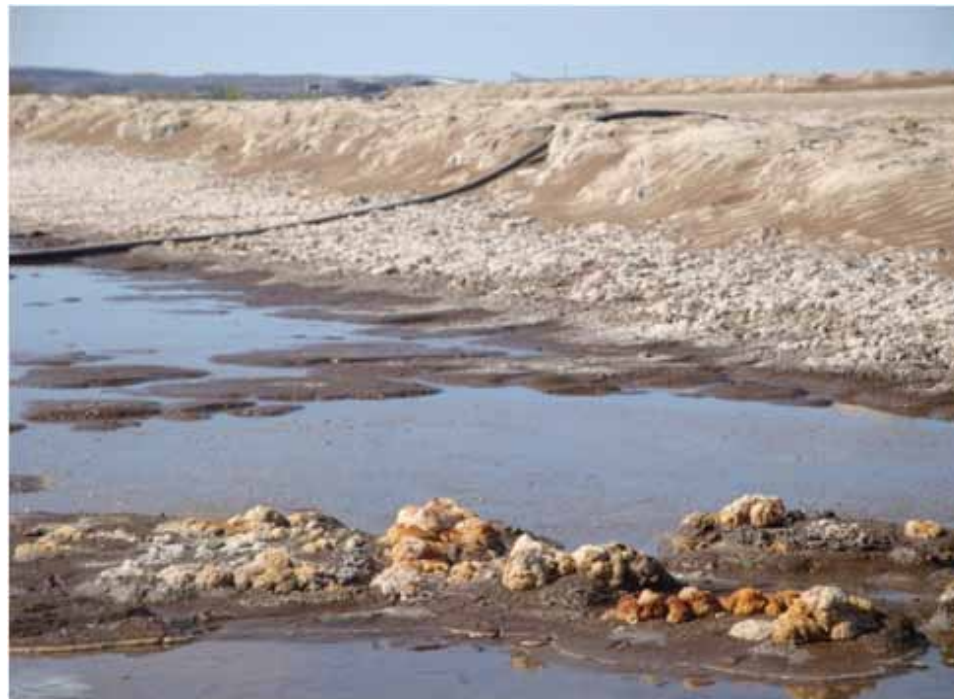
Tailings seepage draining from the foot of Tailings Storage Facility Cell 1 into Surprise Creek (above), and Iron sulfate salts at the surface of Cell 1 (below) (Photo June 2009, Independent Monitor).

in June 2009, the Independent Monitor noted that water from the recovery bores was being pumped back to the top of Cell 1 and applied across the surface to minimise dust emissions. This recovered water was seen to form a "moat" around the outer surface

of Cell 1, which eventually drained into Cell 2. Iron sulfate crystals were observed within the moat (see photograph above), which is indicative of acidic conditions (pH of between 3.6 and 3.8). Field testing of this water later in the week by MRM confirmed that the

pH of this water was between 3.4 and 3.8.

The amount and rate of acid generation from the Tailings Storage Facility and the impact of the acid on the geopolymer barrier continues to be unknown. As such, predicting the impact on the environment and designing the necessary mitigation measures cannot be readily achieved at this time.

The Independent Monitor provided detailed recommendations for further investigation into this matter in a letter to the General Manager of McArthur River Mining and to DRDPIFR. In response, MRM have subsequently undertaken further investigations including:

- external expert consultation;
- additional recovery bores and groundwater monitoring;
- updated groundwater modelling including electromagnetic survey; and
- further tailings dust suppression to eliminate the need to apply water from the recovery bores.

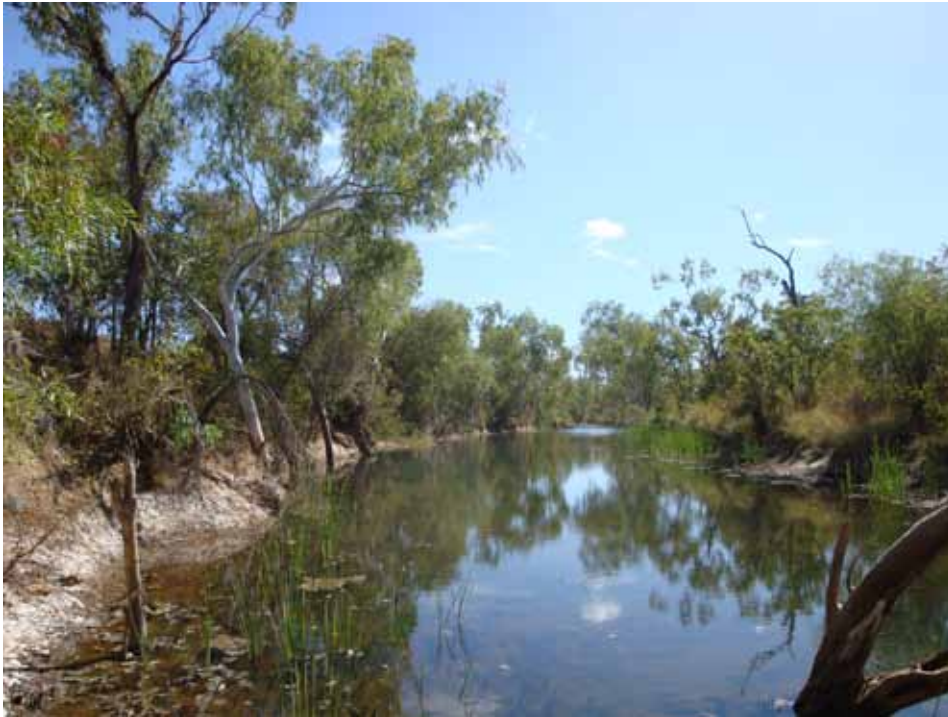
Cell 1 at the Tailings Storage Facility is unlined and in close proximity to Surprise Creek. The presence of alluvium (sands, sandy-clays and silts) and also potential 'paleochannels' (conductive discrete zones of sands and gravels) have resulted in leachate seepage from the Tailings Storage Facility to the creek (as shown in photograph top left). Tailings seepage occurred within two years of commencement of tailings deposition into the facility (circa 1997) and, although it was acknowledged that the tailings may acidify over time, it was considered unlikely in the short-term and unlikely that heavy metals from the tailings would be mobilised.

Salt crystals from Tailings seepage along the edge of Surprise Creek (photo June 2009, Independent Monitor)

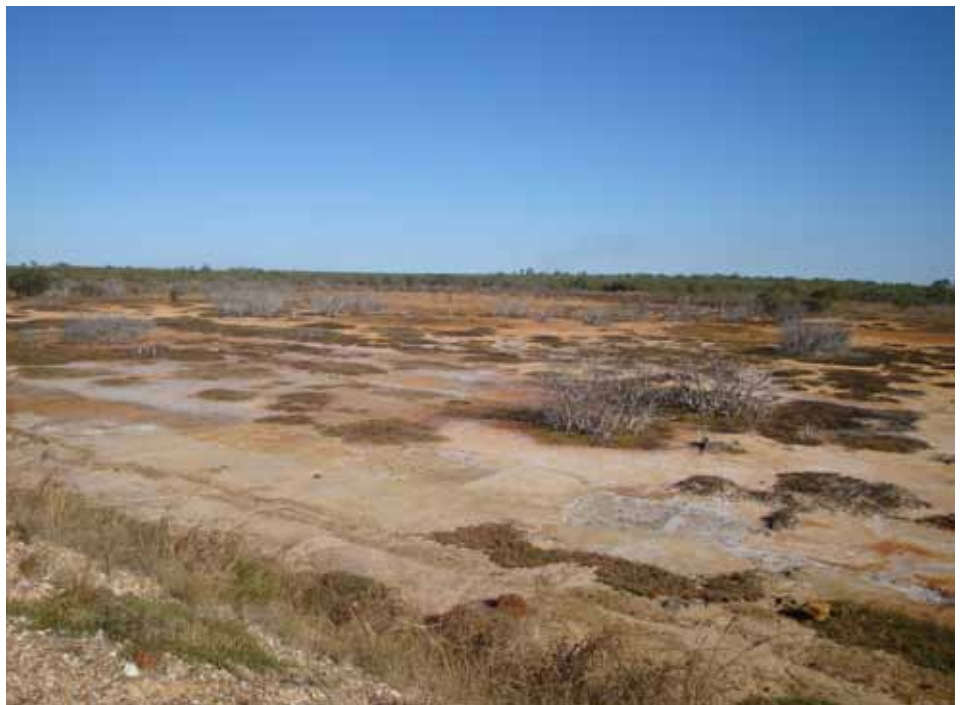
to saline seepage from the ponds that contain dredge material at the Bing Bong Port facility. During the June 2009 site inspection, the Independent Monitor noted significant vegetation die-back and salt crystallisation immediately outside of the dredge pond walls, indicating that saline seepage is migrating through the degraded dredge pond walls. The pond walls and drain design are required to be remediated to ensure that saline seepage does not continue to affect the surrounding land, as shown in the photograph below.

Salt-affected land outside of dredge spoil ponds at Bing Bong Port (photo June 2009, Independent Monitor)

The Independent Monitor recommended that MRM review the future use of the dredge spoil ponds so that this facility can be remediated to meet its environmental and engineering performance objectives in line with generally acceptable industry standards. It was also advised that a Management Plan be developed to include regular environmental and geotechnical inspections and monitoring.

MRM have since undertaken soil sampling around the dredge spoil ponds to investigate the extent and migration of saline leachate impacts, and will also review vegetation dieback through aerial photographs. Recent steps have also been taken by MRM to

reconstruct drains and spillways to divert saline seepage back to sea prior to the next dredging event. The Independent Monitor will review the progress and effectiveness of these and other related mitigation works as part of next year's audit.

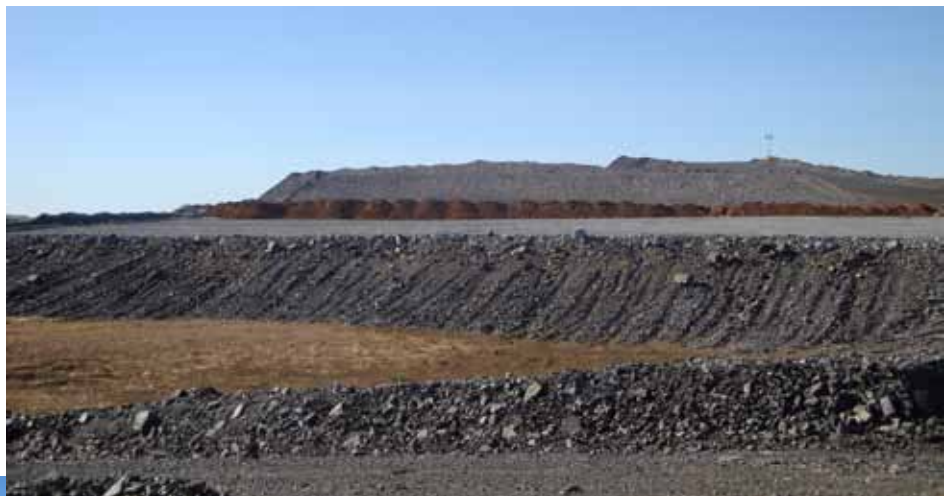
The Overburden Emplacement Facility where waste rock from mining is placed (Photo June 2009, Independent Monitor).

- The Independent Monitor has identified the need for in-place testing of the clay material that lines the base of the Overburden Emplacement Facility. It is important to test this clay liner to ensure that it is physically and chemically suitable to provide geotechnical stability and reduce infiltration of potentially acidic water within the Overburden Emplacement Facility. It is apparent that adequate

testing of this layer has not been undertaken (which was a non-conformance outlined on Page 6), however MRM have stated that this testing will be undertaken as part of future Overburden Emplacement Facility expansions;

was also identified as a non conformance last audit). MRM have stated that these non-conformances will be addressed and rectified through: revegetation trials at Bing Bong Port; improved testing of Overburden Emplacement Facility liner materials in accordance with a new procedure; and the commencement of the mosquito monitoring, respectively.

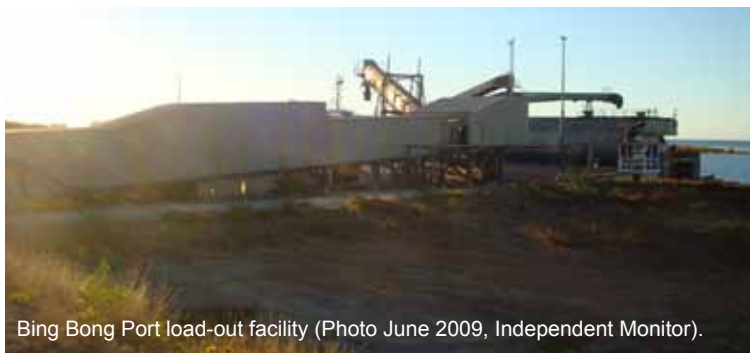
The Independent Monitor is concerned about dust emissions from the Bing Bong load-out facility, as zinc and lead-laden dusts from the concentrate shed are known to be carried by wind from the site and deposited within

marine sediments and terrestrial soils. Unfortunately, the doors to the concentrate shed must remain open so that dangerous gases do not build up within the shed, however this requirement increases the potential for dust to escape.

Bing Bong Port load-out facility (Photo June 2009, Independent Monitor).

the Bing Bong facility to limit the potential for dusts to blow from the site. However, the Independent Monitor recommends that a detailed

fugitive dust study be undertaken at Bing Bong to define the nature and extent of dust emissions, and help determine appropriate mitigation strategies.

MRM have committed to undertaking a dust audit within the next six months, which will highlight any sources of dust generation that require improvement or mitigation.

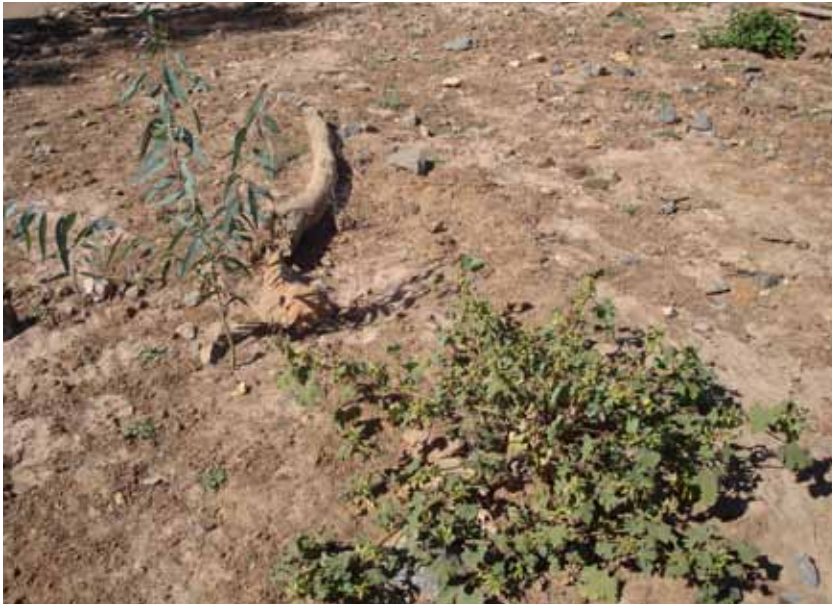
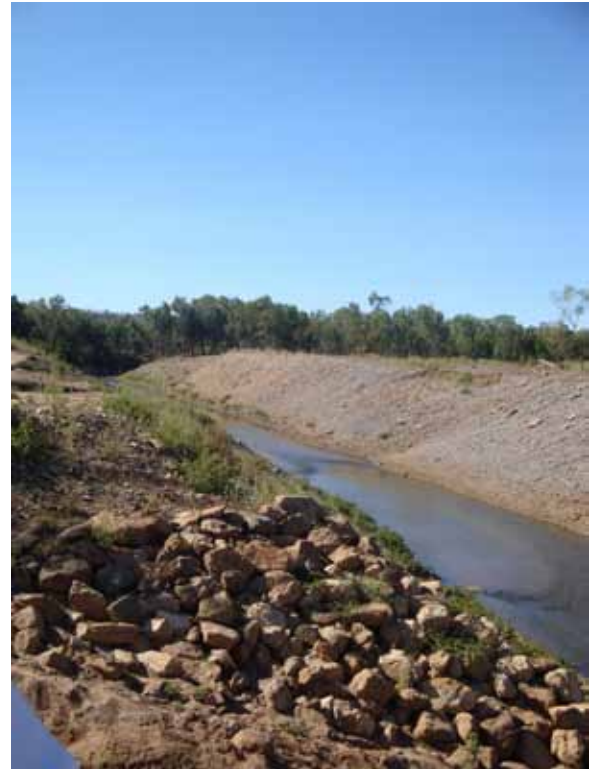
(Above) Nogoora Burr (*Xanthium occidentale*) (right) and native Eucalyptus (left) observed along the McArthur River diversion channel (Photo by Independent Monitor, June 2009).

(Right) Weed infestation lining a portion of the McArthur River diversion channel (Photo by Independent Monitor, June 2009).

The Independent Monitor will be keeping a close eye on revegetation and weed management along the river diversion channels at the mine site. The Independent Monitor observed infestations of weeds, namely Nogoora Burr (*Xanthium occidentale*), along the river diversion channels during both the December 2008 and June 2009 inspections. Whilst MRM have put considerable effort into weed control along the Barney Creek diversion, including spraying and manual removal, the same efforts had not been applied to the McArthur River diversion. The Independent Monitor recommends that additional efforts are required to minimise weeds in the rechannel works.

Since the Independent Monitor's June inspection, MRM have advised that additional resources will be committed to the ongoing weed control program prior to the 2009/2010 wet season, and acknowledged that this work must be continuous during both the initial rehabilitation stage and throughout the life of the Mine.

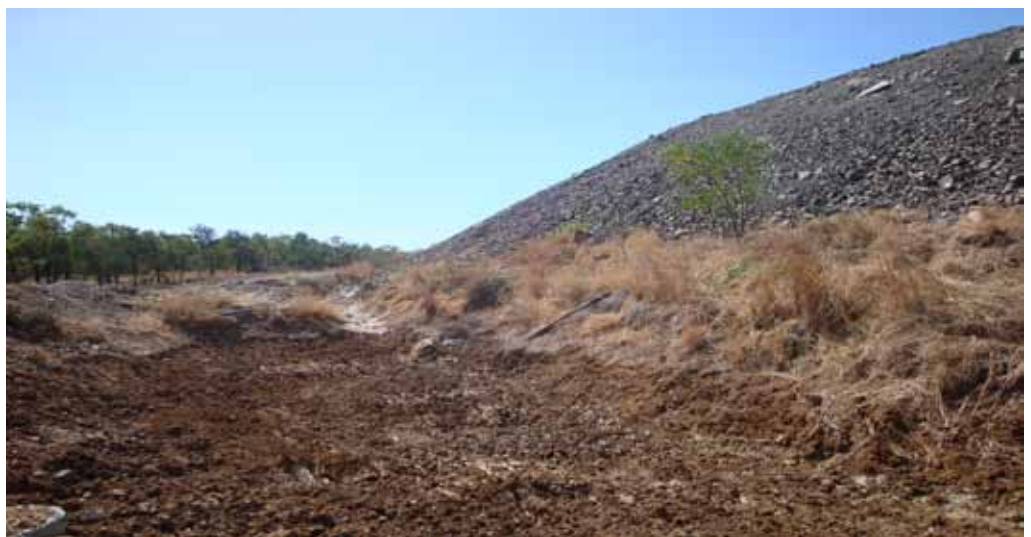
- A drain and sump at the base of the Run of Mine Pad that failed during the last wet season floods was also flagged by the Independent
- Monitor as requiring improved design and rehabilitation (see photograph above). This sump has since been rehabilitated and the Independent Monitor will examine its effectiveness during next year's site inspection;
- The generation of dust from the Run of Mine Pad towards Barney Creek and its tributary is of concern,

Failed drain and sump at the base of the Run of Mine Pad at the Mine site undergoing rehabilitation (Photo June 2009, Independent Monitor).

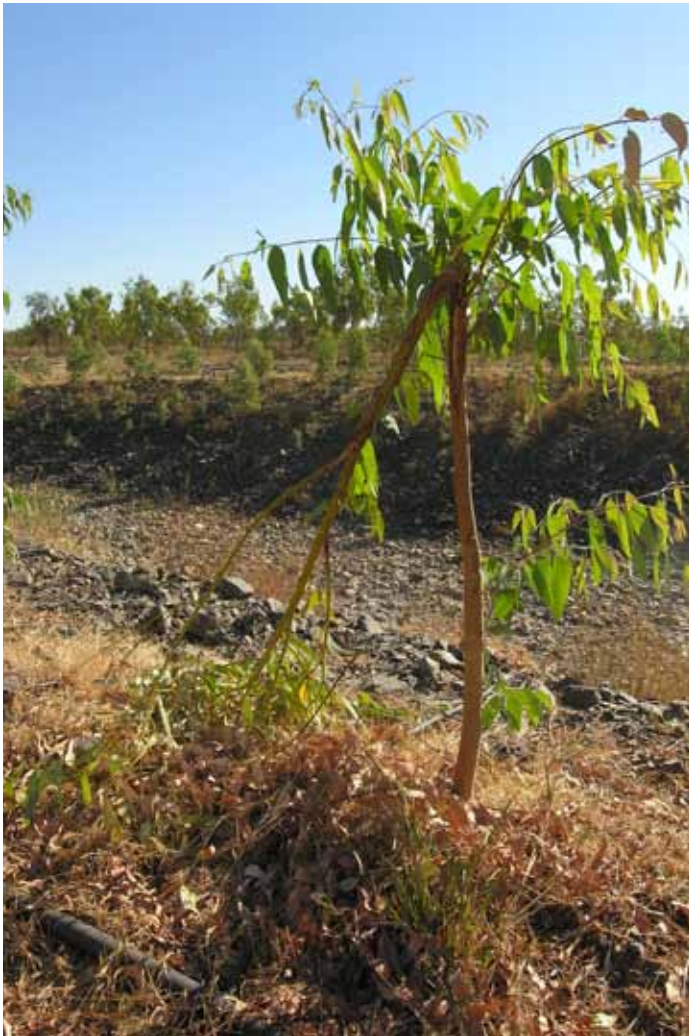
Eucalypt along Barney Creek Diversion that has been damaged by cattle or feral donkeys (Photograph supplied by MRM, June 2009).

- Some asphalted and paved surfaces at the Bing Bong load-out facility were identified as being in poor condition and were recommended to undergo rectification so as to protect the underlying soil from becoming contaminated by site operations. MRM have committed to rectifying these areas; and
- The rapid maintenance of fencing damaged by annual floods must be undertaken by MRM to ensure that cattle and feral donkeys do not hinder rehabilitation efforts along the river diversions by causing erosion and destroying young plants (see photo to the left).

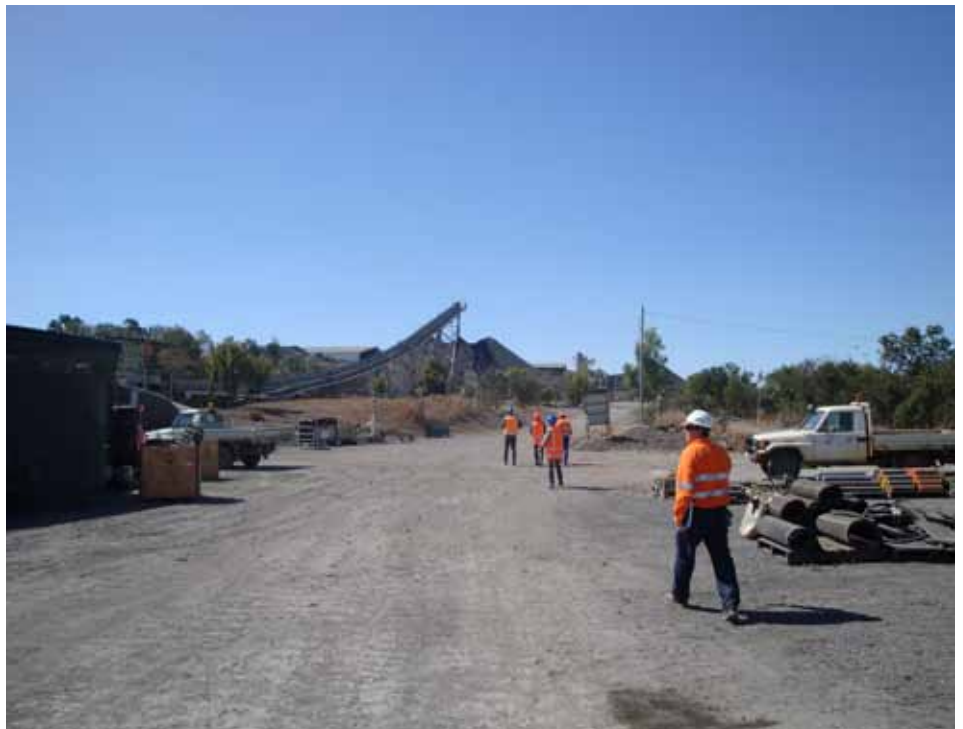
and the Independent Monitor will closely monitor the effectiveness of recently implemented dust monitoring and mitigation measures such as additional sprays and a new dust management plan for the crushing facilities;

Run of Mine Pad at the mine site (Photo June 2009, Independent Monitor).
