16 November 2011

Independent Monitor's Audit Report of the McArthur River Mine for the 2010 Operational Period.

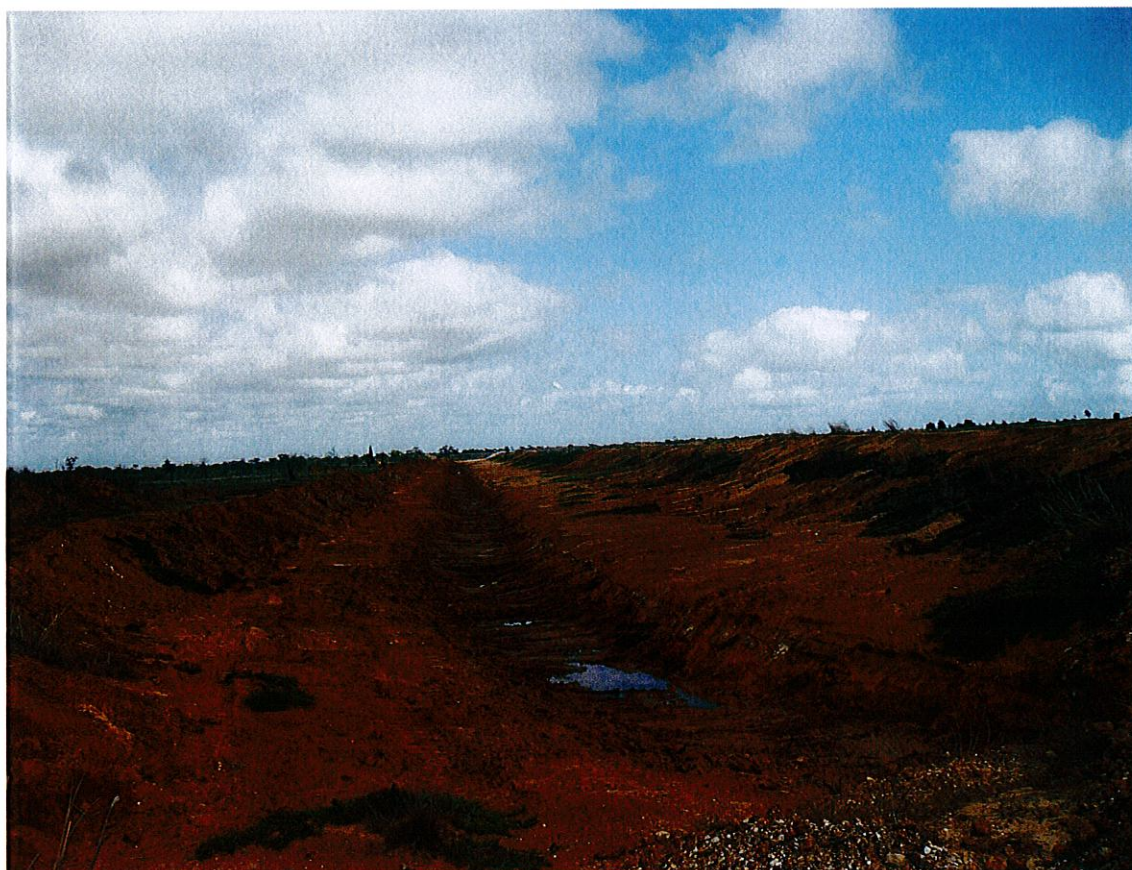
The structural integrity of the Bing Bong dredge spoil pond walls remains as a significant issue this year.

Since the IM's 2010 visit operational work was undertaken on the perimeter and internal walls prior to the 2010/2011 wet season and in early 2011 while rain was still occurring. Material was placed on batters of the last cell and along the perimeter road in order to rectify areas of erosion. All flow through points between cells were also breached in order to allow water to free flow between cells.

Figure One - Completion of cleaned out perimeter drain around Bing Bong dredge spoil

During this year's audit inspection some earthworks were shown to the audit team which occurred during the late part of the wet season. As stated to the IM, further work was planned prior to this wet season and has been completed already as per the following pictures.

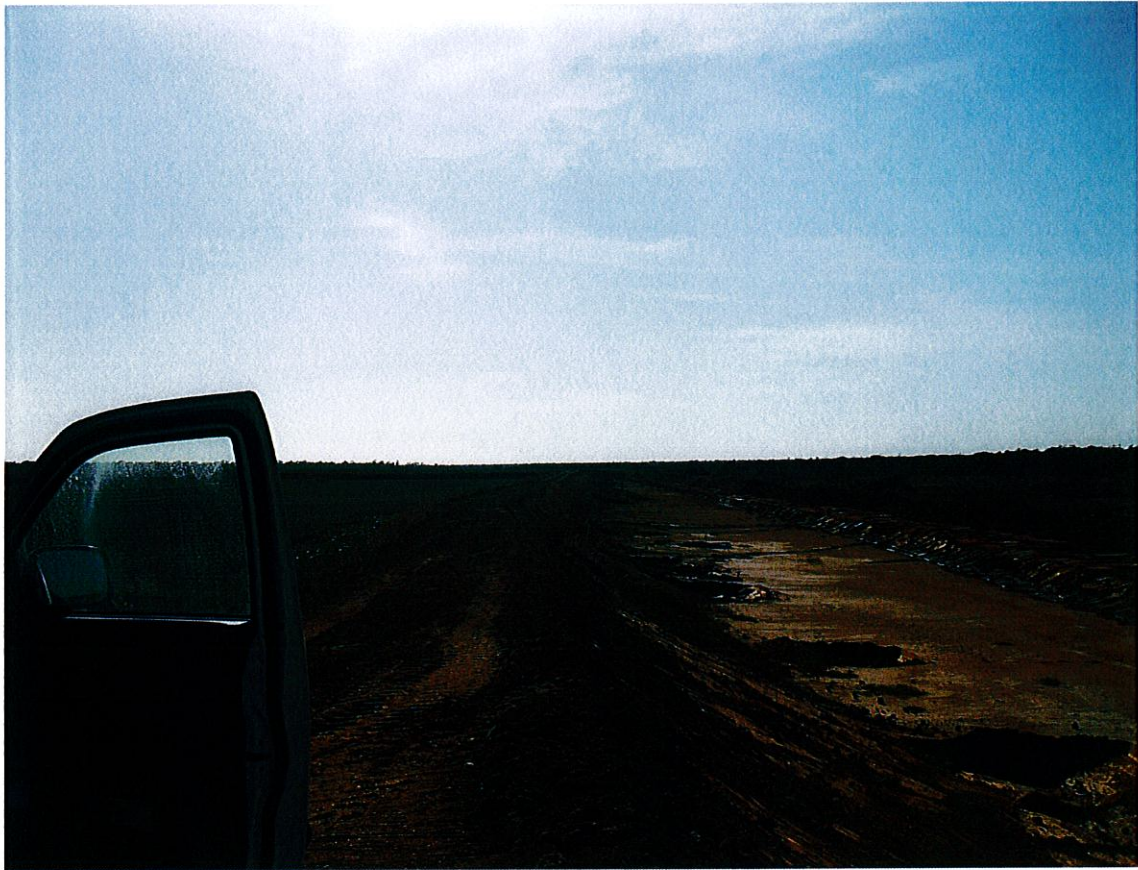
Figure Two – Earthworks completed on perimeter road around Bing Bong dredge spoil

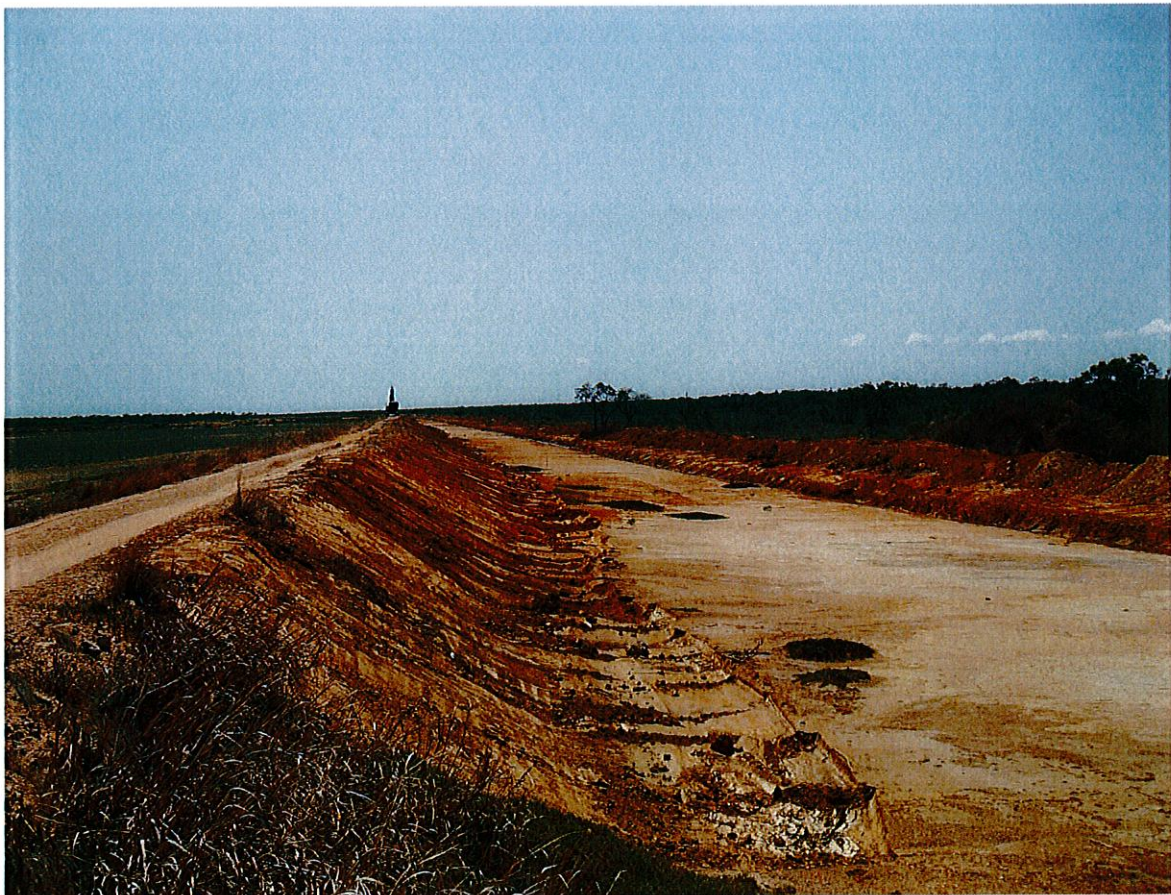
Figure Three- Earthworks completed on perimeter road around Bing Bong dredge spoil (2)

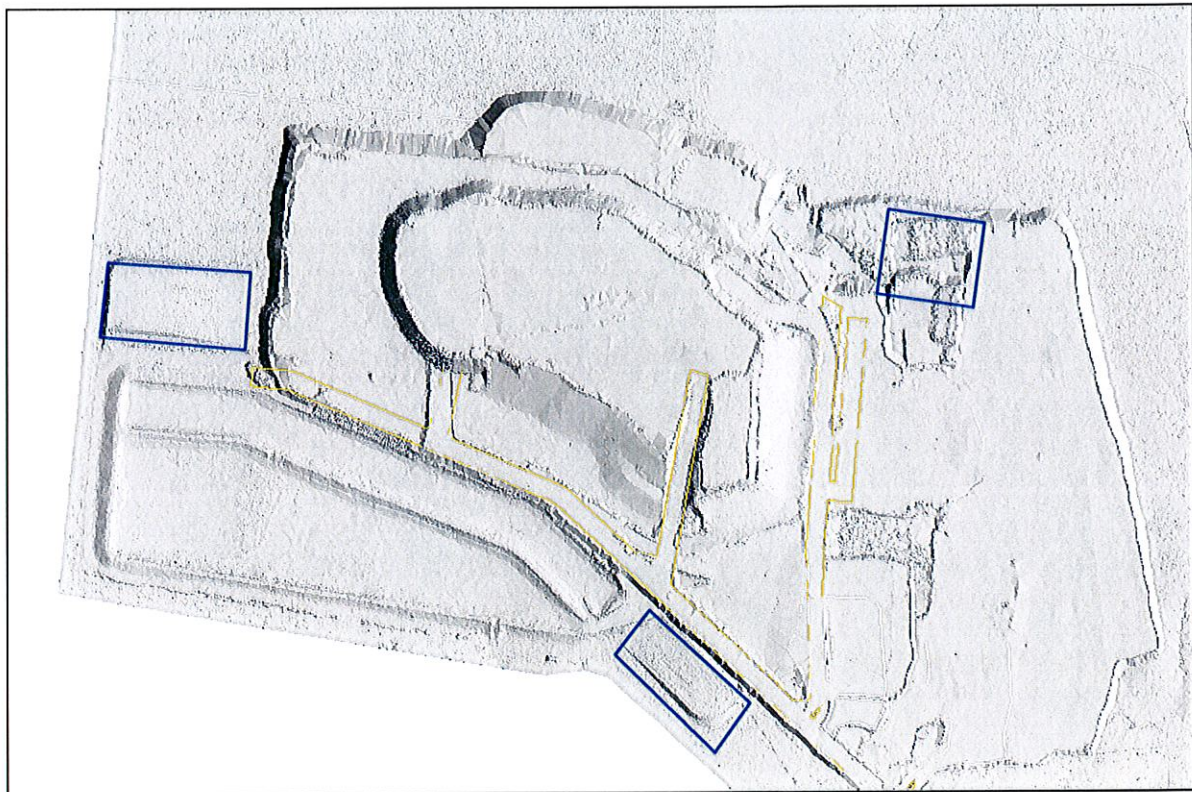
The report states that topsoil stockpiles are not enough for rehabilitation of the tailings dam or waste dump. This is incorrect.

Topsoil is currently stockpiled in three locations at the NOEF. Topsoil is stripped from the ground to expose a clay layer prior to placing a NAF base. Generally up to 300mm of topsoil is removed. The survey pick up of the NOEF as shown below shows the stockpile locations (highlighted in blue).

Figure Two- Topsoil locations at the Northern OEF
