Independent Monitor ENVIRONMENTAL PERFORMANCE ANNUAL REPORT 2017-2018

McARTHUR RIVER MINE

SEPTEMBER 2018
Report No. 01164F_1_v2

**Independent Monitor
Environmental Performance Annual Report
2017-2018**

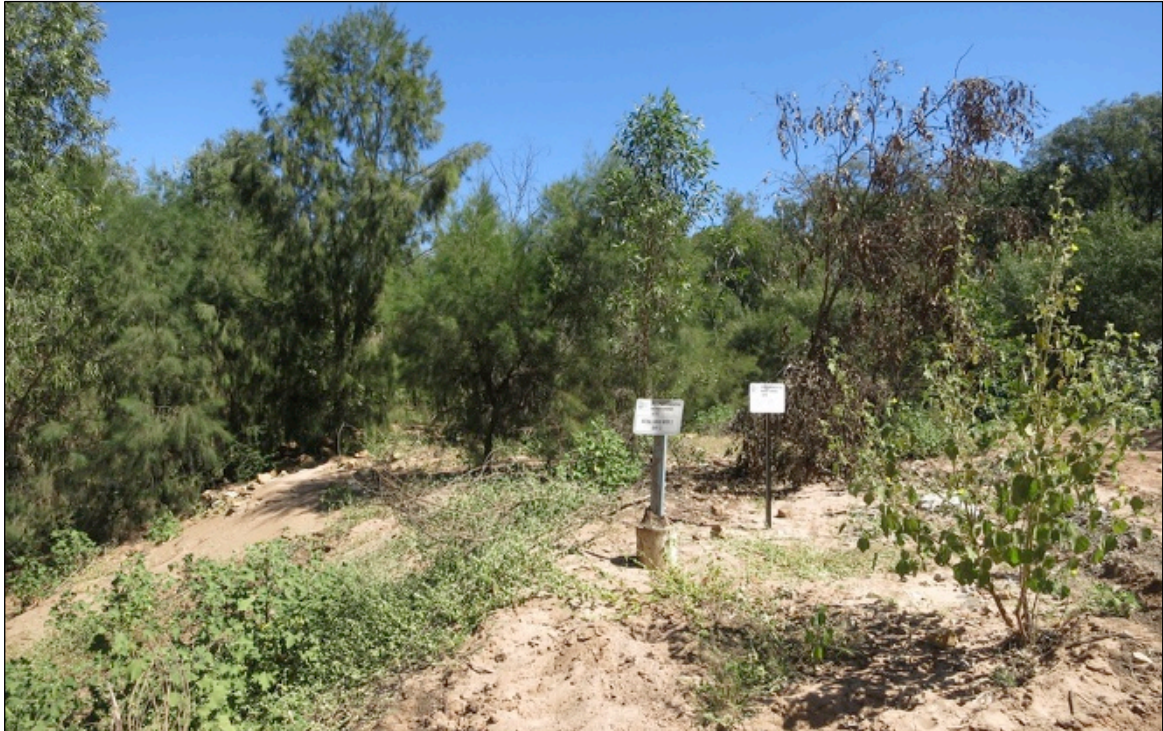
Plate 4.10 – Salt Deposition and Flood Damaged Vegetation at the Barney-Surprise Creek Confluence Observed During the 2018 IM Site Visit
