# Independent Monitor **COMMUNITY REPORT**

McARTHUR RIVER MINE

November 2016

## Environmental Performance 2015

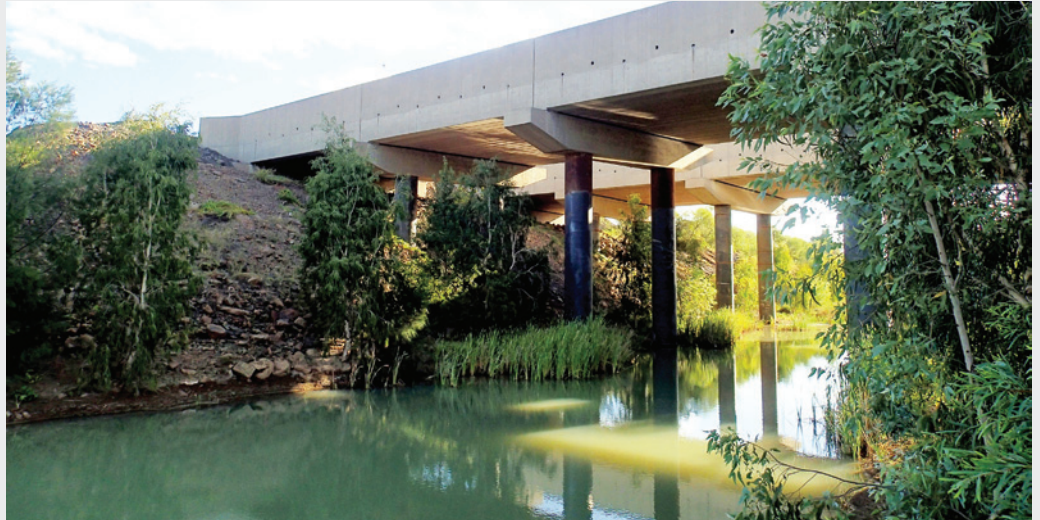
*Barney Creek haul road bridge*

Monitoring adjacent to the bridge showed that there were high levels of wind-blown dust for 6 out of 11 monitoring events. Investigation by MRM has found that this relates to haulage of waste rock during drier months. The IM has recommended that MRM develop a dust management plan for this area, and for the broader mine site.

MRM operates several sediment traps near the bridge and a small dam in the diversion channel itself, to reduce runoff of contaminated water and sediment into the creek. These are cleaned out as required. The IM has also recommended that the remaining drain holes in the bridge be closed off.

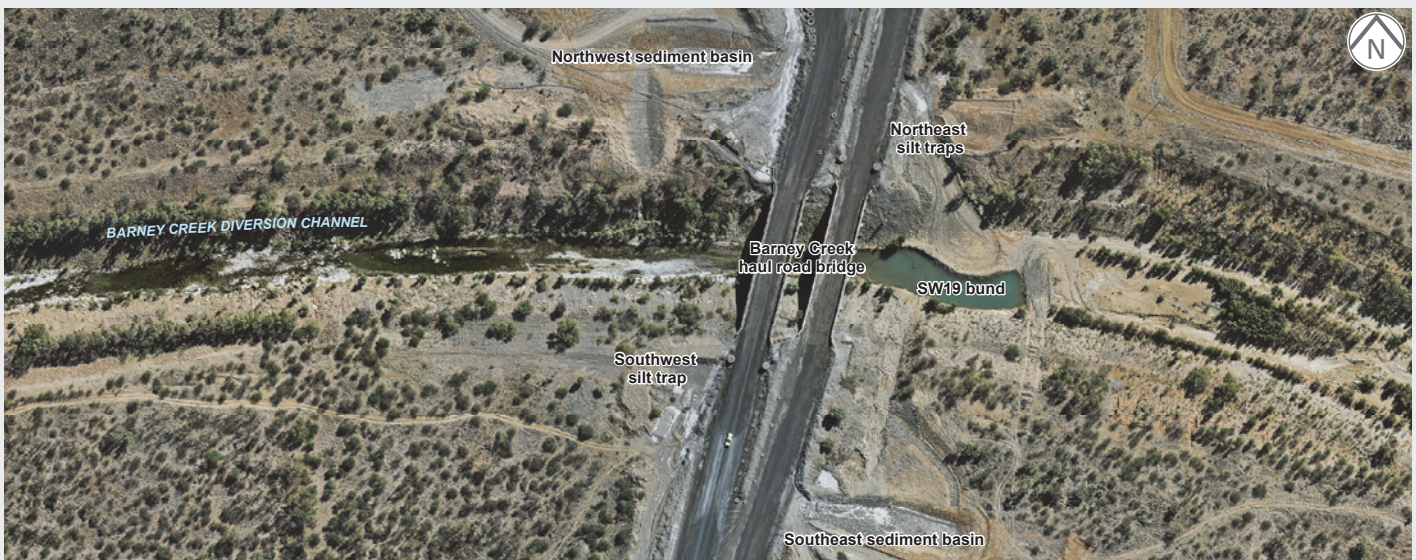
*Sediment control structures at Barney Creek haul road bridge*

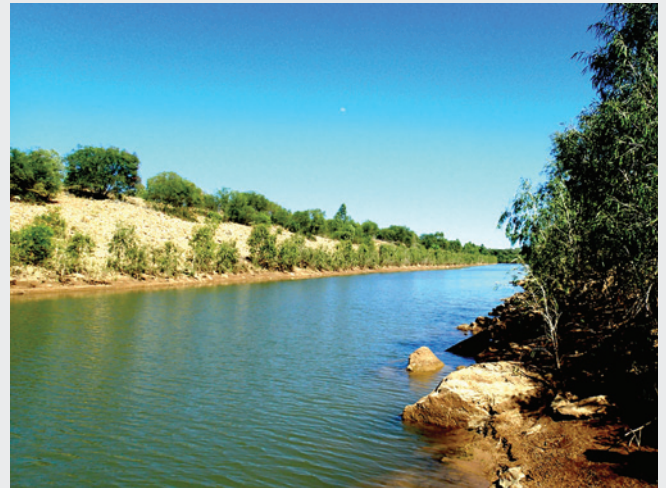
MRM has successfully established more vegetation along the diversion channel, particularly near the waterline. More monitoring of vegetation is being undertaken, and there are fewer weed infestations than in previous years.

Upper middle part of the McArthur River diversion channel, showing successful revegetation along the waterline

Rehabilitation of the diversion channel continues to be slow, and the IM has recommended that MRM prepare a revegetation plan with goals for when the diversion channel should be self-sustaining.

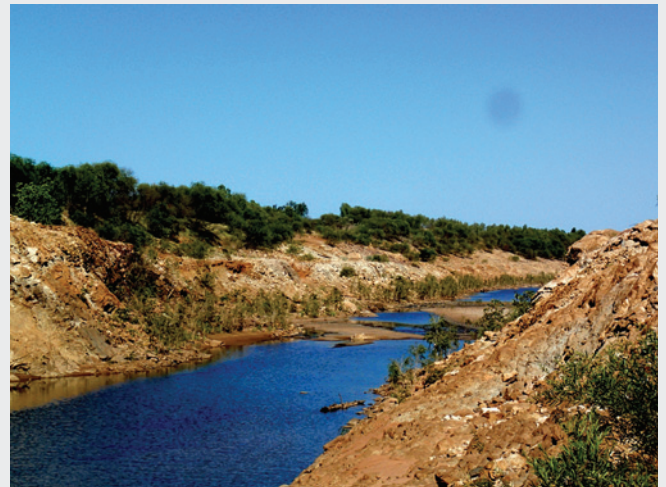
Erosion from the banks of the diversion channel (as well as immediately upstream) continues to be an issue, due to wet season flooding combined with incomplete revegetation.

Mid-section of the diversion channel, where there is most erosion

During 2016, MRM has undertaken a detailed landform condition assessment and erosion mitigation strategy for the diversion channel; the results of this will be discussed in the next IM report.

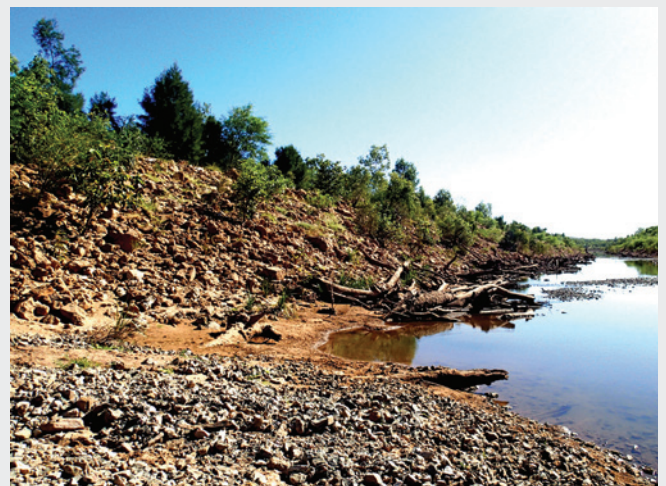
No new large woody debris (LWD) was added to the McArthur River diversion channel during 2015, however the extensive amounts previously added in the downstream end have been retained.

Downstream part of the diversion channel, showing large woody debris installed to create habitat and reduce erosion

The IM recommends that more LWD be installed, as it has been shown to encourage fish and prawns to return to the diversion channels.

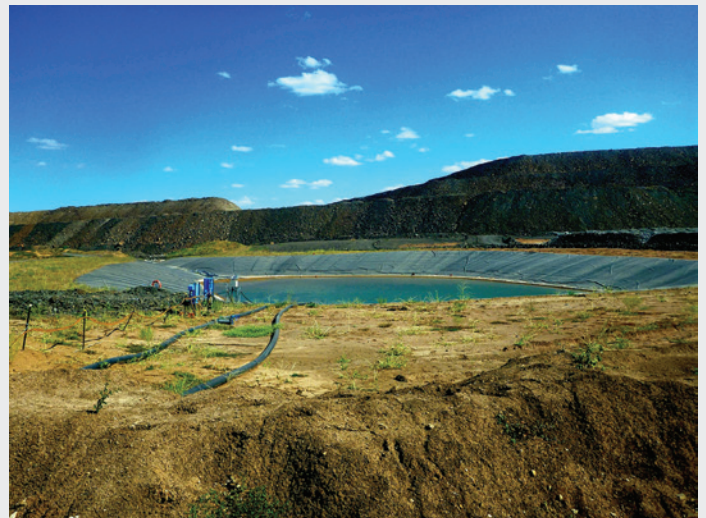
Collecting seepage from the NOEF

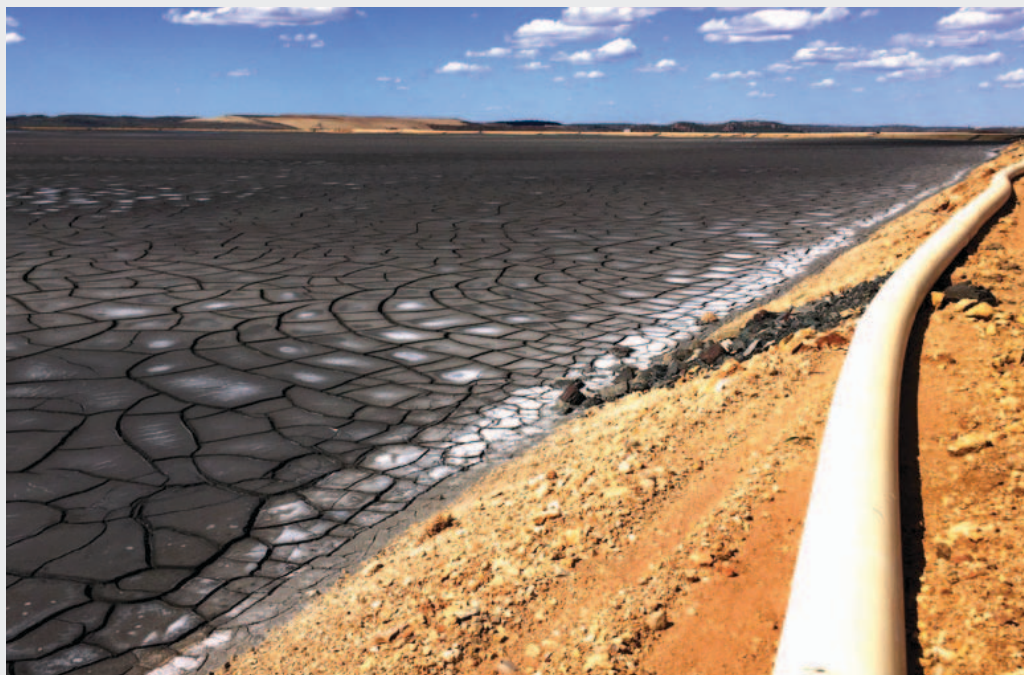
*TSF Cell 2 showing most materials being moist with only minor drying at edges*

The IM noted that during 2015, MRM was able to keep most of the tailings moist, thereby avoiding dust issues.

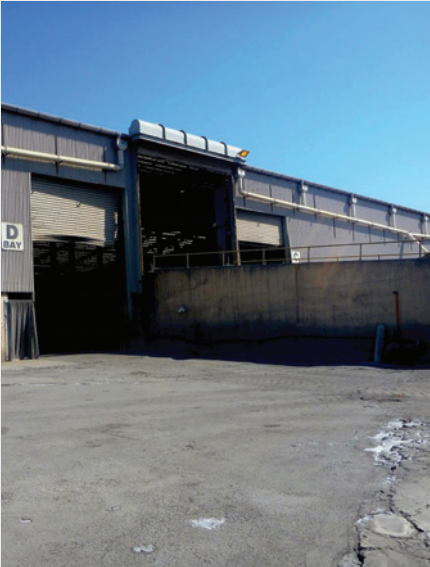
Damaged pavements and concentrate shed doors

There were five days during 2015 where monitoring recorded lead in dust exceeding air quality criteria at Bing Bong Loading Facility.

- The bitumen surface surrounding the loading facility should be repaired to avoid dust and potential for contamination of underlying soils – MRM plan to do this during 2016.
- The doors of the concentrate shed have not been able to be closed for at least the past three years. This is a likely cause of dust issues in the local area, and the IM recommends they be repaired as soon as possible.

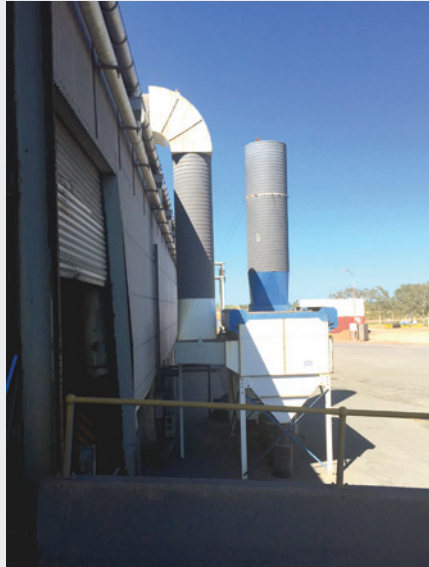
Dust extraction system
