# Statement of Effect of Use or Development Proposal

Clearing permit application – Stage 2 Aquaculture Development, Little Paradise

Applicant: Groote Aqua Aboriginal Corporation (GAAC)

Land: Aquaculture Lease 01 and Lease 02, Little Paradise, Groote Eylandt, Northern Territory

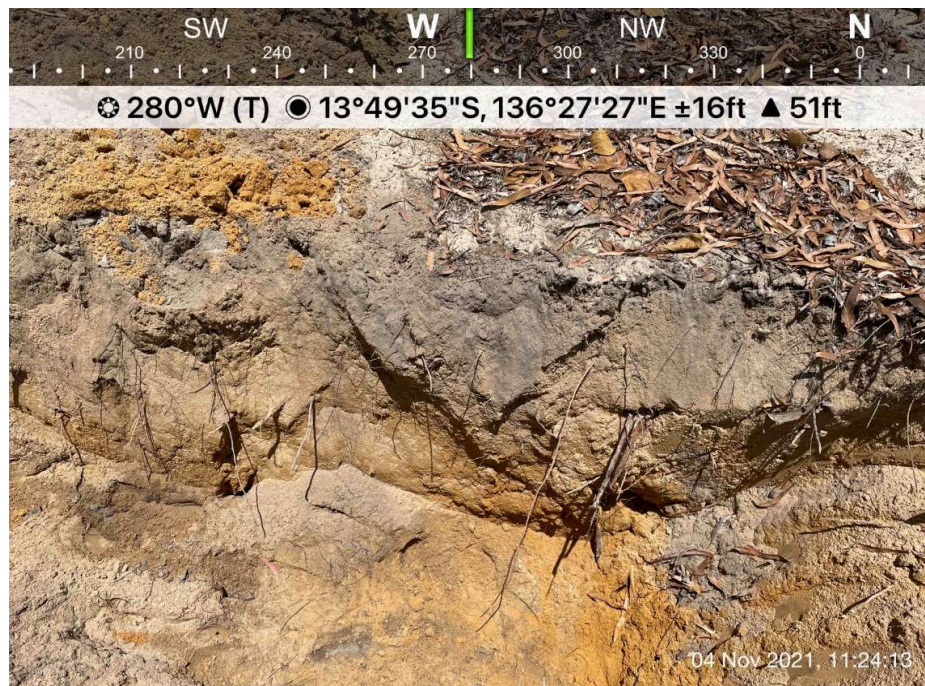
Test Hole 1 pit face

| FIELD DATA | | | | | MATERIAL SUBSTANCE | SOIL CONDITION | | COMMENTS |
|---|---|---|---|---|---|---|---|---|
| | 0.10 | | | | SAND with clay, brown, loose, with roots, moist | L | M | |
| | | | | | SAND trace clay and boulders, light grey to grey brown spotted white, loose to medium dense, dry | L-MD | D | |

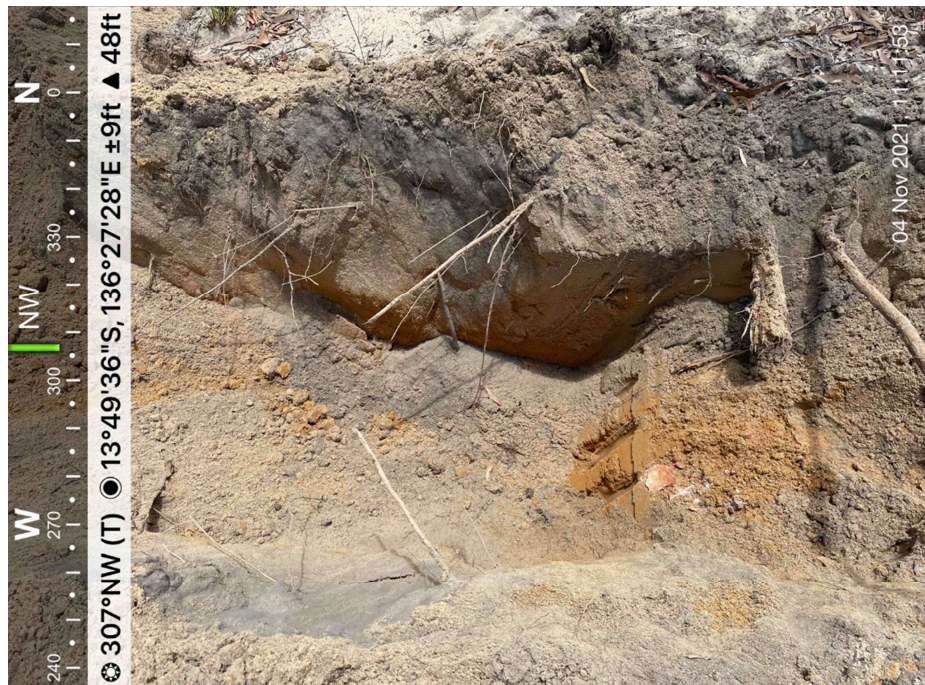
Test Hole pit face

| FIELD DATA | | | | | MATERIAL SUBSTANCE | SOIL CONDITION | | COMMENTS |
|---|---|---|---|---|---|---|---|---|
| | 0.10 | | | | SAND with clay, brown, loose, with roots, moist | L | M | |
| | | | | | SAND trace clay, brown to grey brown, loose to medium dense, dry | L-MD | D | |

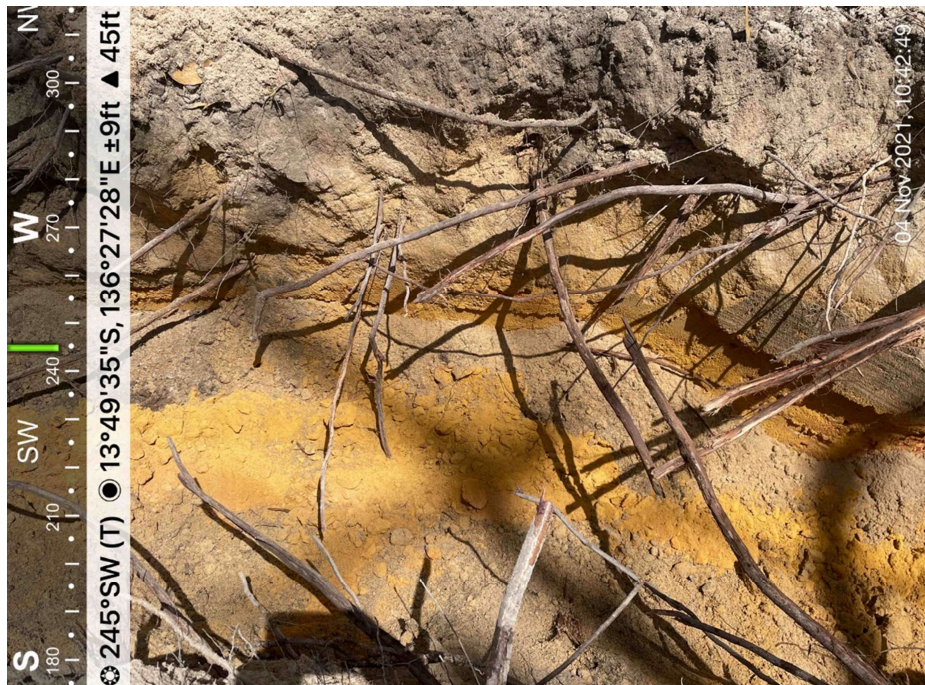
Test Hole pit face

| FIELD DATA | | | | | MATERIAL SUBSTANCE | SOIL CONDITION | | COMMENTS |
|---|---|---|---|---|---|---|---|---|
| | 0.10 | Permeability test at 0.5m | | | SAND with clay, light brown to light grey, loose, with roots, dry | L | M | |
| | 0.40 | | | | SAND trace clay, brown to grey brown, loose to medium dense, dry | L-MD | D | |

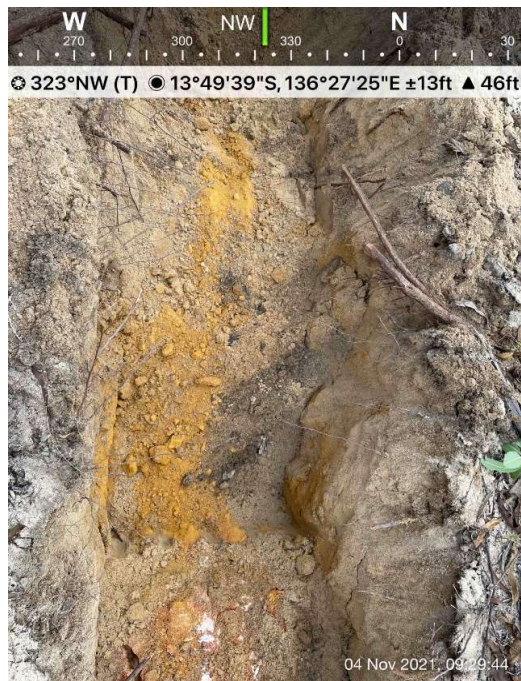
Test Hole pit face

| FIELD DATA | | | | | MATERIAL SUBSTANCE | SOIL CONDITION | | COMMENTS |
|---|---|---|---|---|---|---|---|---|
| | 0.25 | | | | SAND trace clay, light grey to grey brown spotted white, loose, roots, dry | | | |

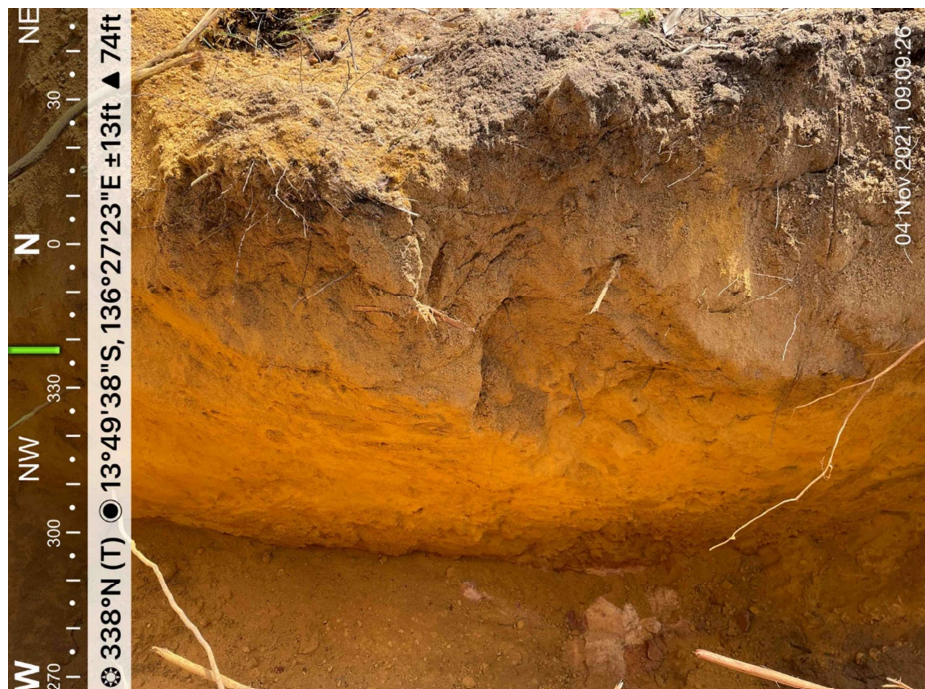
Test Hole pit face

| FIELD DATA | | | | MATERIAL SUBSTANCE | SOIL CONDITION | | COMMENTS |
|---|---|---|---|---|---|---|---|
| 0.05 | | | | SAND with clay, brown, loose, roots, moist | L | M | |
| | | | | SAND light grey and light brown, loose, roots, moist | | | |

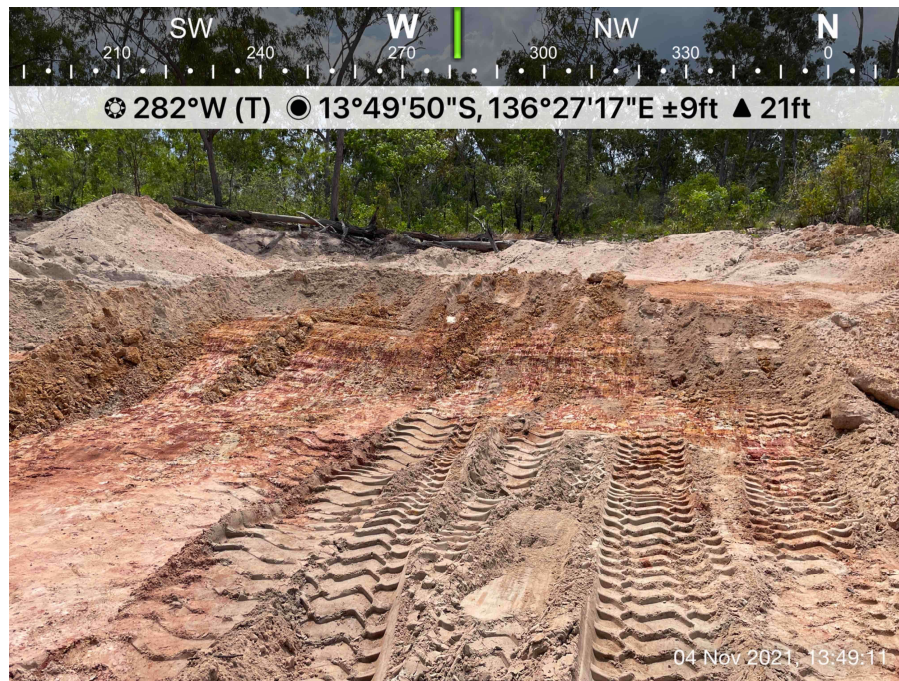
Test Hole in Laterised soils

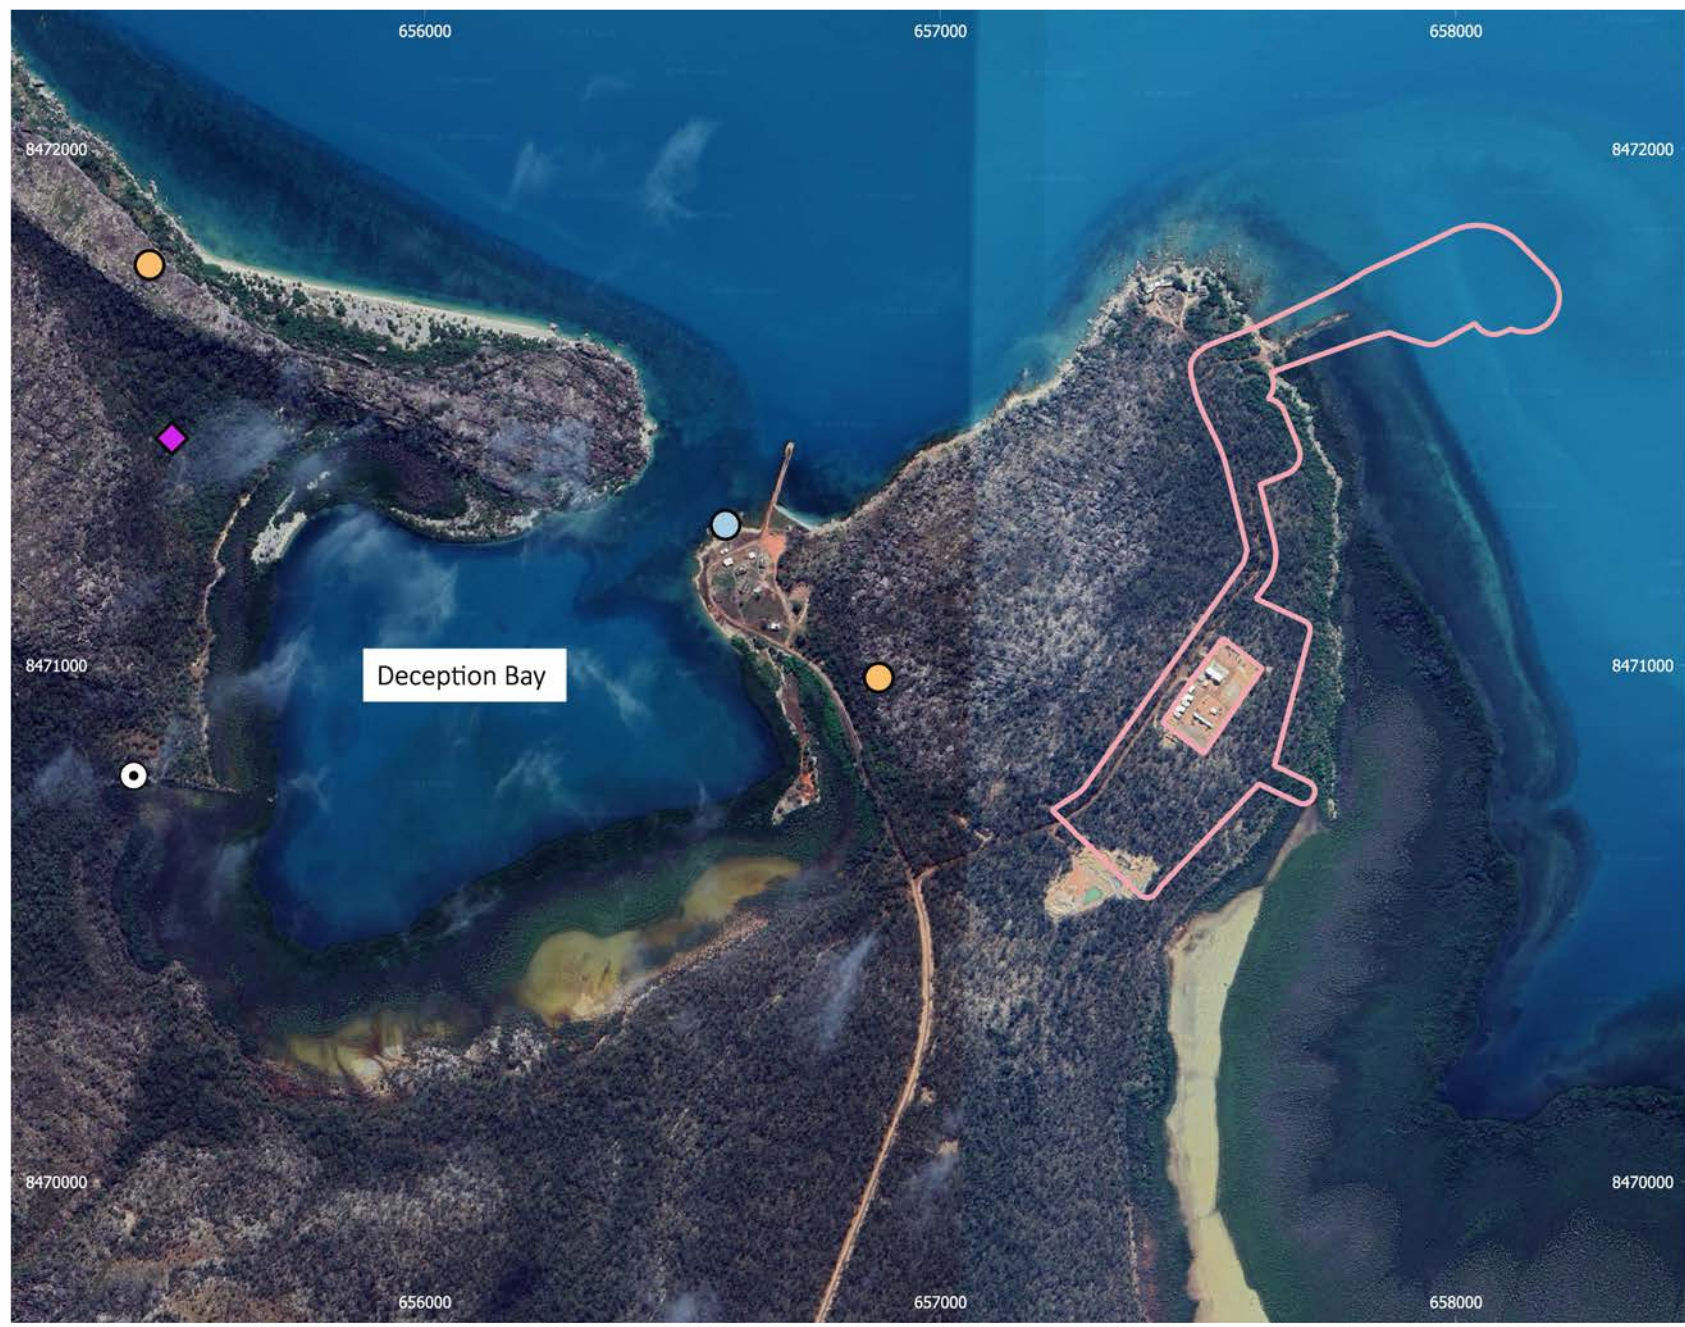
**FIGURE 4** Little Paradise  
 Lease 1 and 2 + Marina Precinct  
 Data Deficient Plants - Existing Data

- Project Area
- Little Paradise Data Deficient  
Plants NT Fauna Atlas NOV 2022**
- ▲ Enhalus acoroides
- Halophila decipiens
- ◆ Polymeria pusilla
- ⊙ Proiphys alba
- Sedopsis sp. Sandstone
- Synostemon trachyspermus

Several plant species that have been collected at sites in the general Project Area are listed as data deficient by the Northern Territory Government (NTG 2023; Table 3.2; Figure 4). None of these species were detected during the 2021-2022 surveys (Kym Brennan, pers com. EMS 2023) (Appendix 1). The previous records of data deficient plant species are outside the current Development footprint at lease 1 and 2 and the marina area. One of these species, *Halophila decipiens*, is a marine sea grass species that was collected in Deception Bay (Figure 4) and may occur at other sites in shallow coastal marine habitats. Based on current knowledge of the site and the habitats within the wider Project Area, the prospect threatened plant species in the higher risk categories (endangered, vulnerable) occurring within the local area appears to be low (EMS 2023).

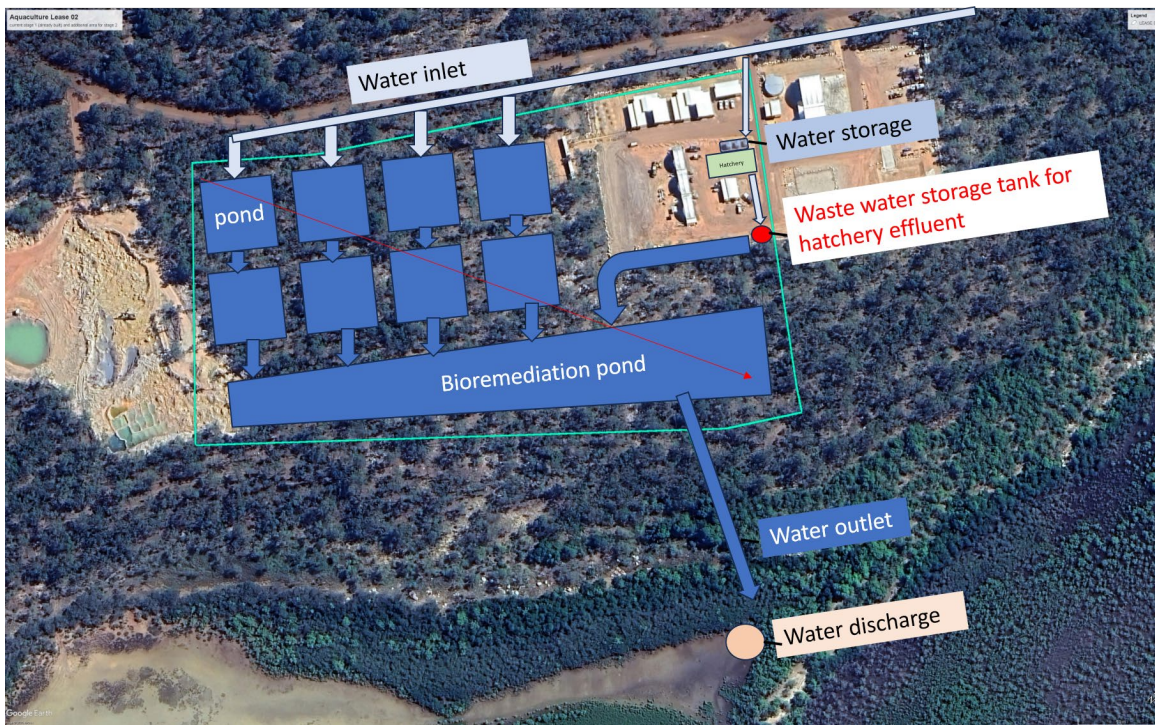
Figure 1a: Site water flow diagram. Light blue arrows indicate pumped water; dark blue arrows indicate gravity-fed water. The red arrow is indicative of the general fall across the site. The waste water storage tank receives hatchery effluent (approximately 15 kL/day), which is treated by ozonation prior to entering the broader pond and bioremediation water circuit ahead of discharge.

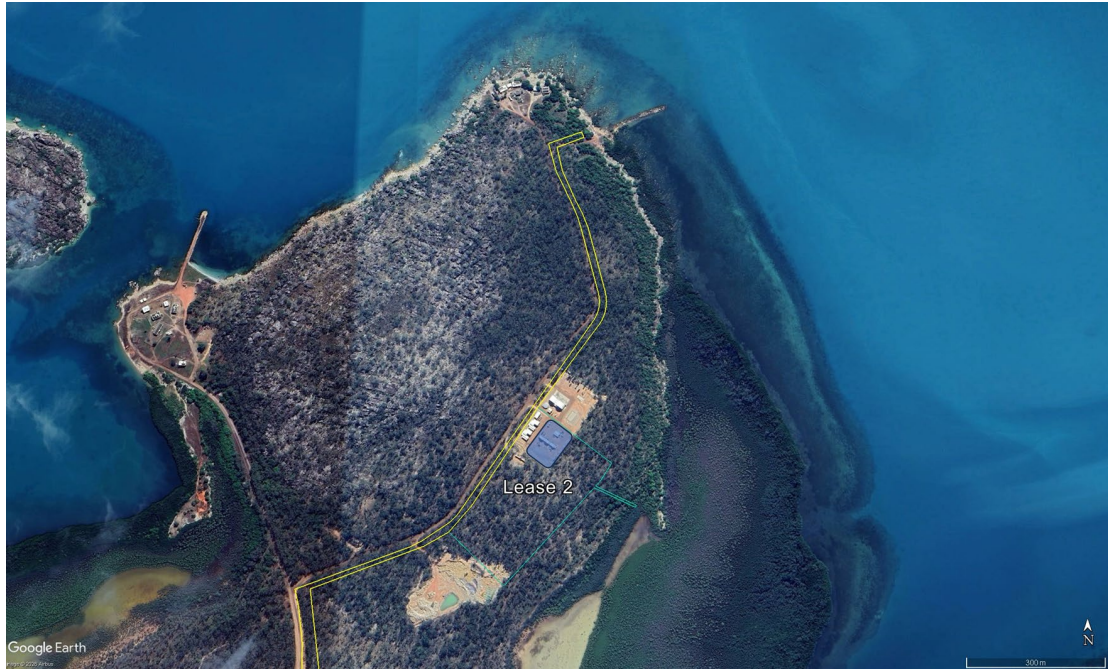
Figure 2: Lease 2 (aquaculture; within light green lines), the current footprint of the actual aquaculture site and the service corridor (currently it only has potable water and fibre; yellow lines).

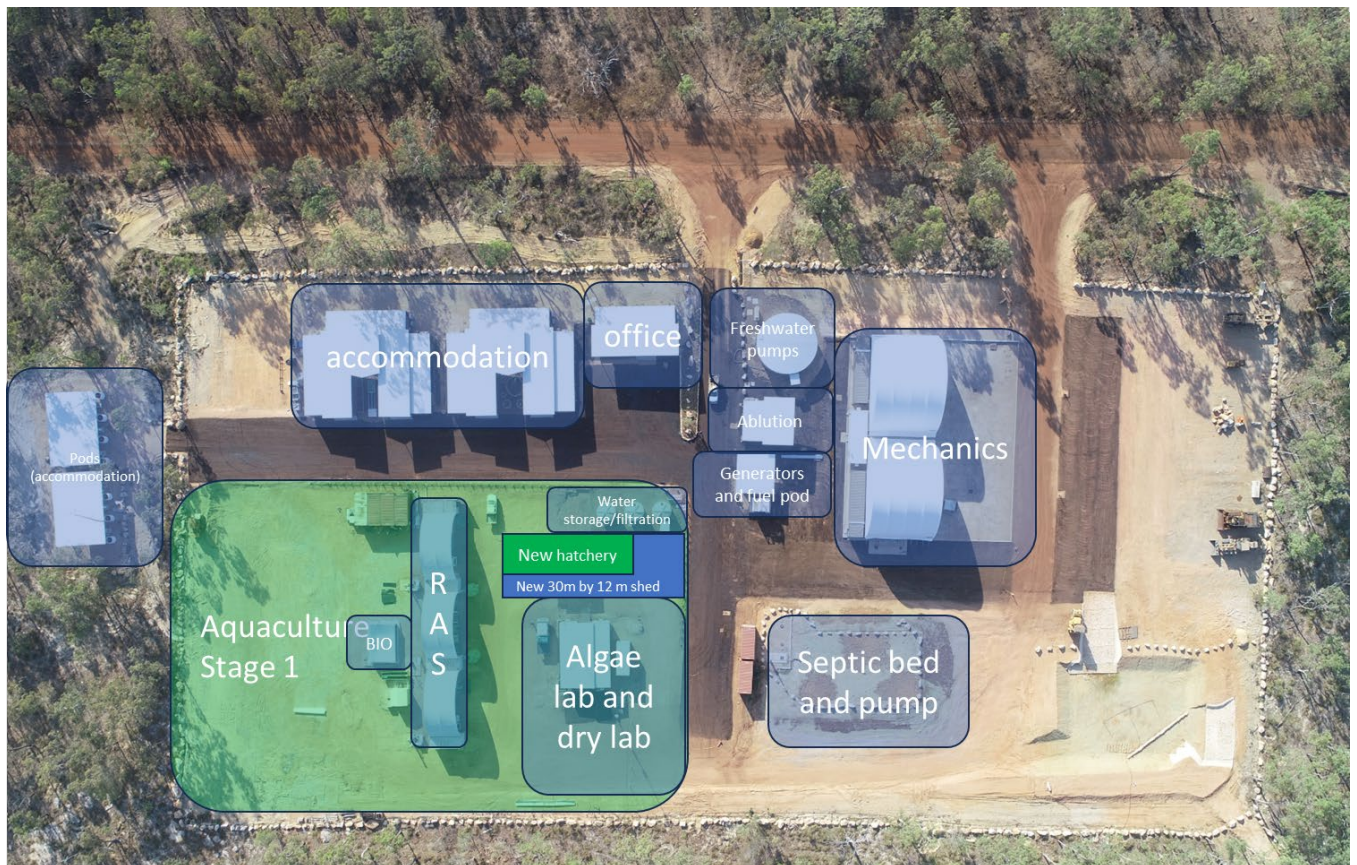
Figure 3: Current aquaculture site layout within blue the future planned shed containing the new hatchery (green).

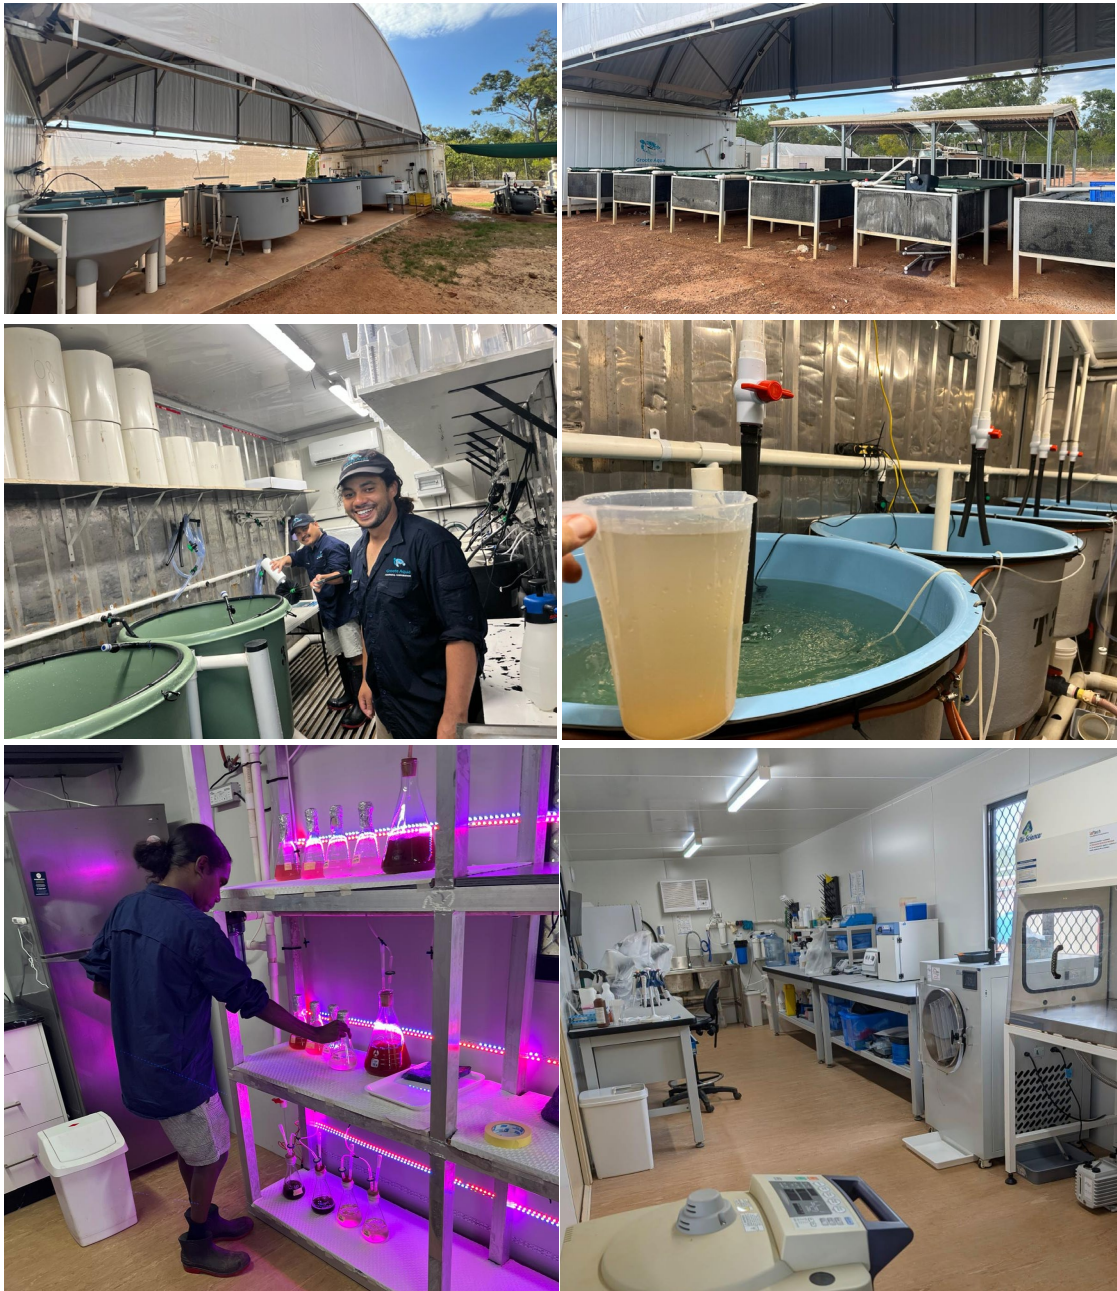
Figure 4: Facilities on the aquaculture site with at the top RAS systems growing rabbitfish, sea cucumber, seaweed and maturing blacklip oysters; in the middle the blacklip oyster hatchery (in that jug there are 15 million oyster larvae) and on the bottom the lab and algae lab.

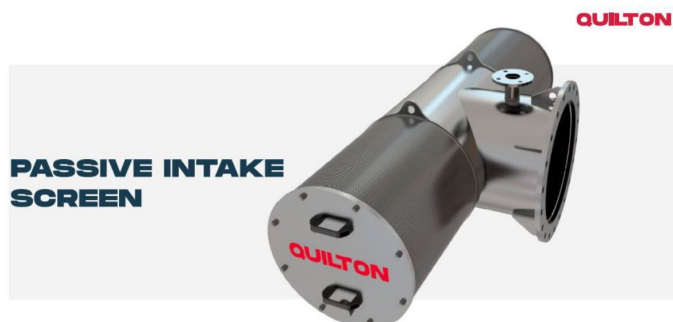
Figure 6: concept drawing of intake line and passive screen.

Seawater for the proposed facility will be sourced from Bartalumba Bay via a dedicated intake pipeline connected to the existing Little Paradise Jetty infrastructure. The intake location has been selected to provide a reliable source of high-quality seawater while minimising environmental disturbance and operational risk. The intake line will be installed along the alignment of the existing breakwater within a cut-and-cover trench. The trench is expected to be excavated using a barge-mounted excavator and will be approximately 1 m deep. The pipe will be secured and protected with concrete ballast blocks, with an end slab installed to support the intake riser. The intake line should extend along the proposed alignment to provide a minimum of 2–3 m of water above the intake at low tide. The seawater intake structure will incorporate a screened intake designed to minimise the entrainment of marine organisms. The screen will utilise a triangular-profile mesh to reduce biofouling and maintain hydraulic performance. A proprietary backwash system may also be incorporated to facilitate cleaning and reduce maintenance requirements.
