# VIB26 Seatbelt assessment

## Vehicle Inspectors Bulletin

The purpose of this bulletin is to provide guidance and assessment on the condition of seatbelts for vehicle roadworthiness.

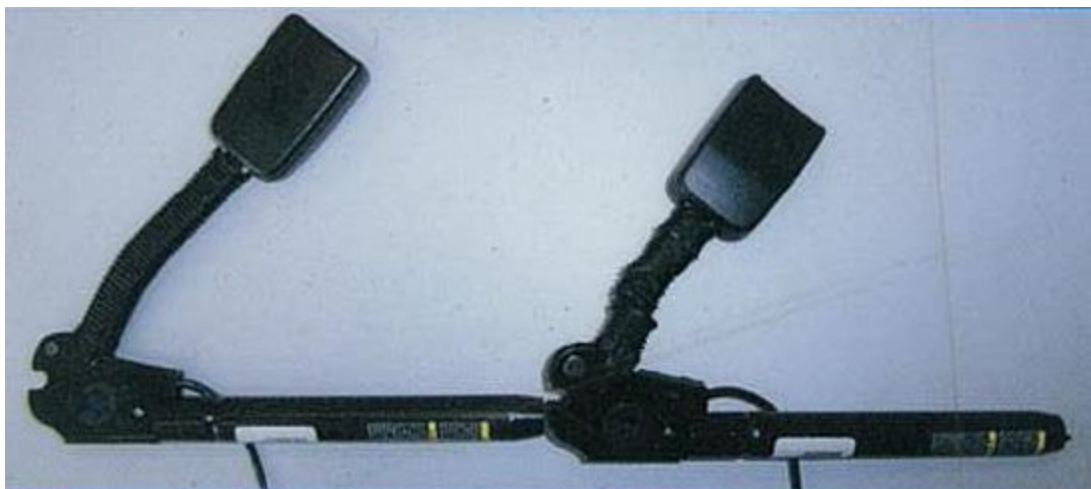
If the pyrotechnical buckle pre-tensioner has fired then the stalk cover will be deformed and the buckle will sit low on the stalk. Some assemblies will expose a red tab or red thread to indicate that the pre-tensioner has deployed.

The deployed pre-tensioner is on the right

Both buckle and belt assemblies **MUST** be replaced.

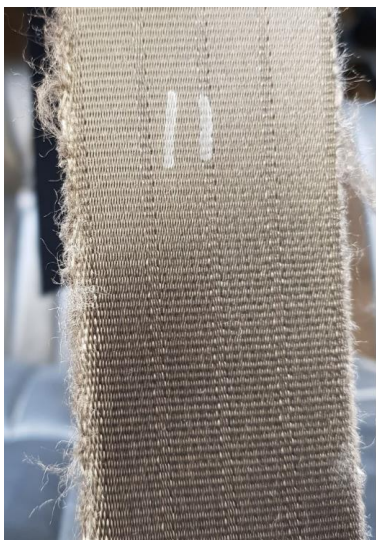
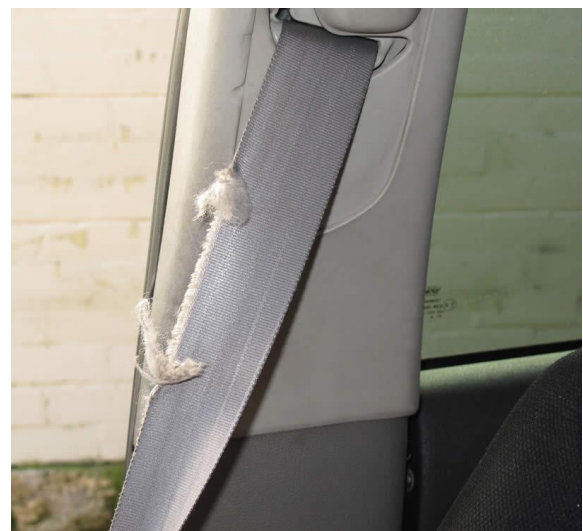
Fraying (outer weave compromised)

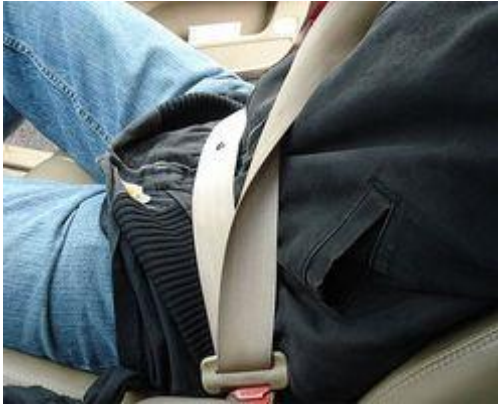
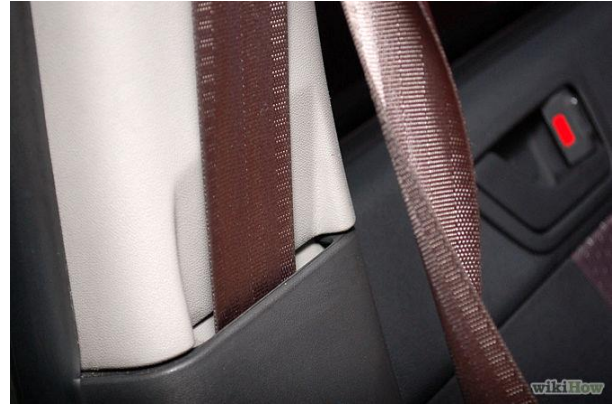
Twisting

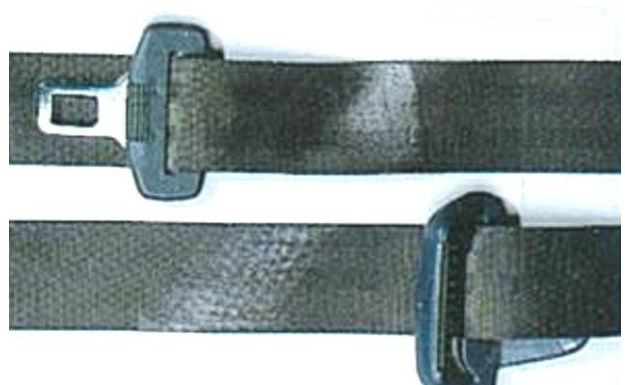
Friction marks (crash damage)

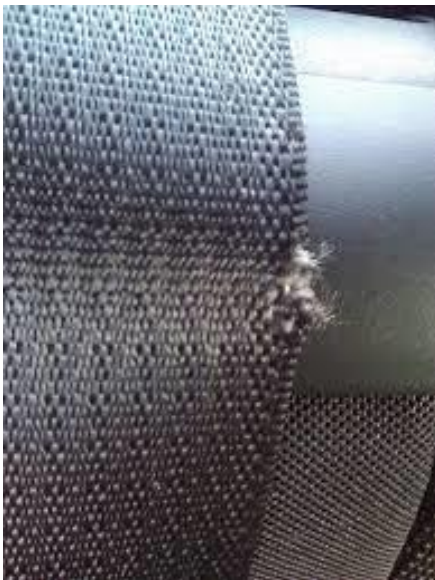
Edge damage (nick)

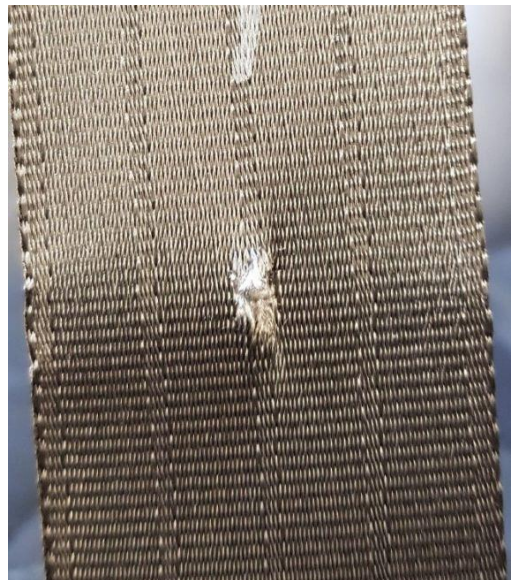
Hole (cut threads)

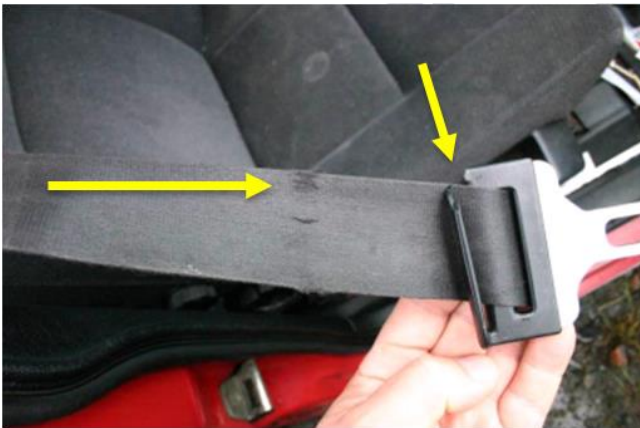
Stretch damage (crash damage)

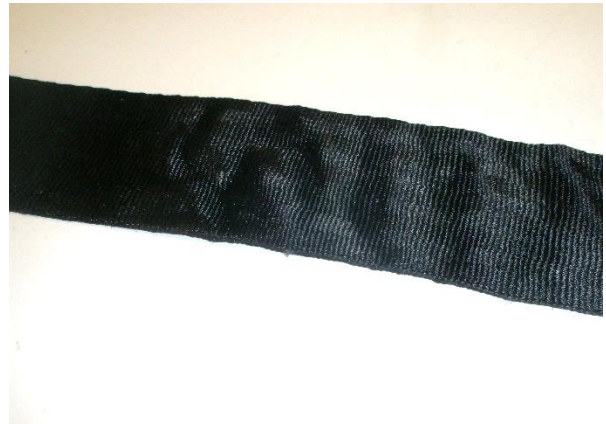
Rippling (crash damage)
