Independent Monitor ENVIRONMENTAL PERFORMANCE ANNUAL REPORT 2015

McARTHUR RIVER MINE

AUGUST 2016
Report No. 01164C_1_v2

**Independent Monitor
Environmental Performance Annual Report
2015**

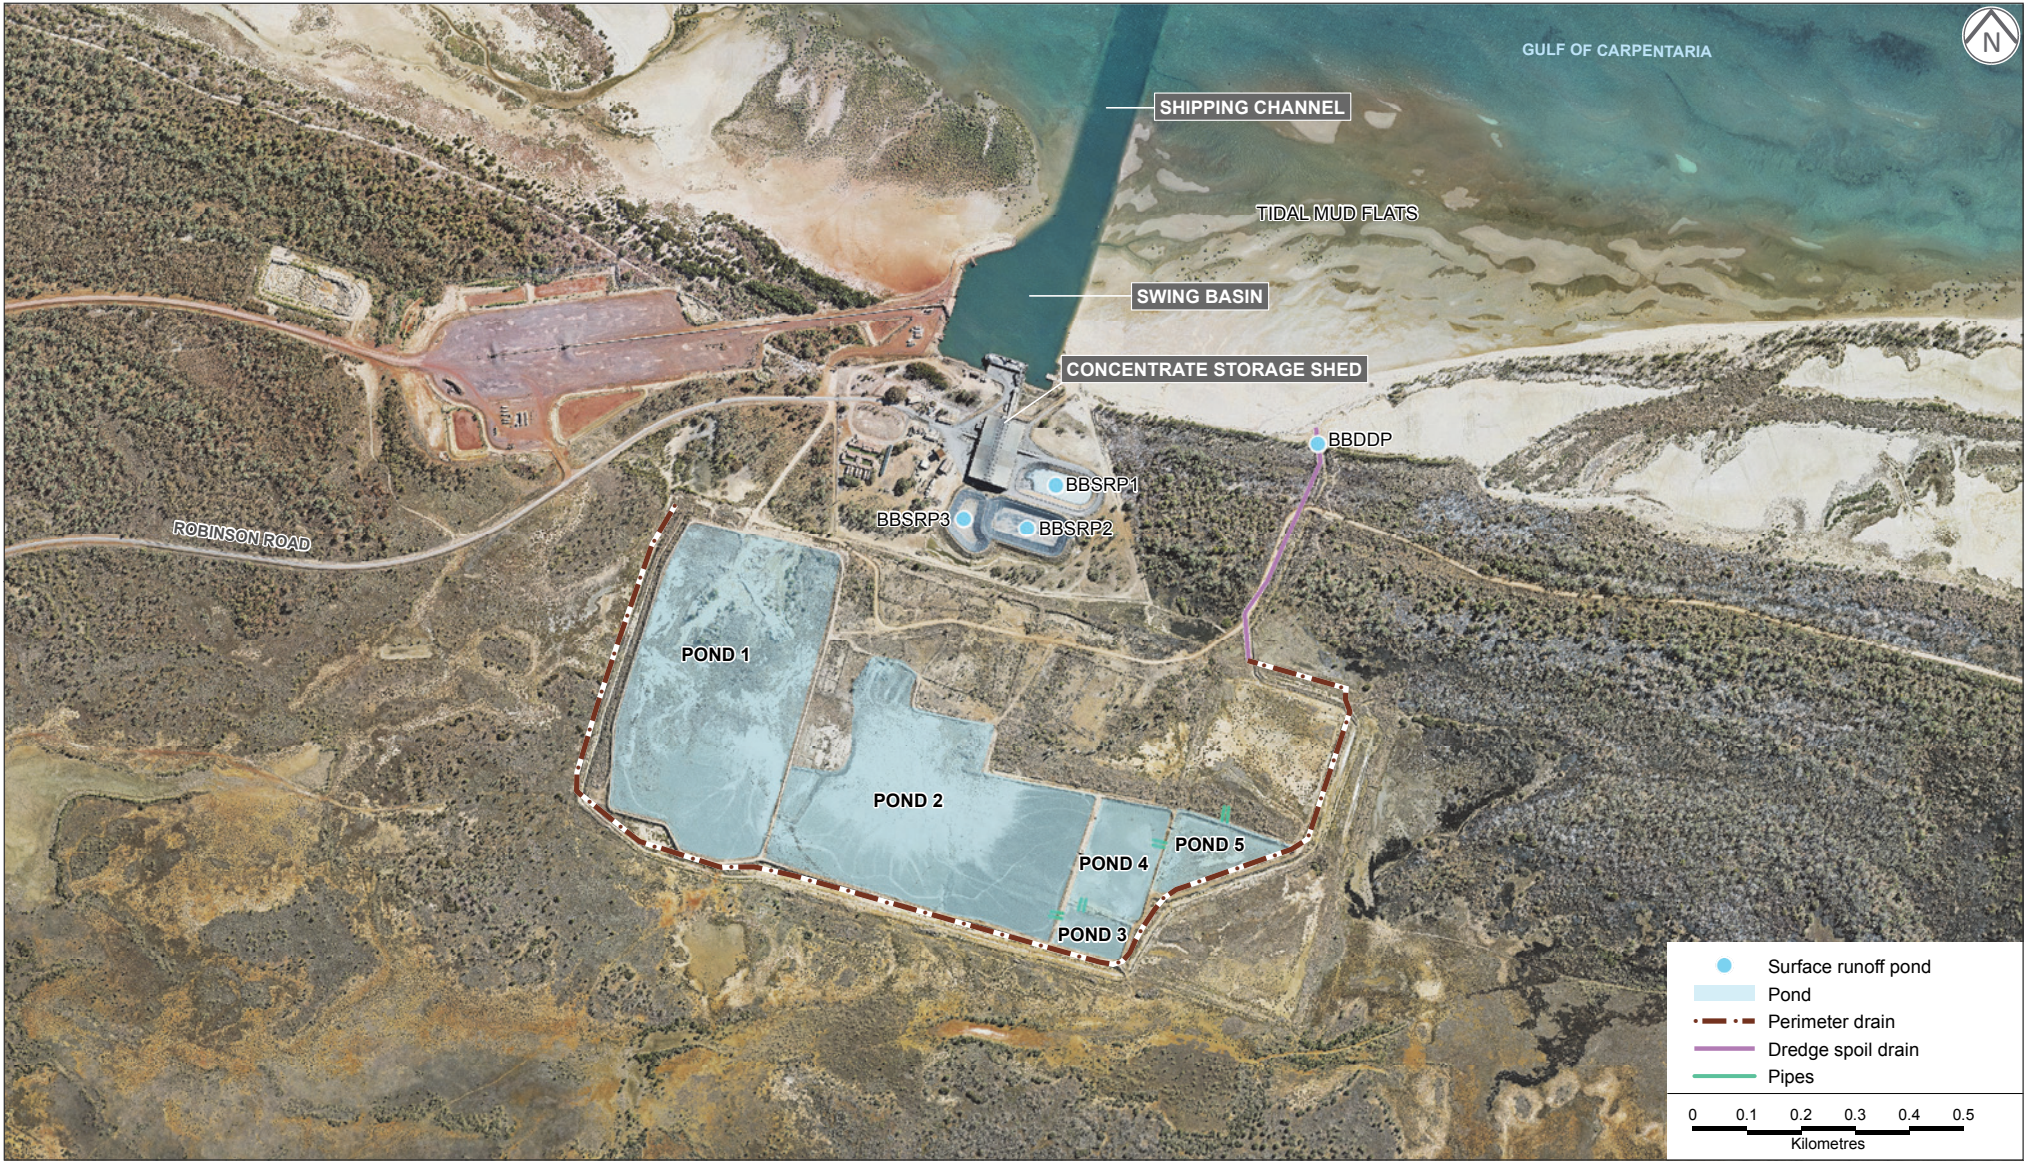
FIGURE 4.3

Advice from MRM (MRM, 2016) is that the general surface water management objectives that apply to Bing Bong Loading Facility are compliance with the WDL and protection of the receiving environment. Surface water management at Bing Bong Loading Facility involves primarily (Figure 4.3):

- ♦ Artificial surface waters – sampling sites are shown in Figure 4.5 (three runoff ponds and three sites along the dredge spoil perimeter drain⁷ (DSD)). Sampling is generally on a monthly basis, subject to dry season conditions, although hydrocarbons are determined on a biannual (twice per year) basis. Both in situ (e.g., pH, temperature, DO, EC, turbidity) and laboratory (e.g., TDS, TSS, filtered (<0.45 µm) trace metals) analysis is undertaken. Figure 4.3 shows the location of site BBDDP, which is the authorised discharge point specified in the WDL.

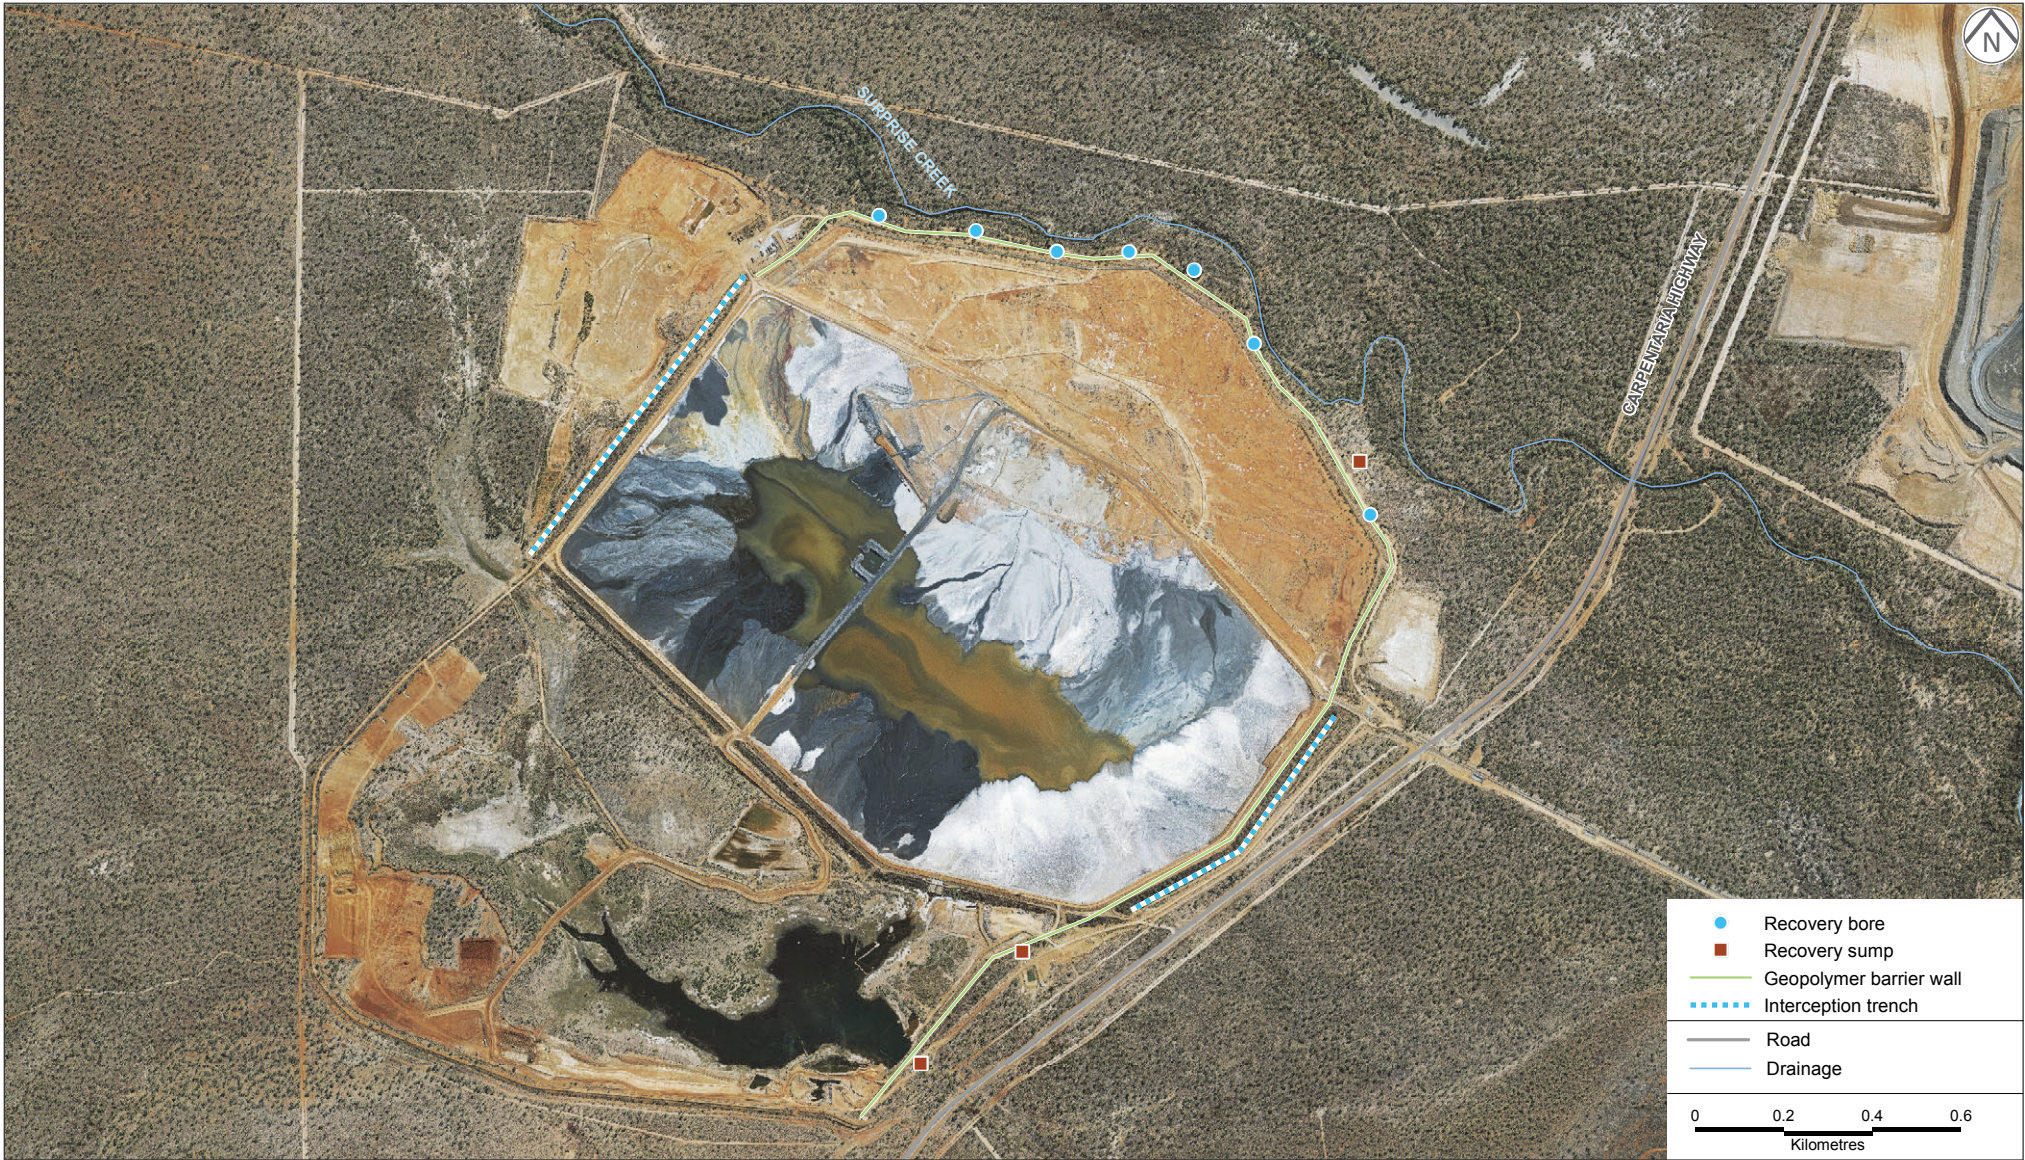
FIGURE 4.12

groundwater into the pit by installing barriers across the southern limb of a palaeochannel and at discrete groundwater inflow points along the southern edge of the pit. The palaeochannel is thought to trend through the pit and provide a conduit to the McArthur River.

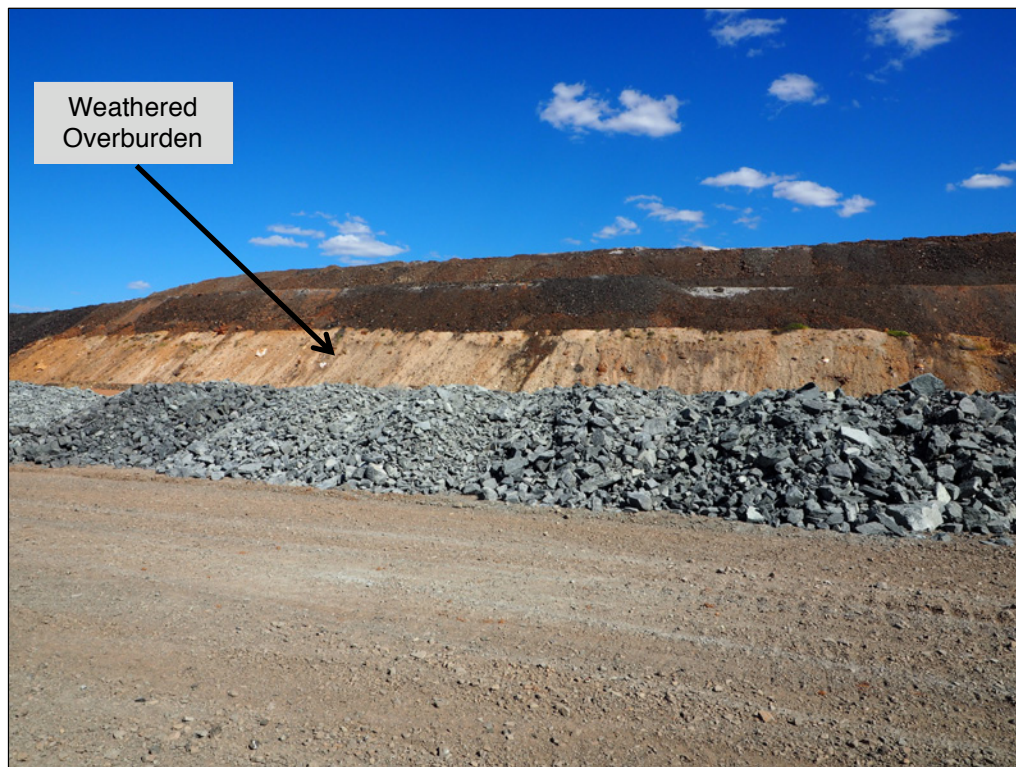
Plate 4.1 – Weathered Alluvial on North Face of NOEF

The new resource waste rock block model is being used to recreate the composition of the NOEF, by applying the full criteria to materials already mined and using historic dispatch data to estimate where it was placed. McArthur River Mining staff demonstrated the initial results and the modelled distribution of waste rock types appeared to correspond reasonably well to observations from the NOEF drilling. It is understood that this will be further developed and calibrated with drilling to better understand the distribution of rock types in the NOEF, which will assist finalising remediation options and cover system designs.

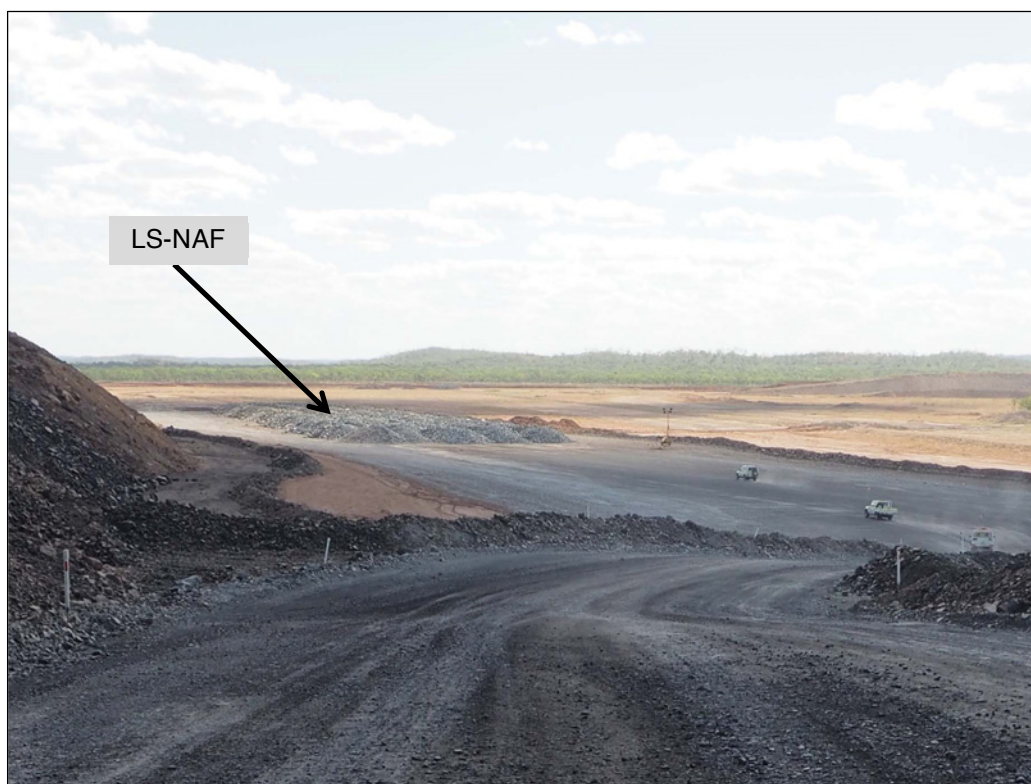
**Plate 4.2 – Paddock Dumped LS-NAF Materials at the
Base of Central West Part of the NOEF**

- ♦ Placing LS-NAF at the dump base to the 1:100 flood level (Plate 4.2).
- ♦ Placing compacted clay (600 mm) over the LS-NAF base (Plate 4.3).
- ♦ Stockpiling LS-NAF materials in designated areas on the eastern side of the NOEF for use in specific zones requiring this material.
- ♦ Constructing the MS-NAF halo zone, using paddock dumping and traffic compaction (Plate 4.4).
- ♦ Paddock dumping PAF(HC) and PAF(RE) materials in lifts of 2 m or less with roller compaction.
- ♦ Monitoring and managing PAF(RE) materials as required.
- ♦ Placing interim clay layers to help control infiltration during the next wet season and spontaneous combustion in PAF(RE) materials.

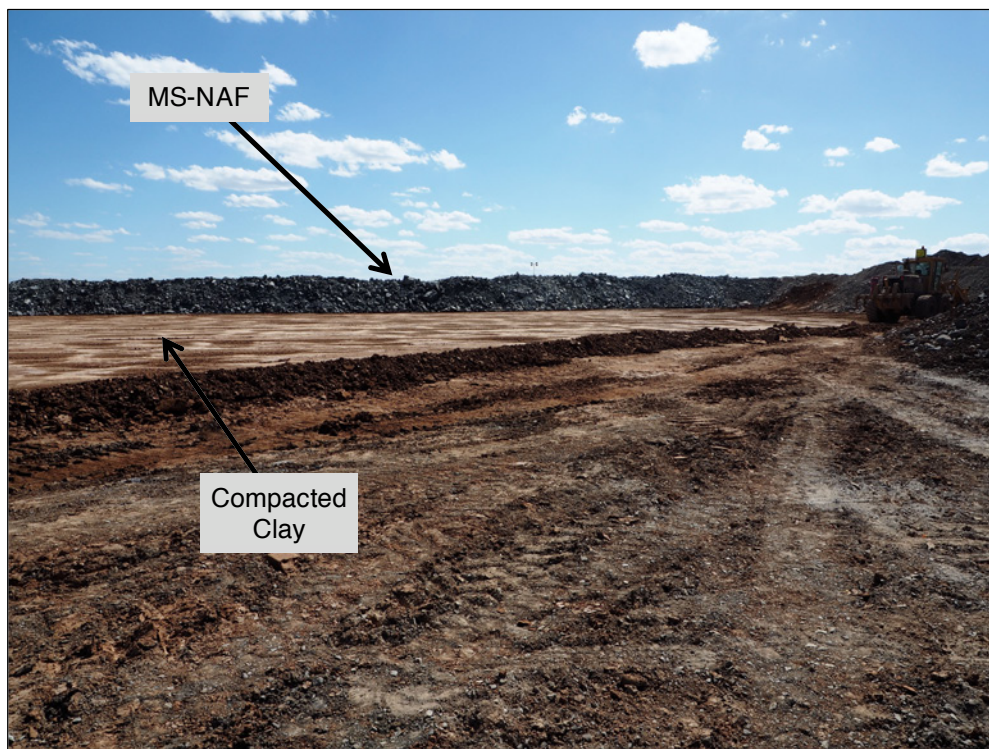
**Plate 4.3 – Compacted Clay Layer (600 mm) Constructed on LS-NAF Materials on the South
Side of the NOEF, with MS-NAF Materials Being Paddock Dumped over the Top**

These measures are a significant improvement on previous dump construction and are considered appropriate by the IM. However, MRM may modify current construction approaches and design as follows:

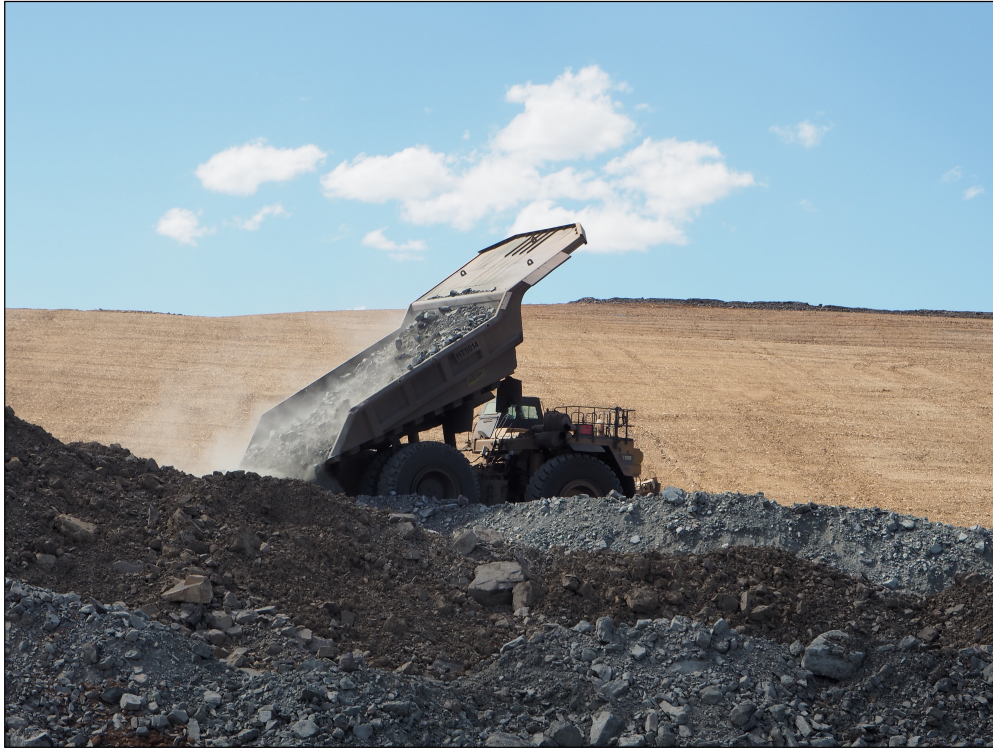
Plate 4.4 – Construction of MS-NAF Halo Zone on the South Side of the NOEF

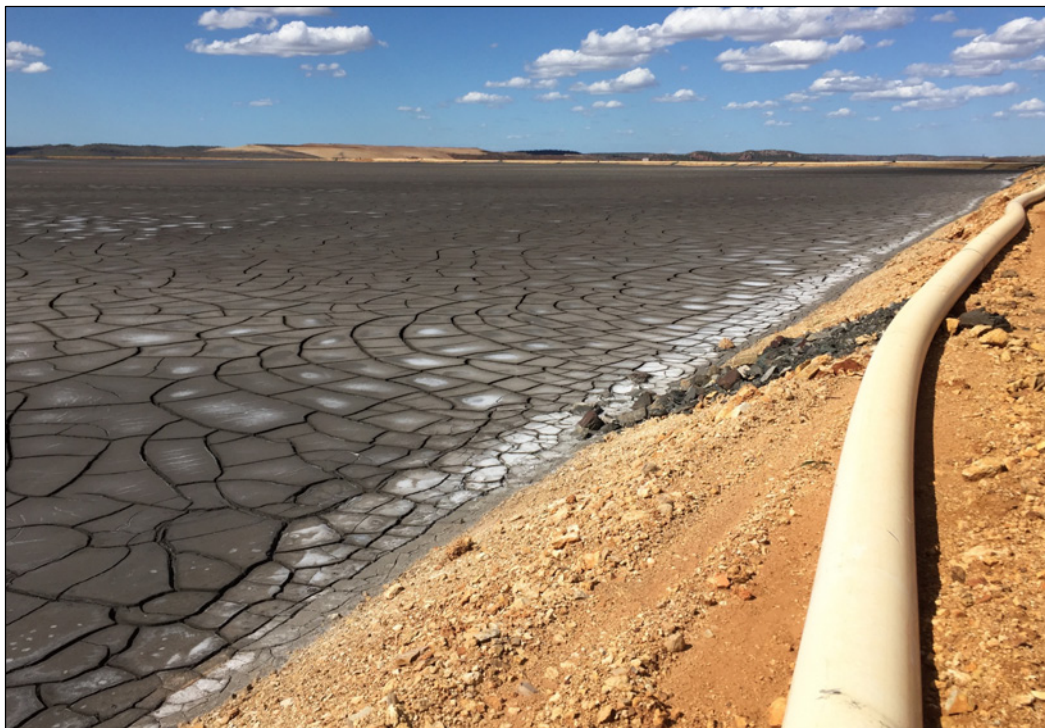
**Plate 4.5 –TSF Cell 2 Surface, Showing Most Materials Being Moist
with only Minor Drying Around the Edges**

The modified design and operation of Cell 2 that was implemented in the last IM reporting period continued, with active beaching of tailings around the perimeter of the cell using multiple spigots, lower water content in the tailings discharge slurry, and removal of excess decant water. Inspection of the TSF during the IM's site visit confirmed the success of the beaching strategy and minimal water storage. The tailings are generally discharged from one spigot at a time, rotating clockwise around the 47 spigots installed on the Cell 2 perimeter, with a cycle time of around 35 to 40 days, so that older tailings are constantly being covered with fresh wet tailings. Inspection of the surface of beached areas showed that older areas still maintained high moisture content due to the fine and bi-modal nature of the tailings (50:50 mix of <50 µm and <7 µm). There was no obvious dust issue, and most of the tailings surface showed little evidence of drying and salt formation (Plate 4.5 and 4.6). The main exception was an area of salt accumulation on tailings surfaces on the eastern side of the decant causeway (Plate 4.7). This area appears to be not as conducive to continued tailings deposition, resulting in drying out and oxidation of tailings. Control of dust and oxidation in this area may require water spraying if the deposition methods cannot be modified.

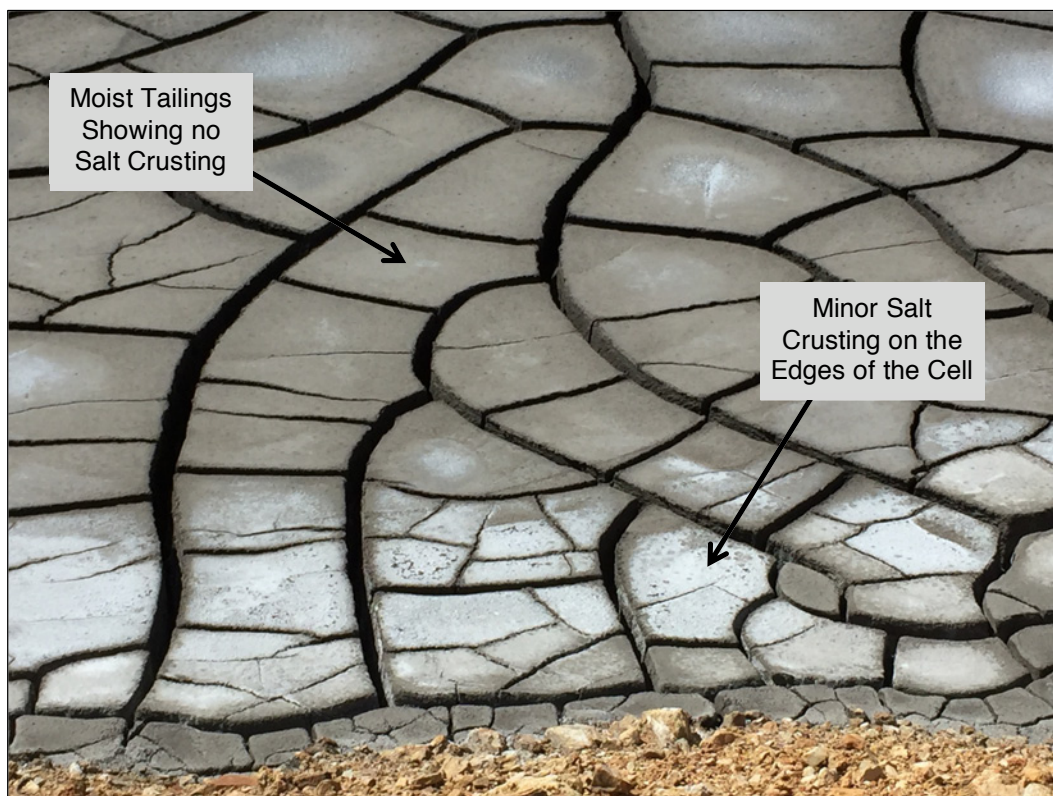
Plate 4.6 –TSF Cell 2 Surface in More Detail

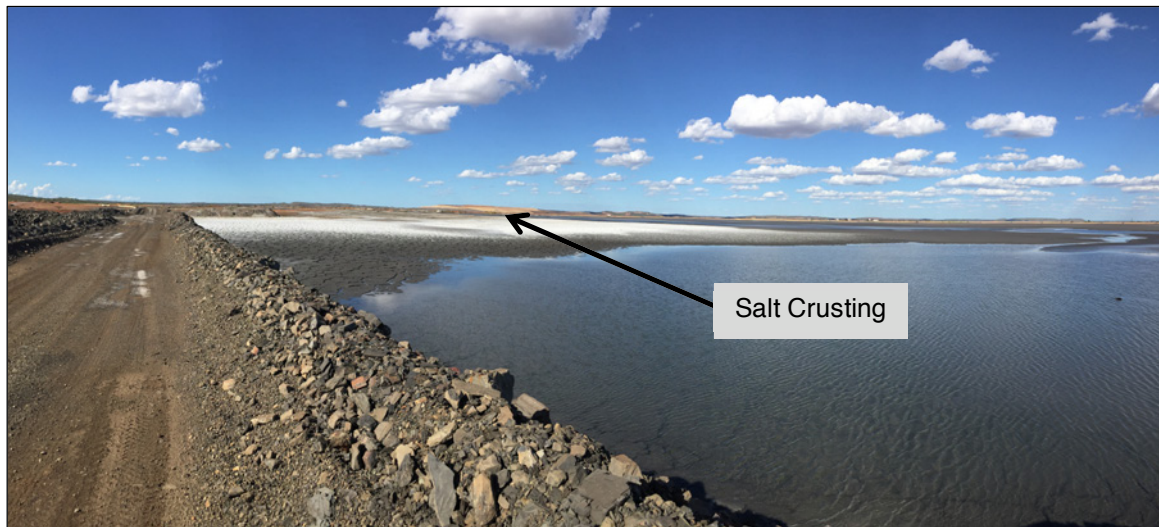
**Plate 4.7 –TSF Cell 2 Showing Salt Accumulation on Tailings Surfaces
East of the Decant Causeway**

The current tailings and water management approach at Cell 2 will reduce seepage into groundwater, but it may take some time before this is evident in groundwater monitoring bores. The recent low rainfall wet season has obviously assisted in minimising water stored in the TSF and consequent seepage. Maintaining low seepage from the TSF may be more of a challenge in a high rainfall wet season.

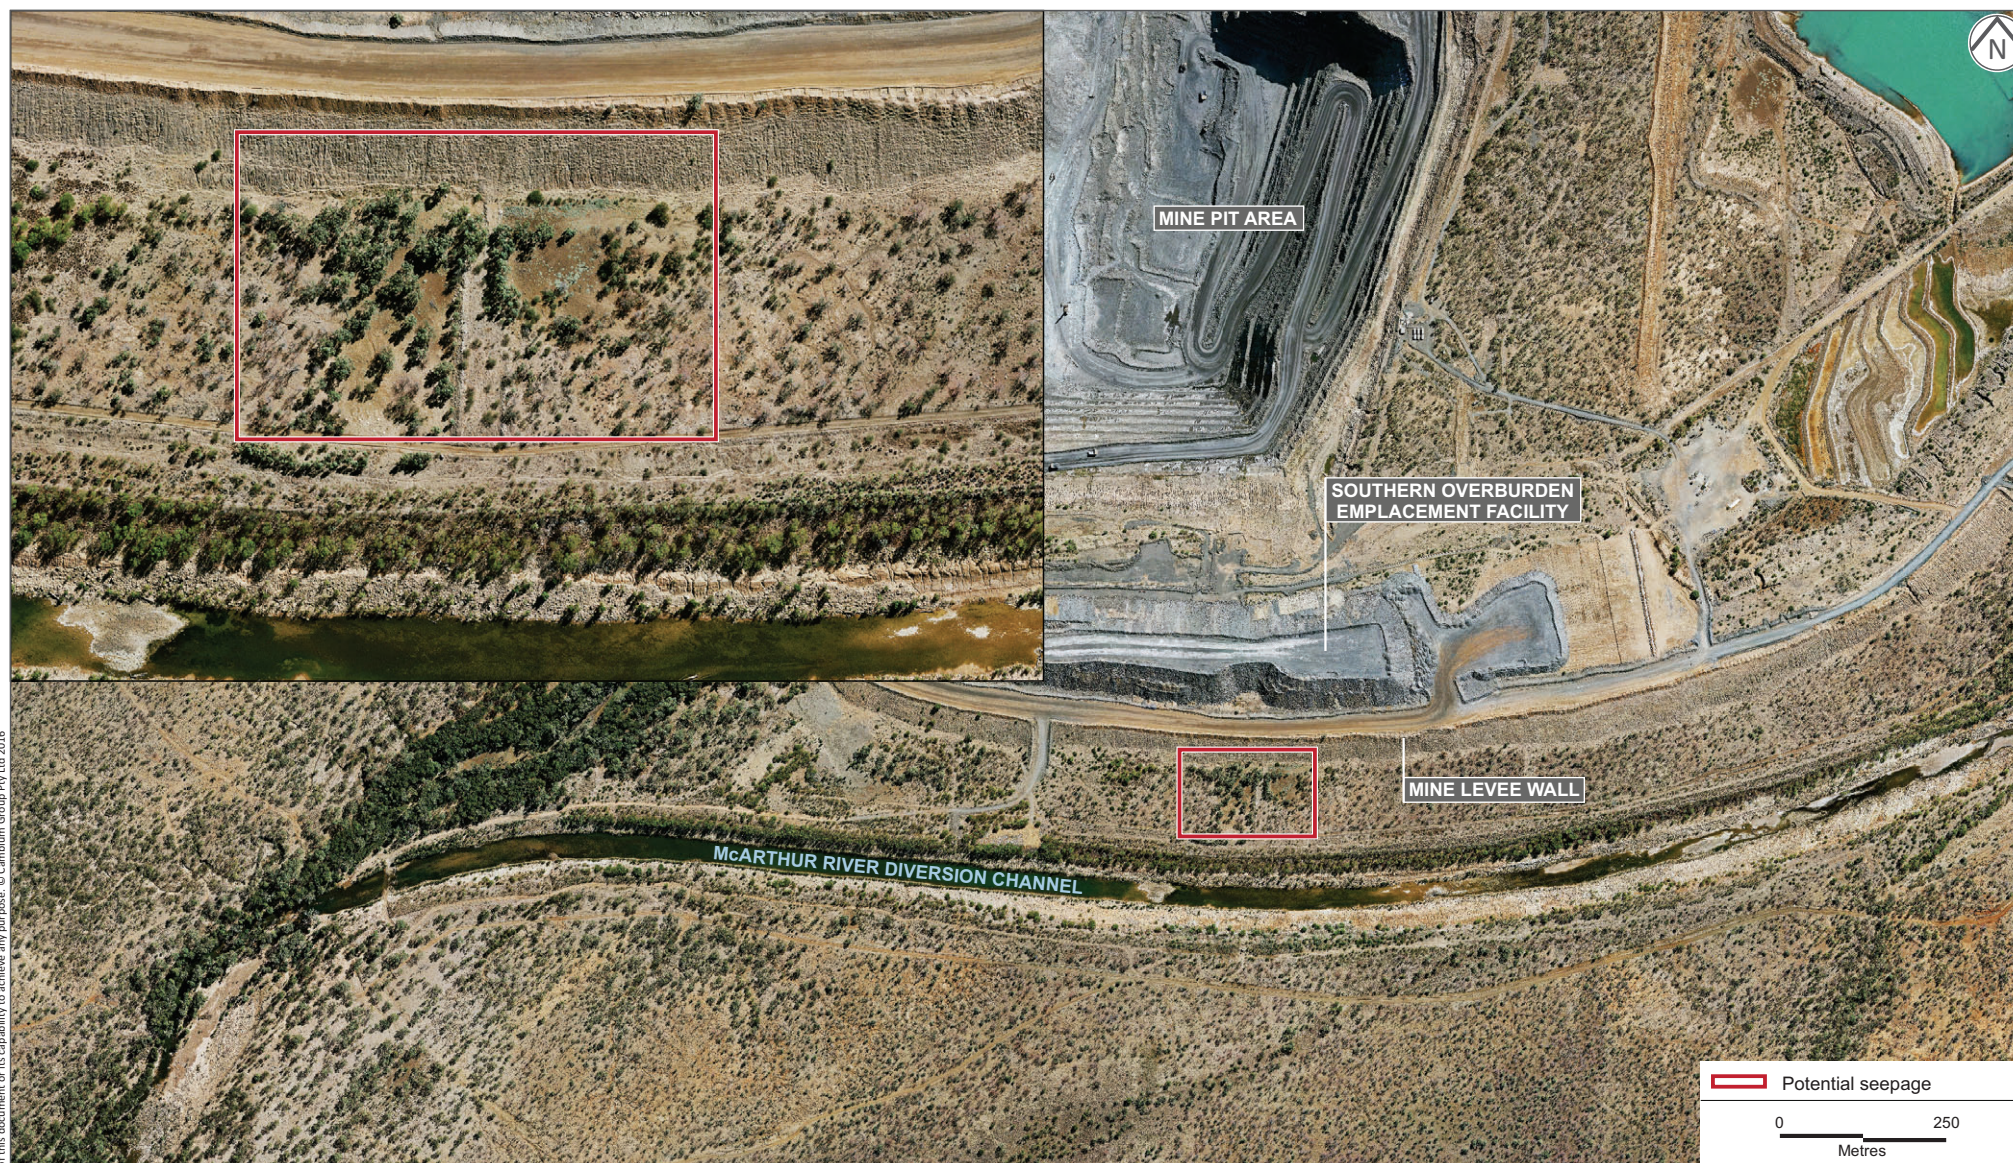
FIGURE 4.21

McArthur River Mining's submission was based on a formal engineering risk assessment and modelling. However, these types of assessment are normally reserved for design purposes and not for assessing operating facilities. The IM found evidence in aerial photographs to suggest that seepage from the SOEF could be migrating in a southerly direction midway along the southern batter, resulting in surface discolouration and dieback (Figure 4.21). This evidence has been

subsequently countered by MRM with other photographic evidence that suggests no visible impact. Additionally, the IM understands that work has been undertaken in November 2015 (outside the reporting period) to demonstrate that the direction of groundwater movement at depth in this area is northwards, away from the McArthur River diversion channel and towards the pit.

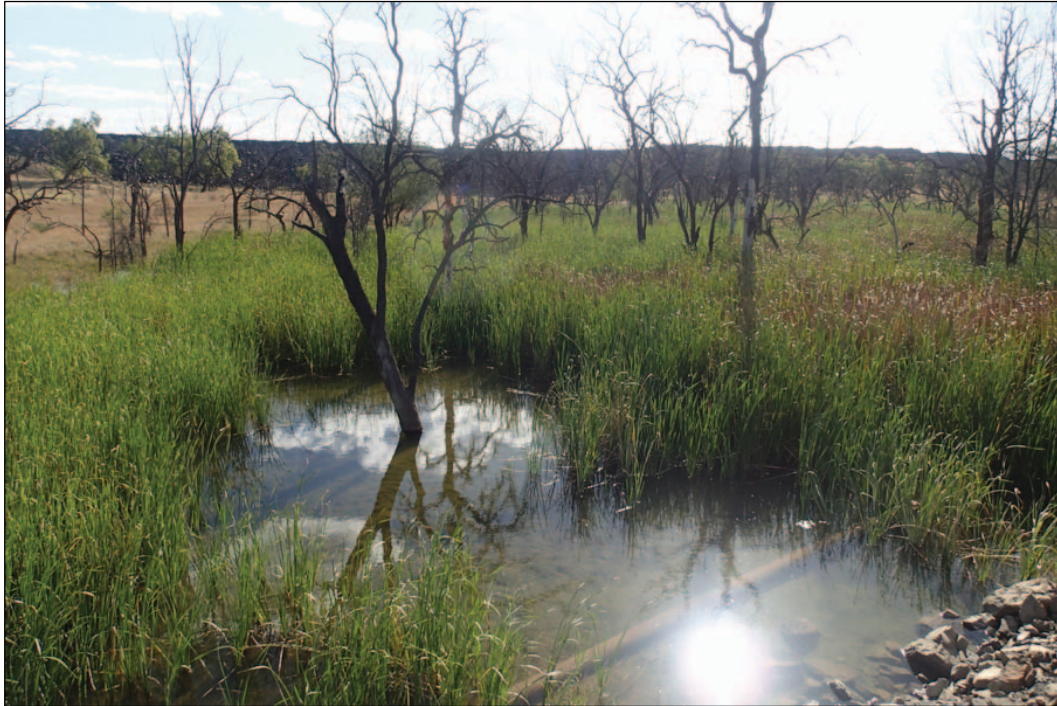
Plate 4.8 – SEL in April 2016 (Numerous Fish Were Visible at the Site)

The SEL was designed to be overtopped in a 1 in 3 year flood event and as a result is regularly overtopped by floodwaters (Plate 4.8), leading to regular mixing of captured runoff with floodwaters. During the 2013-2014 wet season, it was breached three times allowing 300 ML of floodwaters behind the levee. It is likely that fish also swam over the levee at this time.

The SEL was originally designed to contain seepage from the east side of the NOEF and also to provide minor flood protection (MRM, 2015c). The former purpose (capture of NOEF seepage) was superseded by the SE Bund, which was constructed to the west of the SEL around Q2 2015 (MRM, 2015d). McArthur River Mining has advised that since this time, the SEL has been used as a holding and staging pond for managed release water collected from sediment traps and borrow pits to the northeast of the NOEF. The multi-purpose function (and later changed function) of the SEL may have resulted in incident reporting being inconsistent. The initial incident report said that the SEL was to protect the NOEF from floodwaters. However, while providing additional information to the DME, MRM subsequently reported that the SEL was constructed to catch runoff during rainfall events and intercept NOEF leachate.

The intended purpose/s of the SEL at the time of the incident reflect on the implications of that incident. In terms of the SEL being a floodwater protection levee, the fish kill is not of particular concern since fish kills are common in the ephemeral watercourses of northern Australia as many waterholes contract and water temperatures increase in the lead up to the wet season. However, it does raise concerns regarding the value of a flood protection levee that is regularly overtopped and, potentially, the role and need for the SEL in relation to floodwaters should be reviewed.

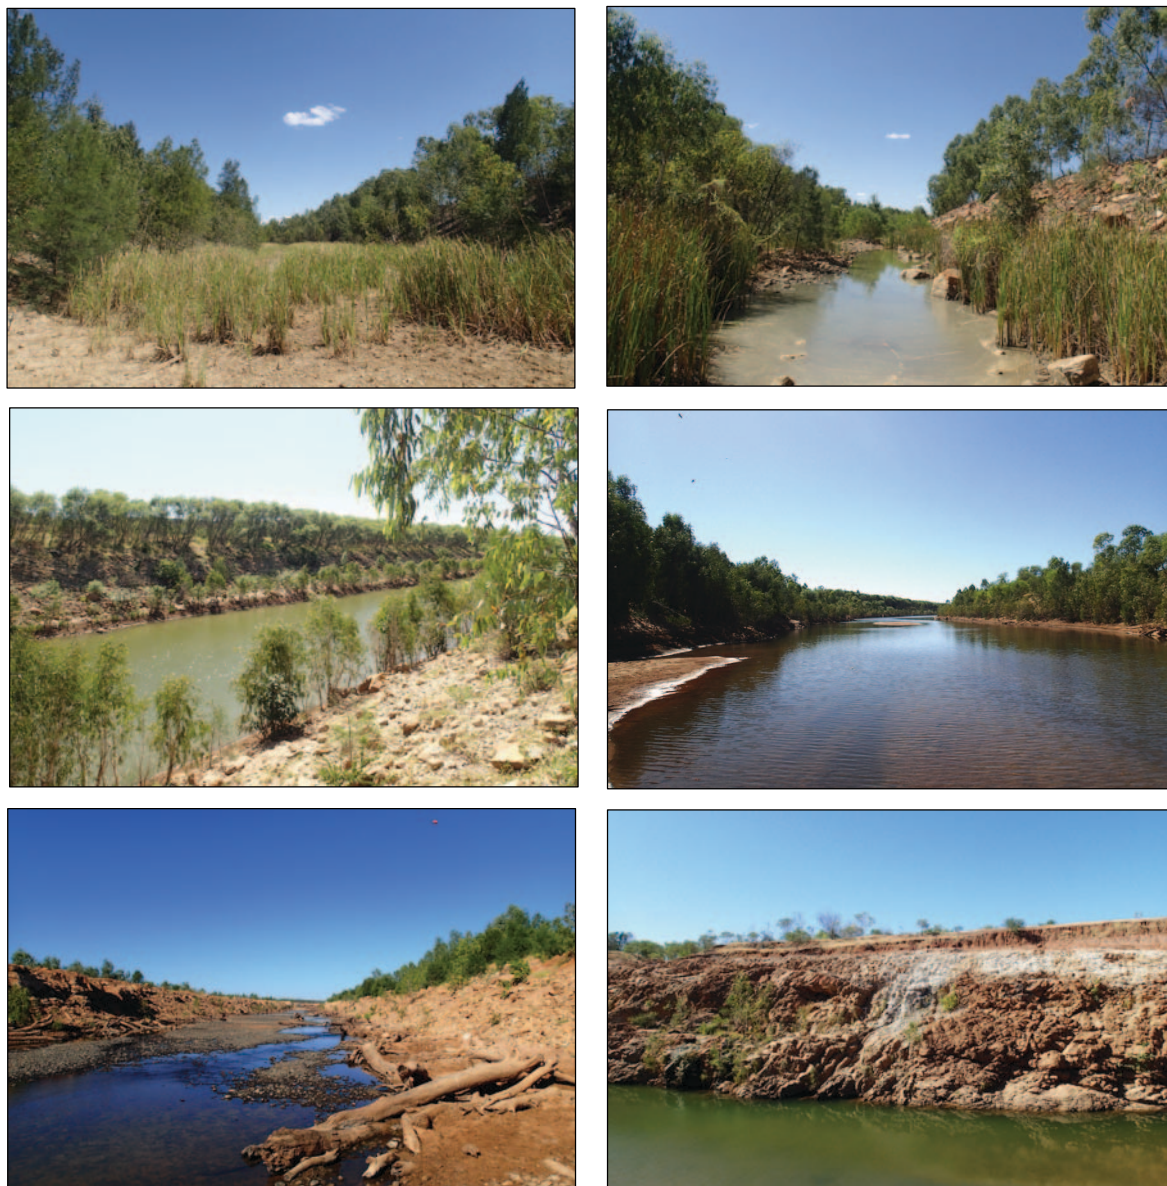
Clockwise from top left: 1. Barney Creek diversion channel at the confluence with Surprise Creek (SW18) looking up Barney Creek. 2. At the same location looking downstream. 3. Good revegetation at the upstream end of the McArthur River diversion channel. 4. Sparse vegetation along the rocky walls of the middle section of the McArthur River diversion channel. 5. Large woody debris, sediment deposits and low vegetation at the downstream end of the McArthur River diversion channel. 6. Reasonable low water shoreline revegetation towards the upstream end of the McArthur River diversion channel.

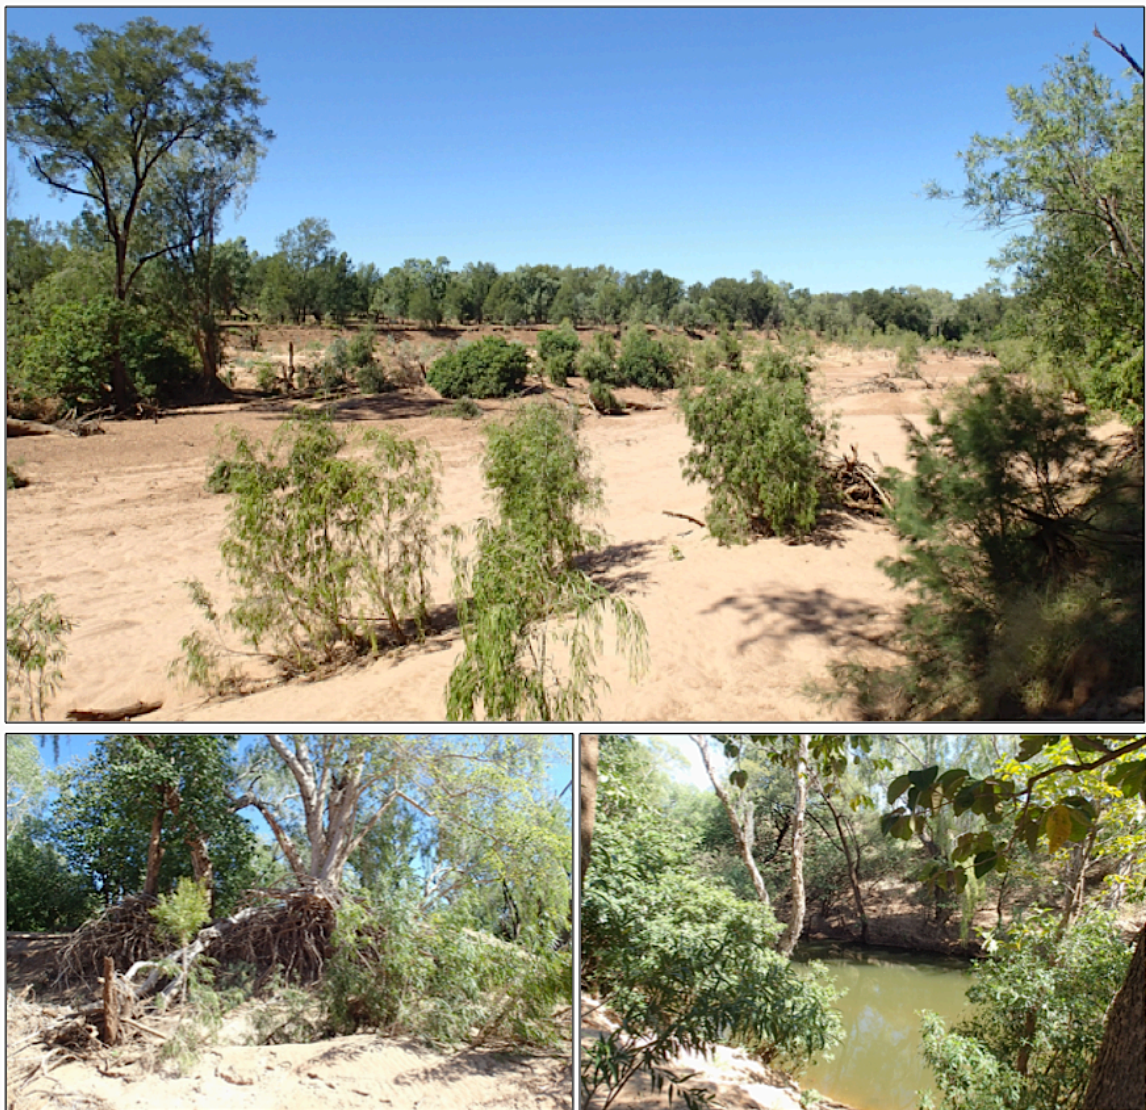
For the first time, the edge macroinvertebrate communities at this site were impacted, most likely as a result of this erosion. Bank and in-stream structures are also being impacted by the erosion at this site. McArthur River Mining should investigate the underlying causes for this erosion (which may be covered as part of the upcoming geomorphological assessment of the McArthur River and Barney Creek diversion channels; (see Section 4.4)), and if it is occurring as a result of the McArthur River diversion channel, mitigation measures should be implemented.

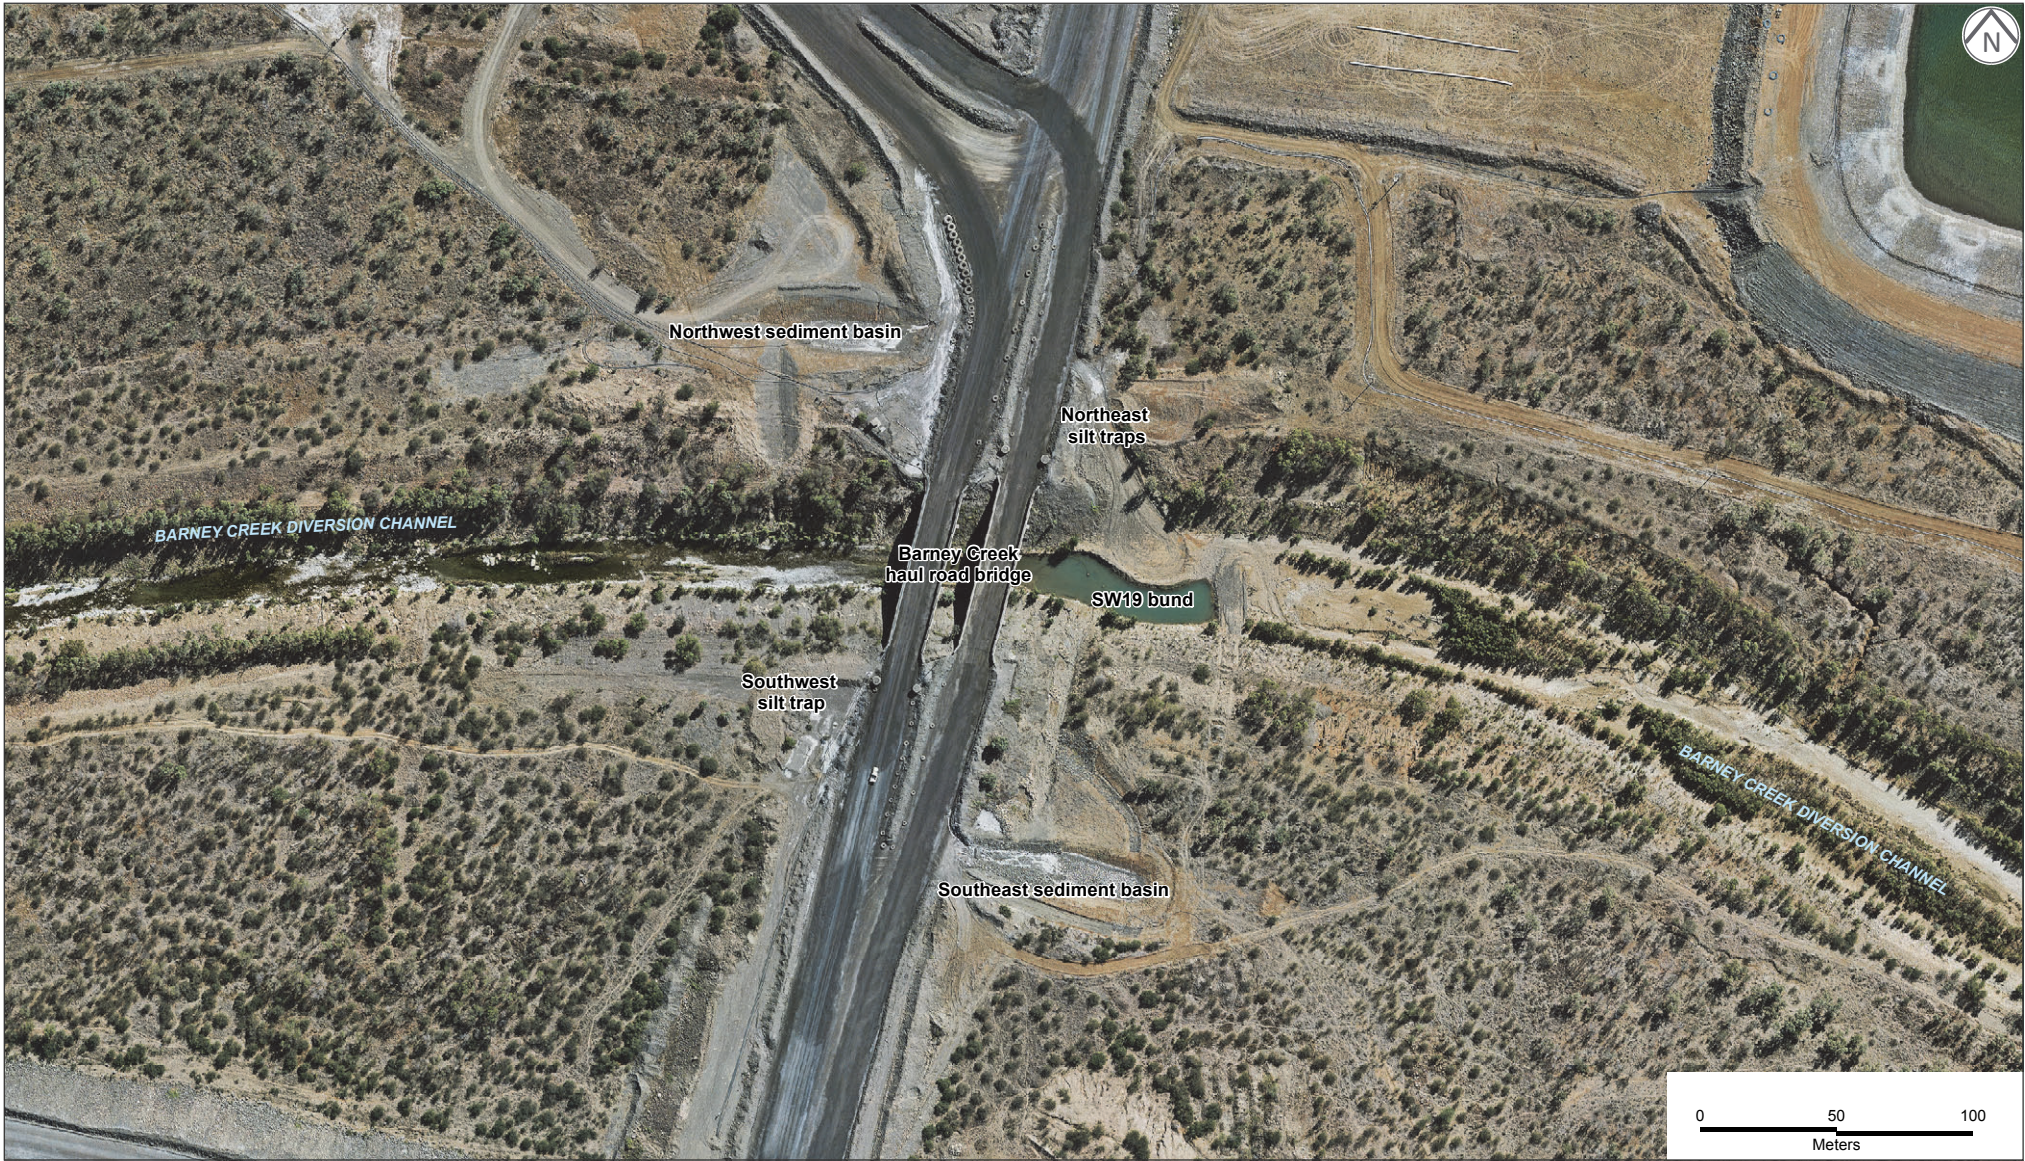
FIGURE 4.34

- ♦ Southeast of the bridge – a permanent ‘Type F’ sediment basin¹⁸ (MRM, 2015c), which reduces contaminated sediment supply to the creek.
- ♦ Northeast of the bridge – a minor silt trap/sediment pond.
- ♦ Southwest of the bridge – two minor silt traps.
- ♦ Immediately downstream of the bridge at FS19/SW19 – a bund/small dam constructed within the Barney Creek diversion channel during the 2014 operational year remains in place to capture contaminated water and sediment (although flow still occurs to varying degrees in all but the driest months).
