Independent Monitor ENVIRONMENTAL PERFORMANCE ANNUAL REPORT 2015

McARTHUR RIVER MINE

AUGUST 2016
Report No. 01164C_1_v2

**Independent Monitor
Environmental Performance Annual Report
2015**

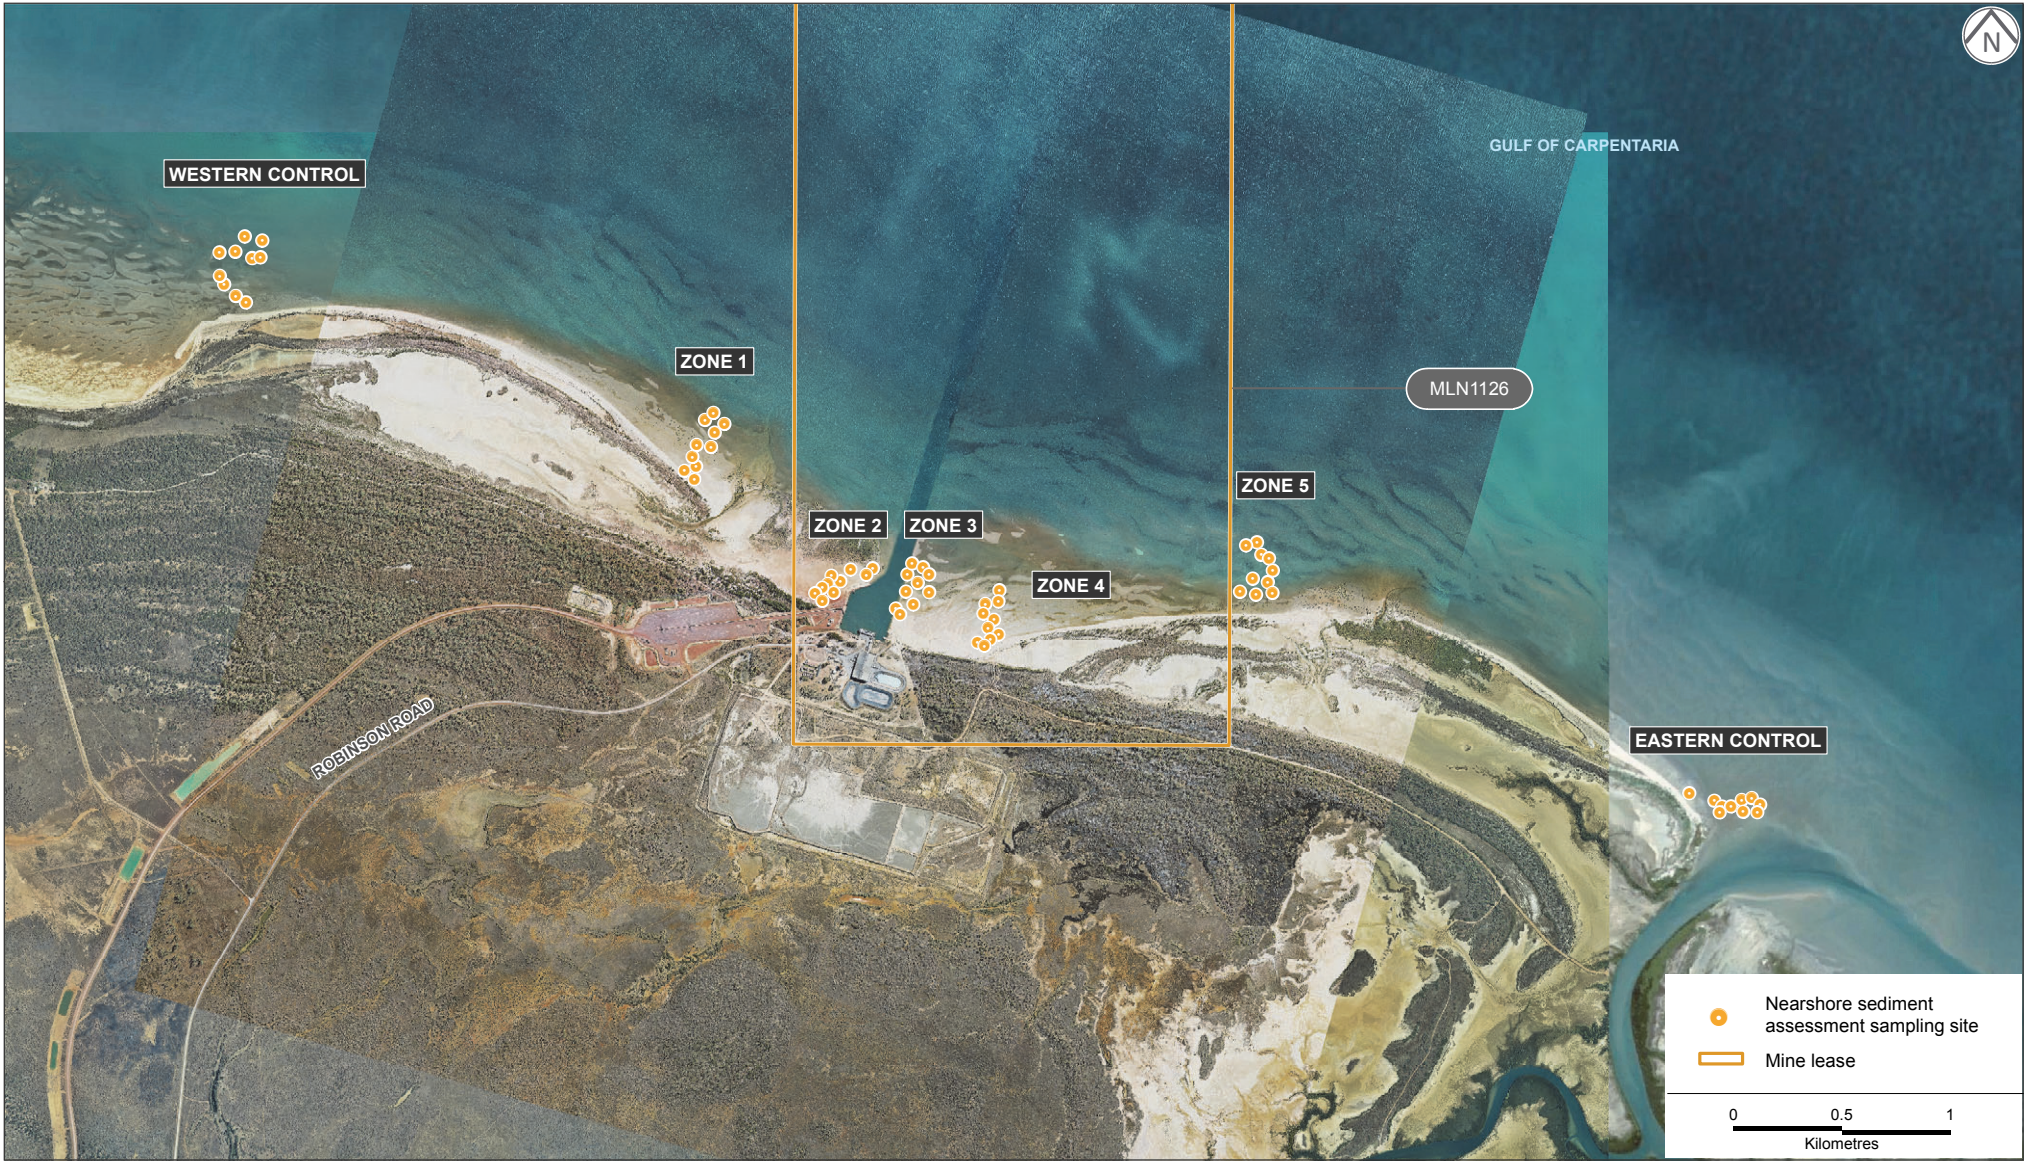
FIGURE 4.36

- ♦ Seasonal marine sediment sampling events during the 2015 operational period, as part of:
 - The annual marine monitoring program (AMMP) undertaken in December 2014, with sampling sites as shown in Figure 4.30.
 - The nearshore sediment assessment undertaken in August 2015, with sampling sites as shown in Figure 4.36.
 - The trans-shipment area seafloor sediment assessment, undertaken in December 2014, with sampling sites as per Figure 4.37.

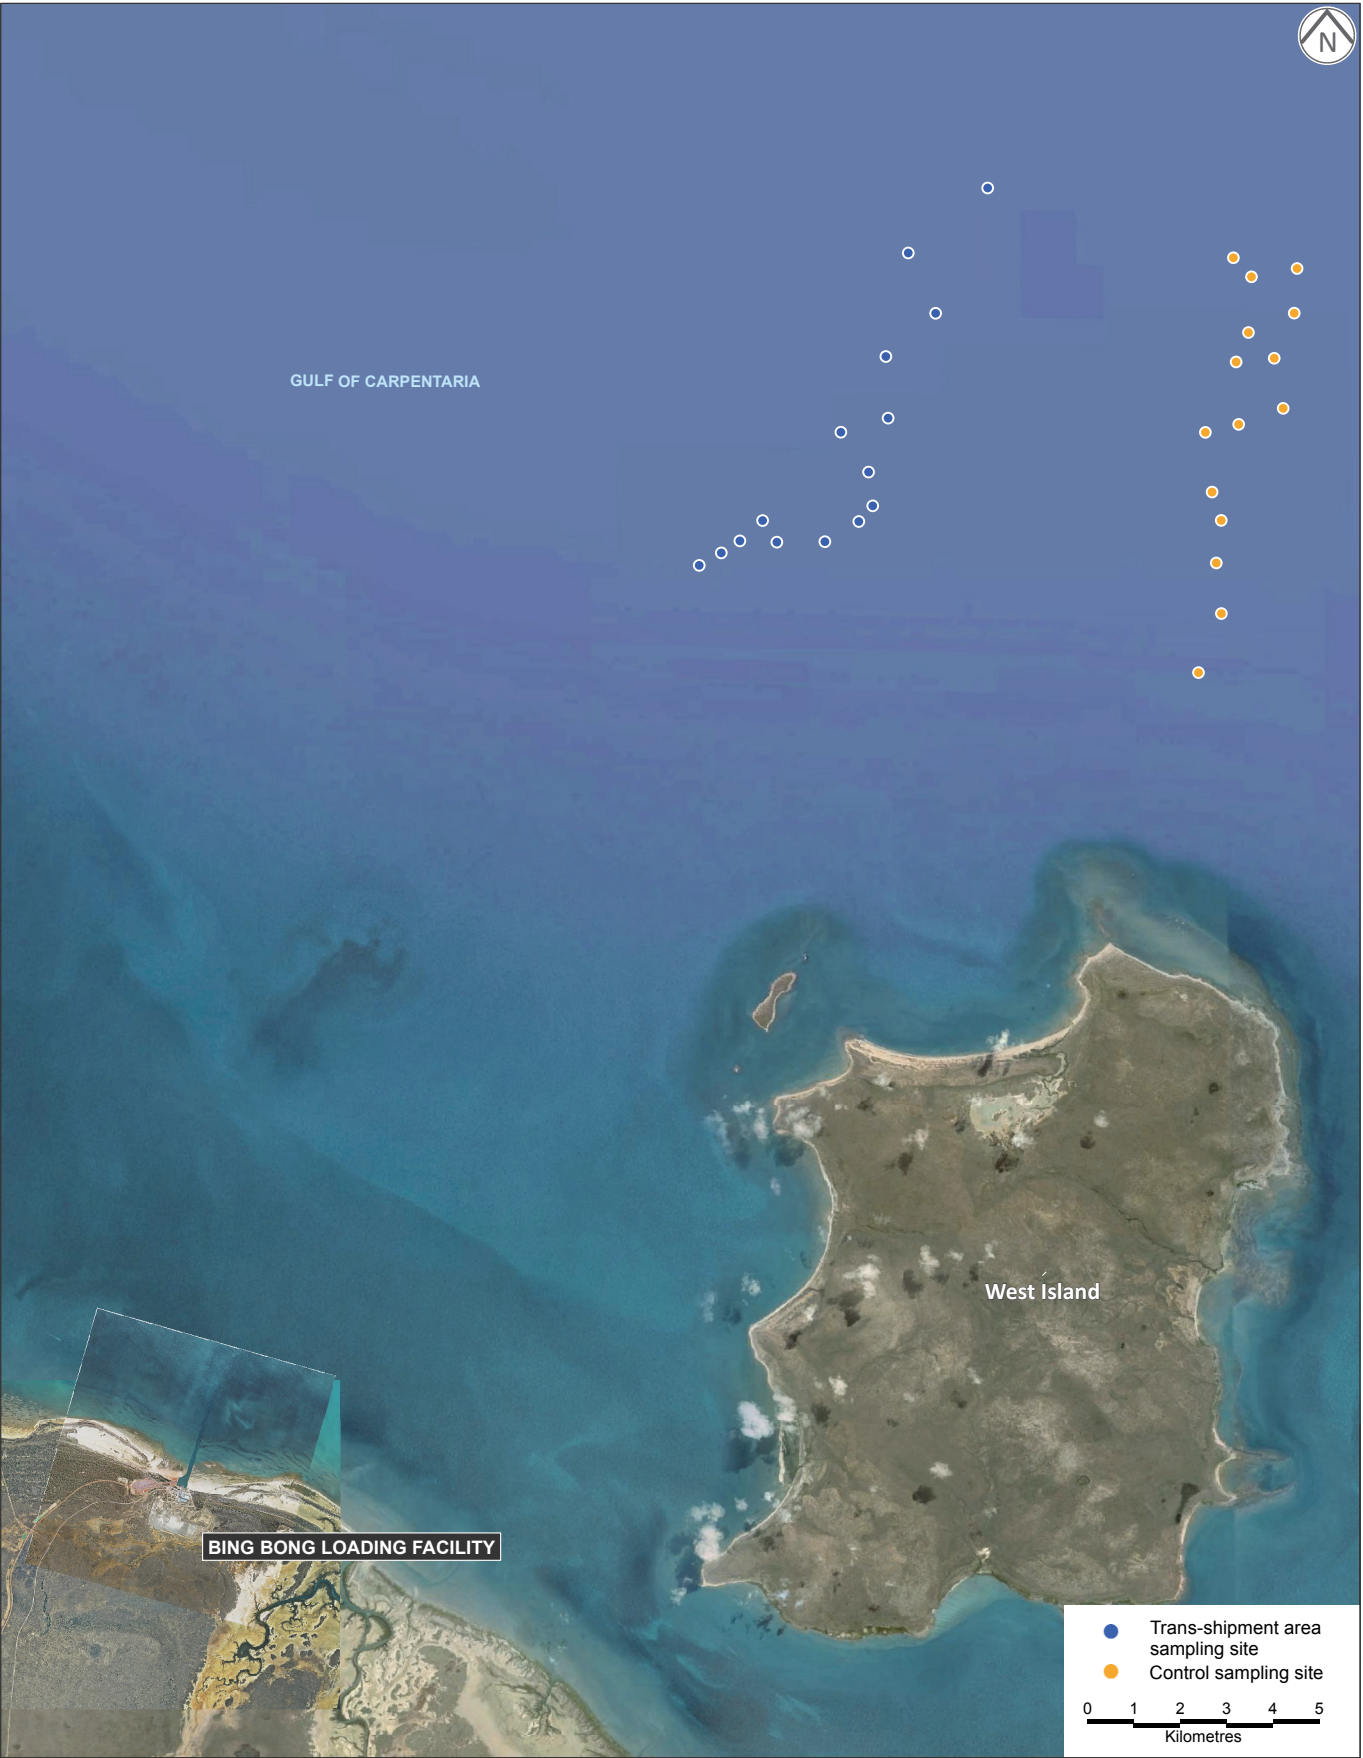
FIGURE 4.37

TRANS-SHIPMENT AREA SAMPLING SITES

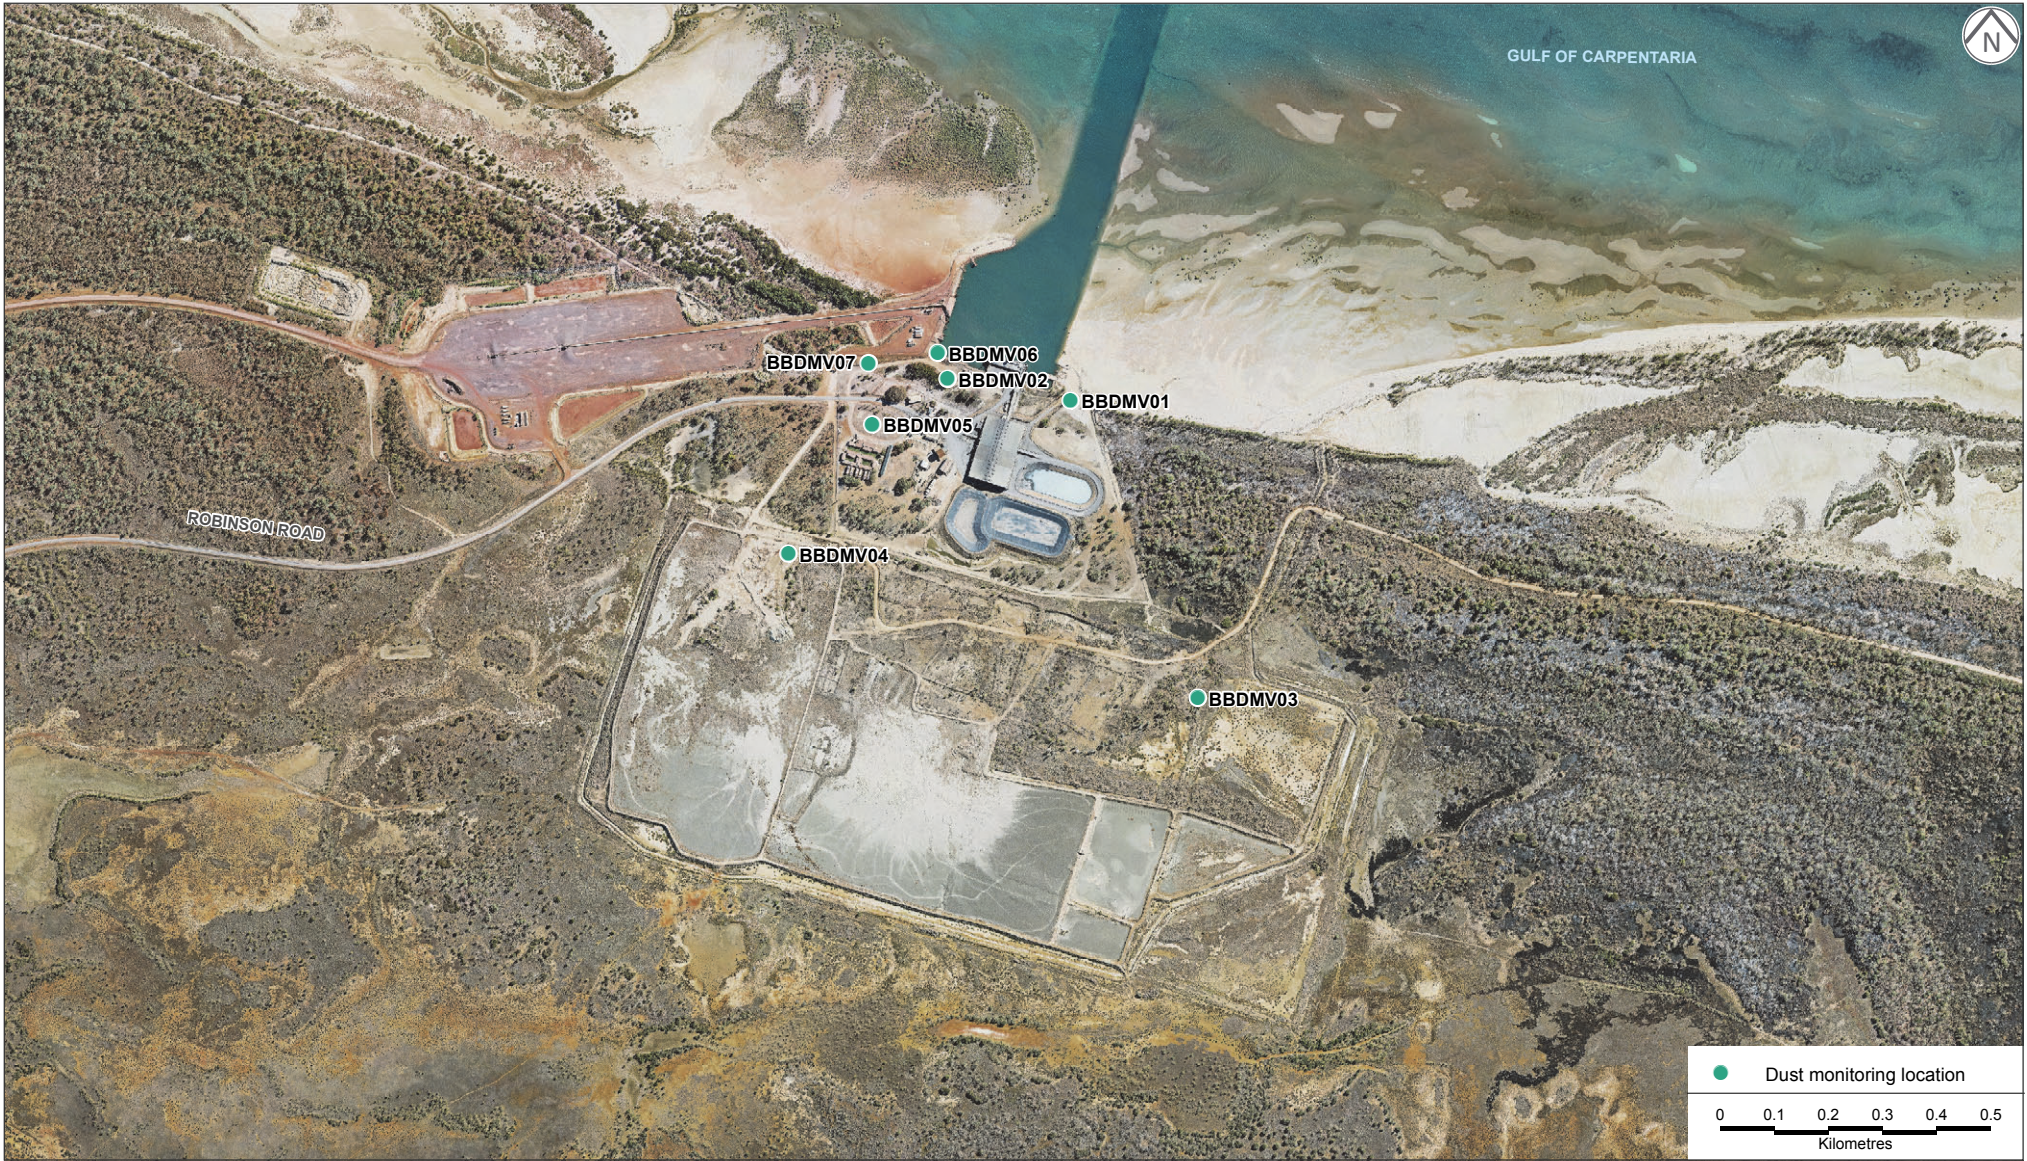
FIGURE 4.39

- ♦ At Bing Bong Loading Facility, seven sites²¹ were sampled during the operational year, as shown in Figure 4.39. Key dust sources in the vicinity of the loading facility include:

- ♦ At Bing Bong Loading Facility, dust monitoring site BBDMV06 has been replaced by new site BBDMV07 (see Figure 4.39), correlating with a new soil monitoring site. The original site BBDMV06 was overtaken by development associated with the WDR iron ore loading dock and conveyor (MRM, 2015c) and a temporary site (of the same name) was established in a slightly different location. Site BBDMV07 is a new site located approximately 30 m west of site BBDMV06, near the Bing Bong Loading Facility boundary fence.

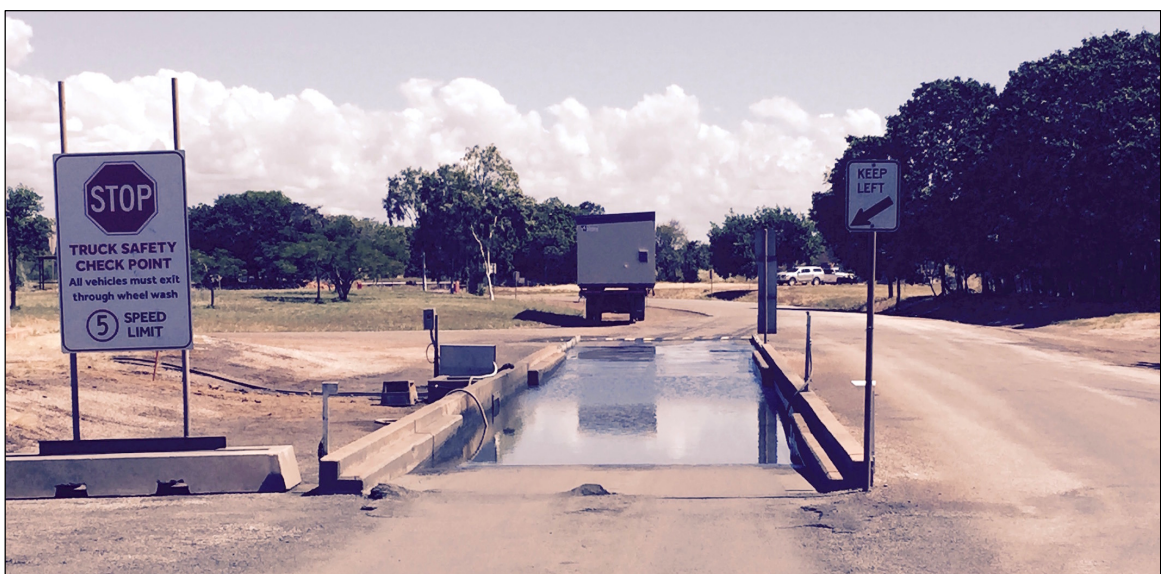
- ♦ The concrete apron (at the ship-loader) is washed down following completion of every ship-loading event.
- ♦ A truck wheel wash (Plate 4.11) to minimise dust emissions from heavy vehicles leaving the facility.

Plate 4.11 – Truck Wheel Wash at Bing Bong Loading Facility

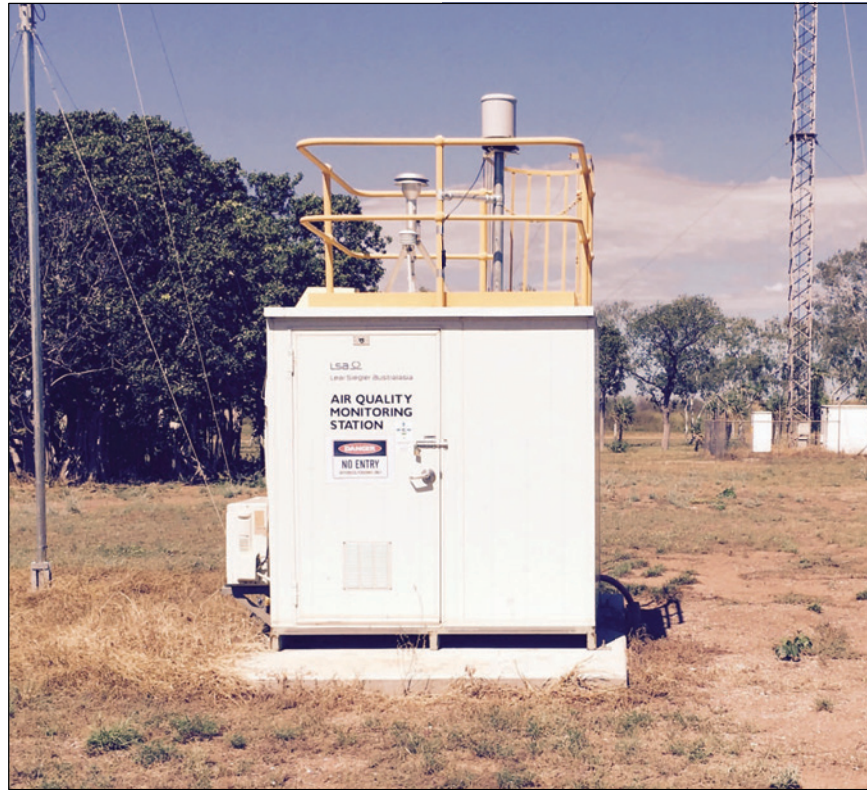
- ♦ During the IM site visit in April 2016, a new tapered element oscillating microbalance (TEOM) unit, which samples particulates as PM₁₀, was observed at Bing Bong Loading Facility, near the camp (Plate 4.12). This unit is also fitted with weather monitoring equipment. The IM has

been informed that a similar unit has been installed near the mine site accommodation. As these units were installed during the 2016 operational year (in January/February, 2016), they will be discussed further in next year's IM report.

Plate 4.12 – New TEOM Unit at Bing Bong Loading Facility

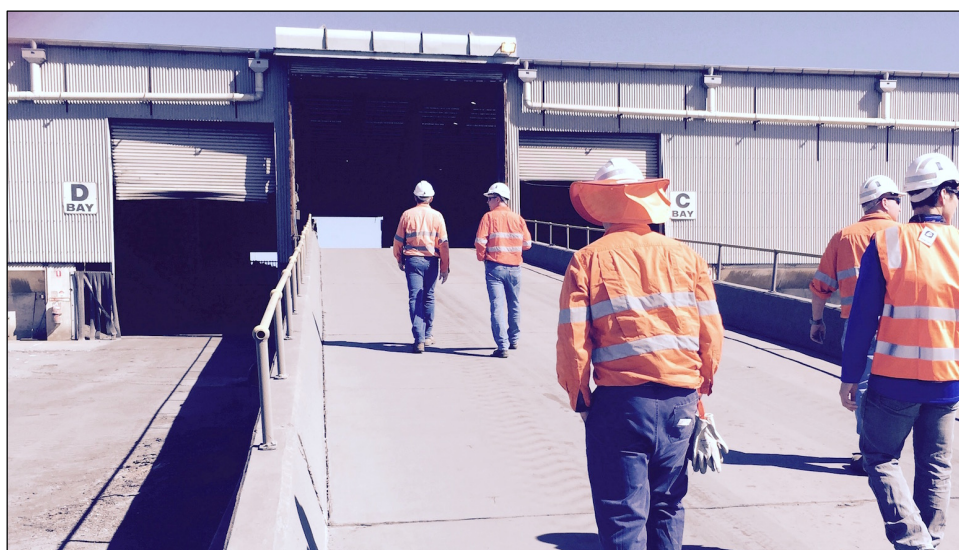
Dust management at Bing Bong Loading Facility	The doors of the concentrate shed should be repaired so that they can be closed except during truck access and egress	<ul style="list-style-type: none"> ♦ During the April 2016 site visit, the IM observed that as per the past two years, the concentrate shed doors were still not operational (Plate 4.13). McArthur River Mining advised that their engineers have been instructed to consider options for the replacement of these doors. MRM (2016) has also stated that a cost benefit analysis is being completed

Plate 4.13 – Non-operational Doors at Bing Bong Loading Facility Concentrate Shed

Photo taken in April, 2016.
