Erosion and Sediment Control Plan
Date: 26/06/2014
Drawing No: ESCP-003

NT Portion 1234
101 Territory Rd, Katherine
Clearing Area 2
Mango Orchard
Map 3 of 3

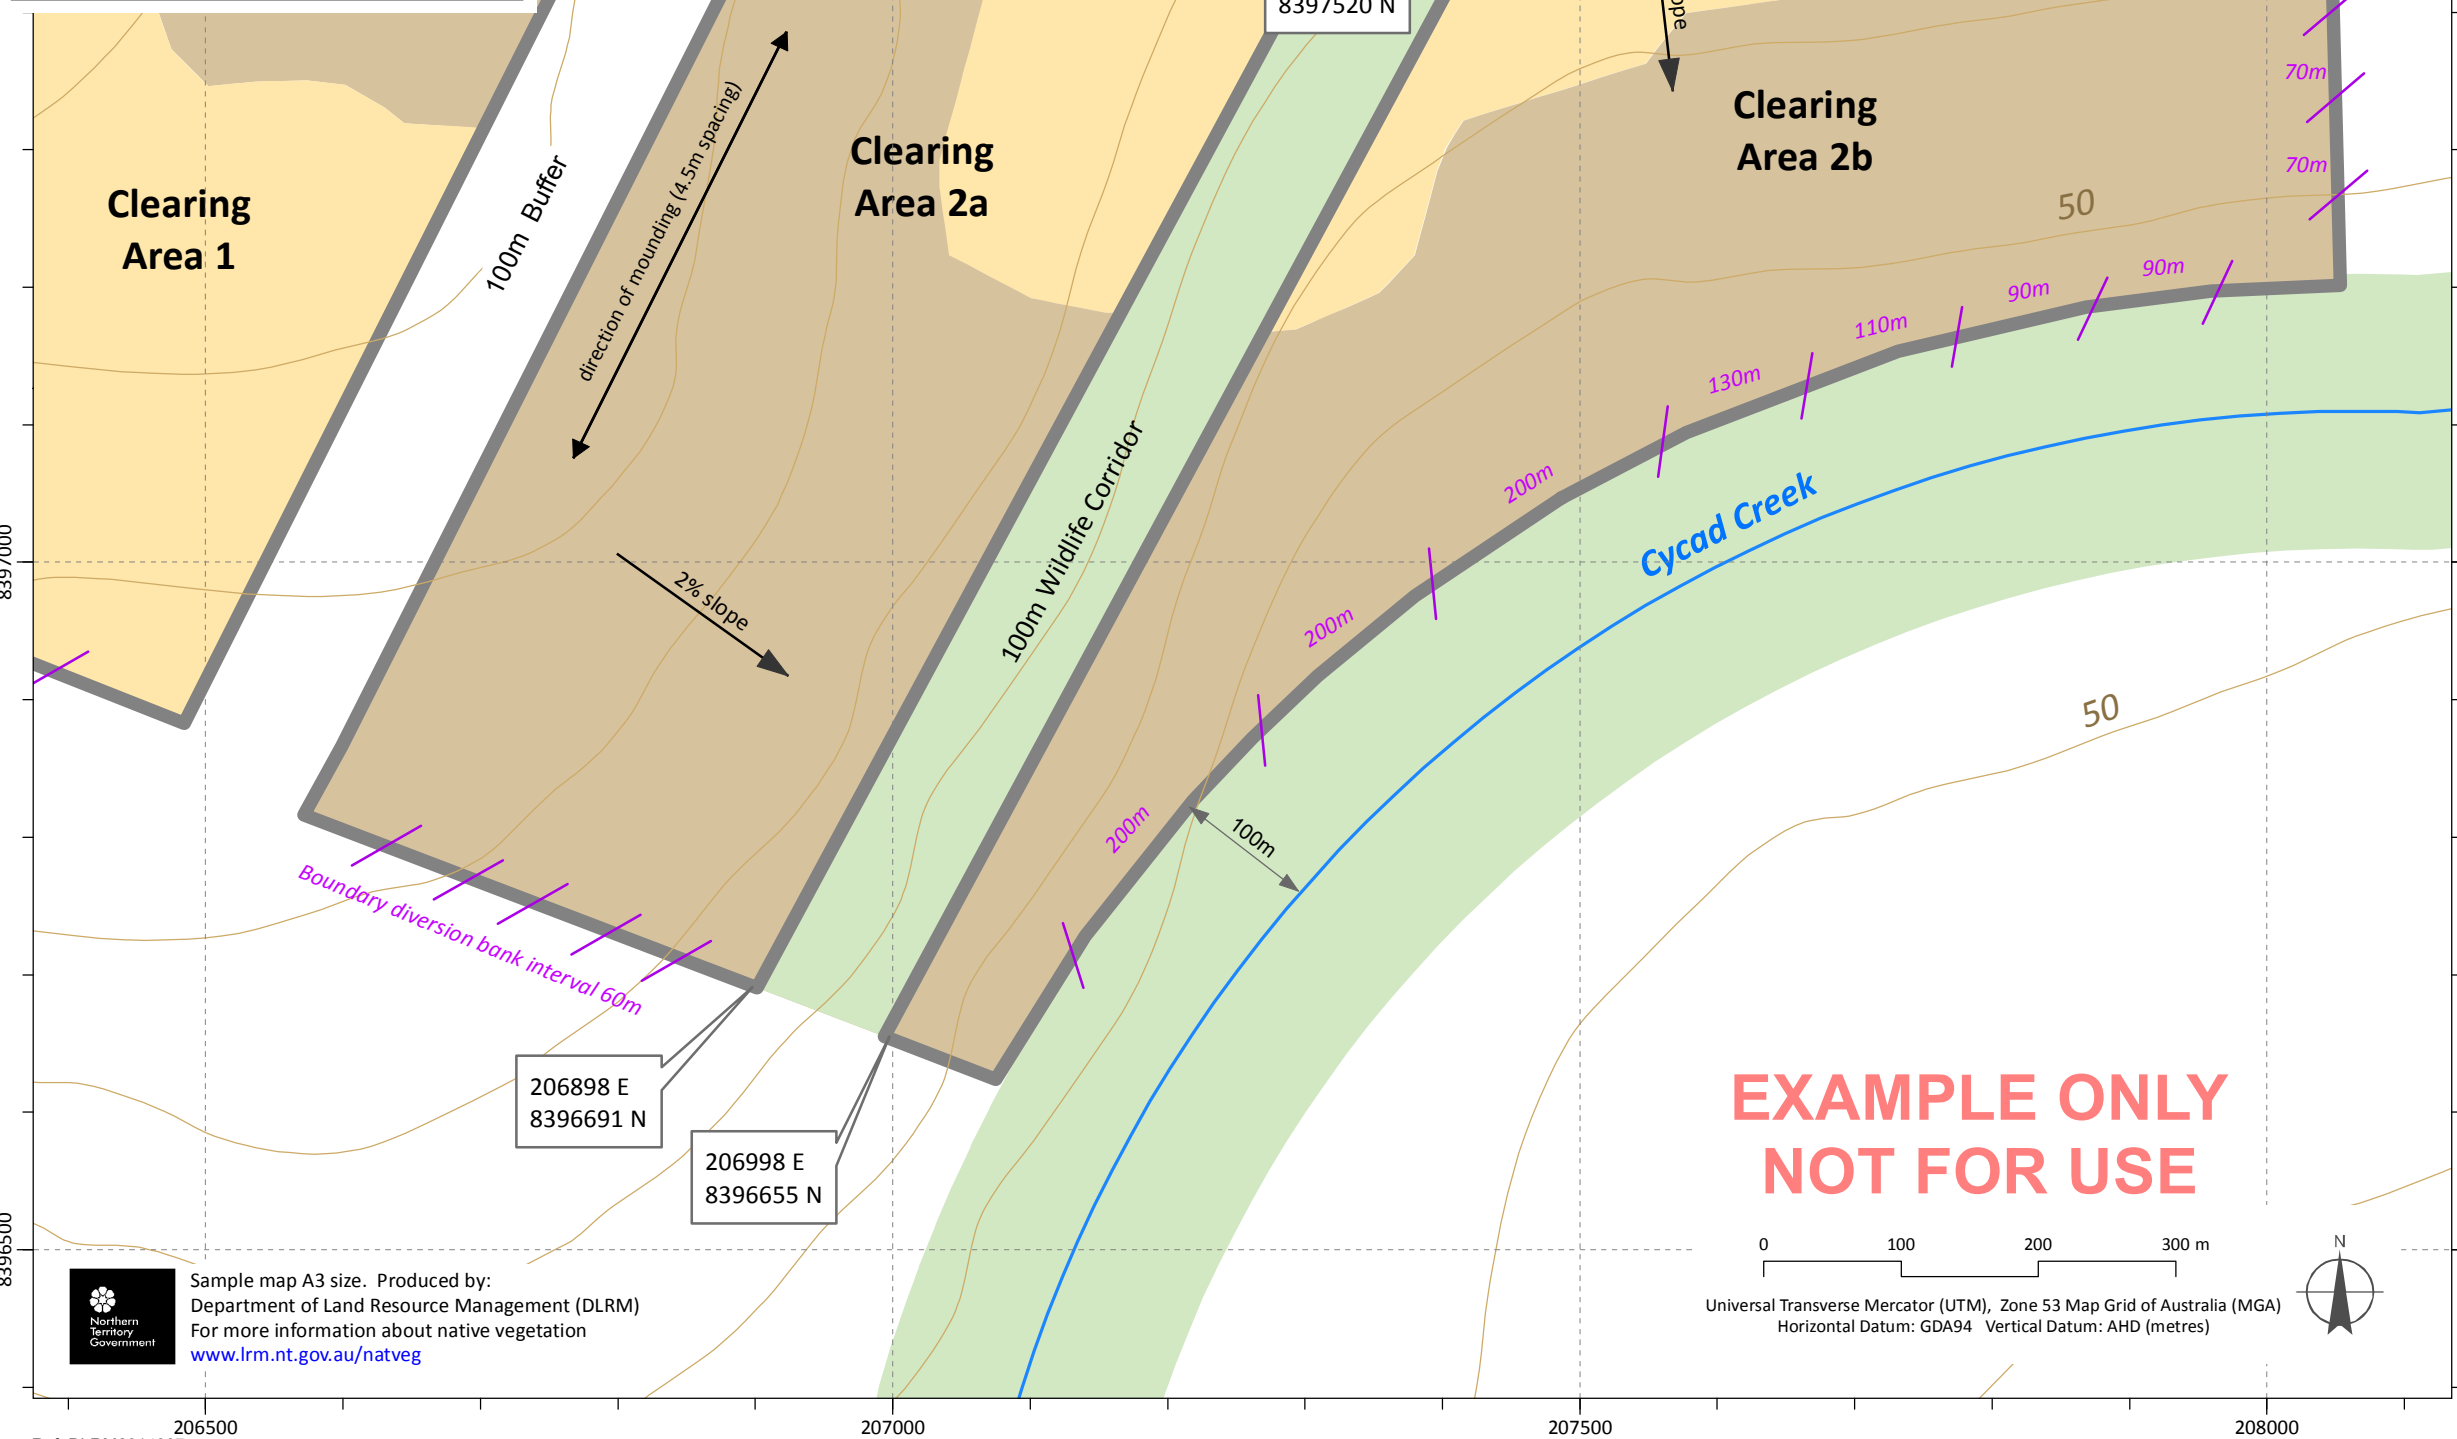
- Construction Notes**
- Permitted clearing area digital linework to be obtained from DLRM
 - Contractor to inspect & flag clearing area prior to commencement of works

- 100m buffer along creek on western boundary to be confirmed prior to commencement of works
 - 100m buffer from edge of sinkhole on northern property boundary to be confirmed prior to commencement of works

- Early Nov 2014 – clear paddock & leave felled veg in situ until Sep 2015
 - Clearing method – chain using two bulldozers equipped with GPS
 - Early Sep 2015 – windrow felled veg at right angles to contour & burn (Permit to Burn to be obtained from Bushfires NT)

- Early Sep 2015 – construct diversion banks on boundaries
 - Early Nov 2015– prepare soil using offset disc plough to rip & mound across slope at 4.5m spacing

- Early Nov 2015 – lay irrigation, plant mango trees & seed inter-row spacings with Jarra grass
 - 100m wide wildlife corridor to be permanently retained & regularly maintained

- Firebreaks 10m wide, maintained using slasher.
