INDEPENDENT MONITOR'S AUDIT OF THE MCARTHUR RIVER MINE FOR THE 2010 OPERATIONAL PERIOD

ENVIRONMENTAL EARTH SCIENCES VIC

**REPORT TO THE MINISTER FOR PRIMARY INDUSTRY FISHERIES AND
RESOURCES**

OCTOBER 2011

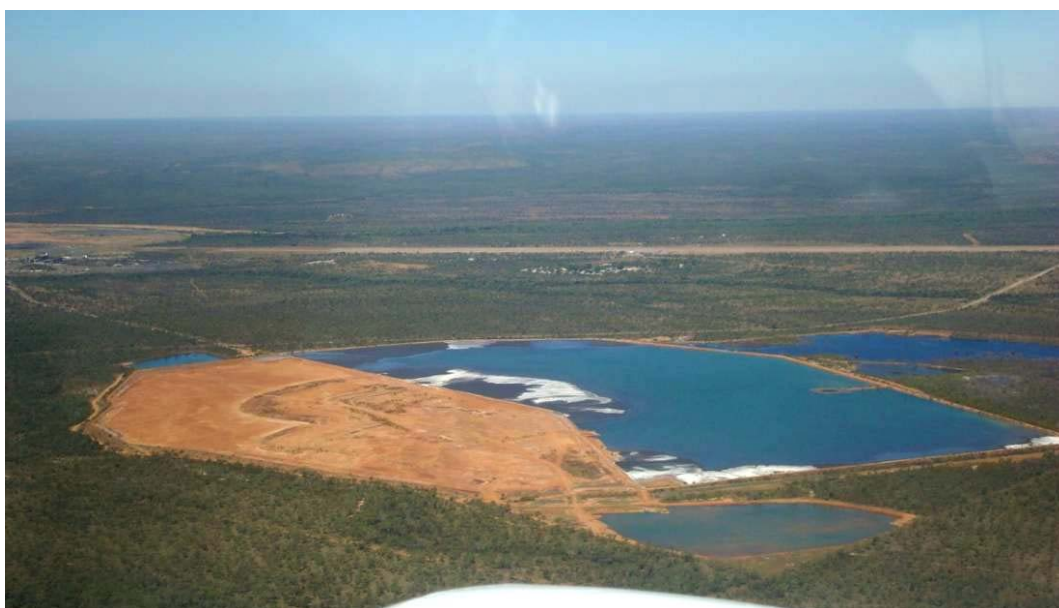
Plate 2 Excess water still stored in TSF Cell 2 in 2011. Note the completion of the clay capping of TSF Cell1 since the previous audit. The cap now acts as a measure to suppress talings dust emissions. Photo: Independent Monitor, 1 June 2011.

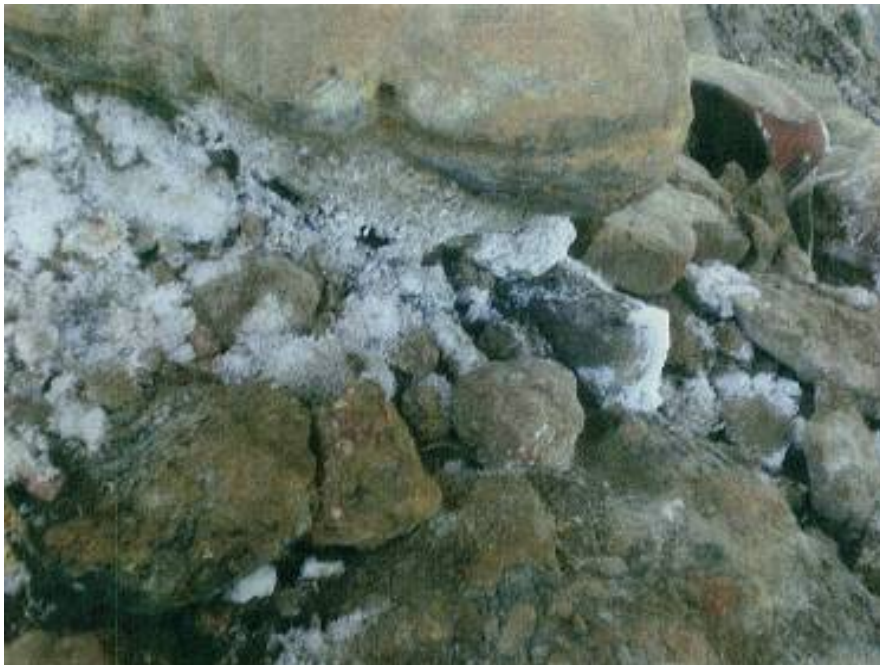
Photos of a white substance on rocks under the Surprise Creek Bridge crossing along the Carpentaria Highway were provided to the DoR by the Environment Centre NT on 1 December 2010 (see Plate 4).

Plate 4 Photo of significant salt build up on rocks along Surprise Creek at the bridge crossing along Carpentaria Highway. Photo: Environment Centre NT

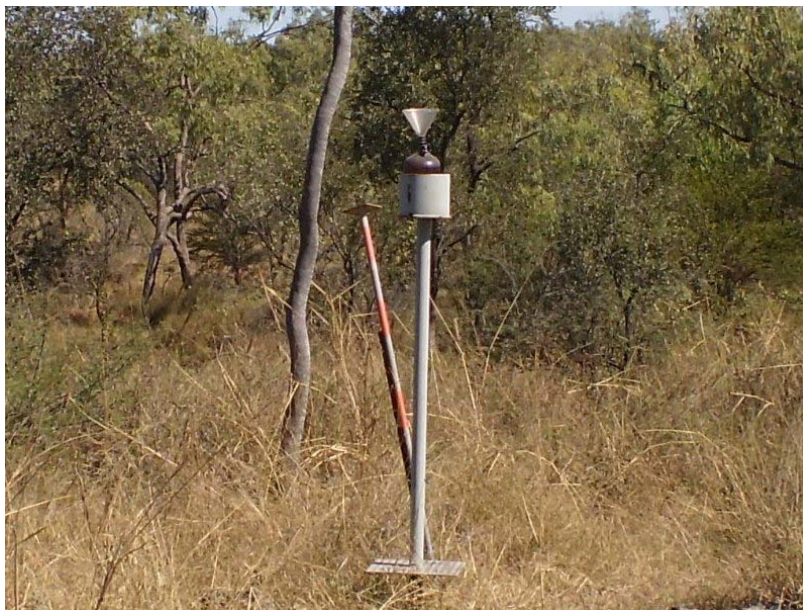
Plate 6 Depositional dust monitoring location. Source: Independent Monitor.

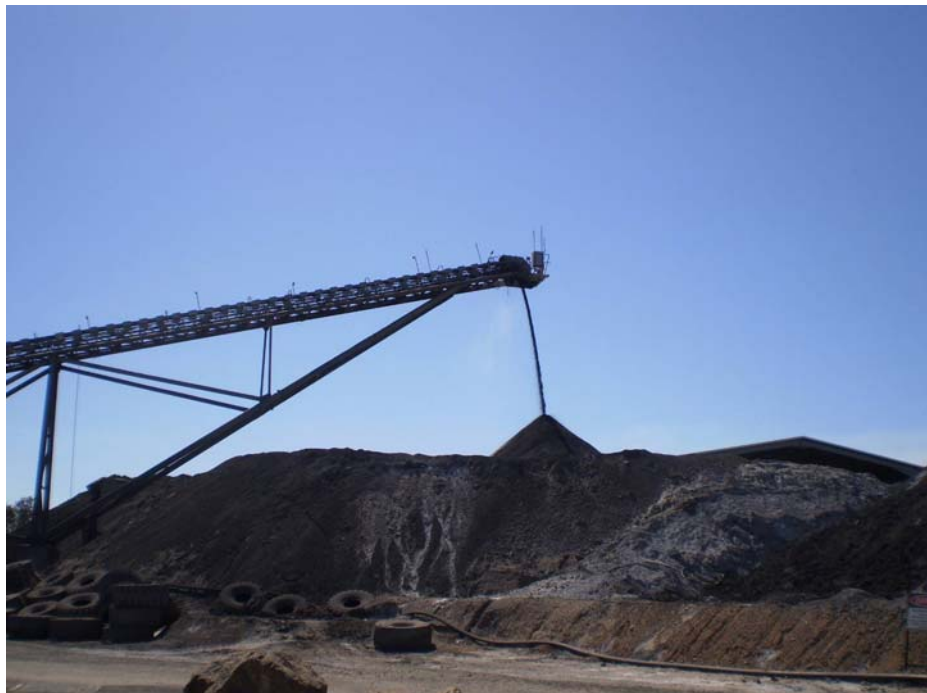
However, MRM staff did advise that an additional hood had been placed on the plant to try to limit dust, and that sprays were working throughout the plant to suppress dust. The IM also observed that a spray at the top end of the PACRIM conveyor line is now used constantly rather than intermittently (Plate 8).

Plate 8 Sprays located at the top of the conveyor are now used more often.

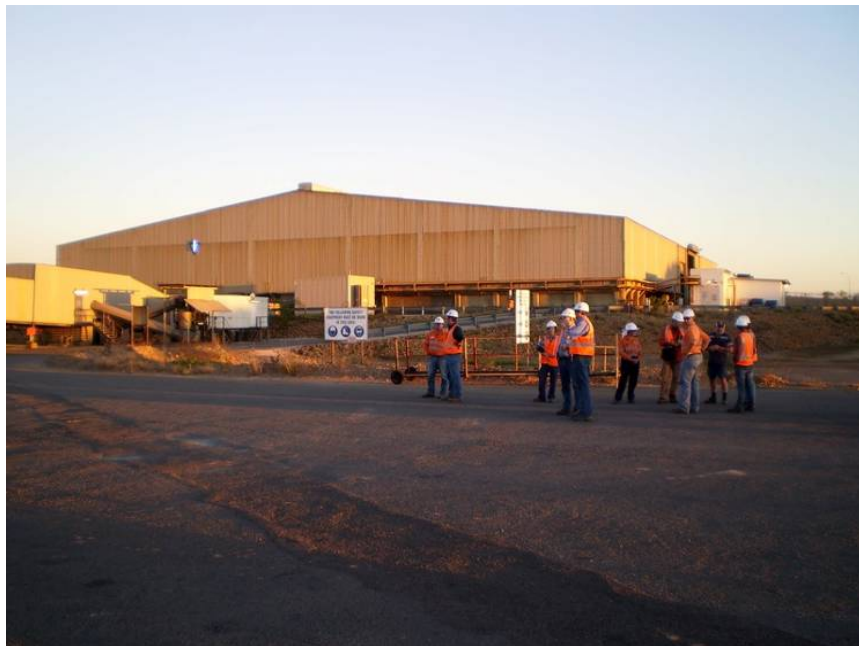
Plate 12 Independent Monitor team outside of concentrate storage shed at Bing Bong Port facility.

- due to lack of training of the operator, the dust suppression system on the working drill rig was not functioning (see Plate 11);
- fine dusts are present below the ejection chute of the mobile crushing plant and within the stockpiles of processed stone;
- concentrates of varying degree of moisture are stored in the shed (Plate 12). As concentrate dries out it increases the risk of fugitive dust emissions from the shed;

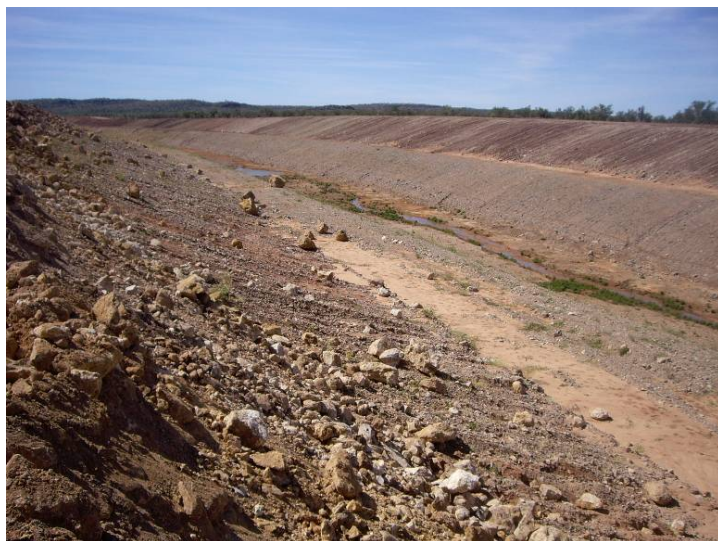
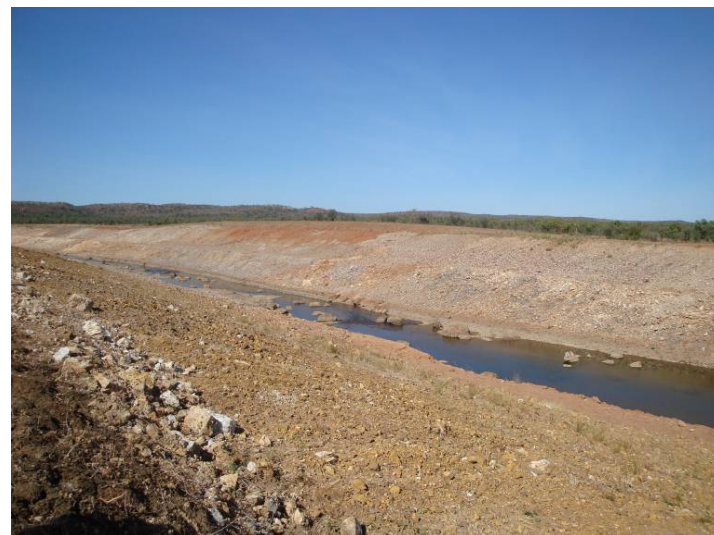
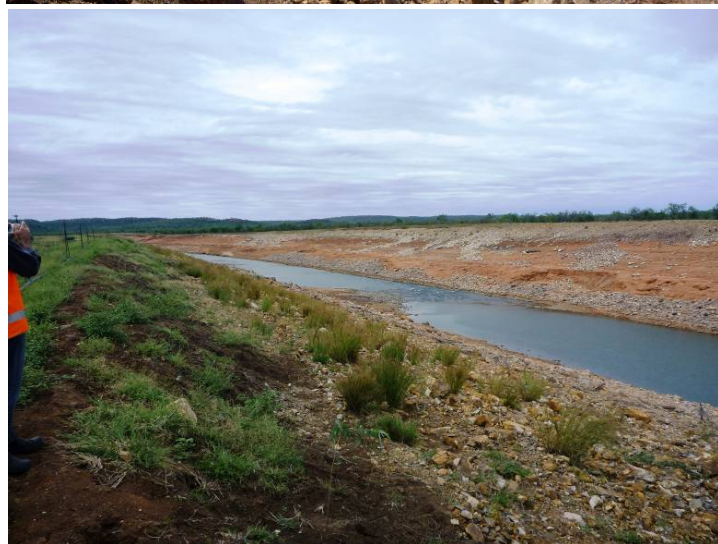
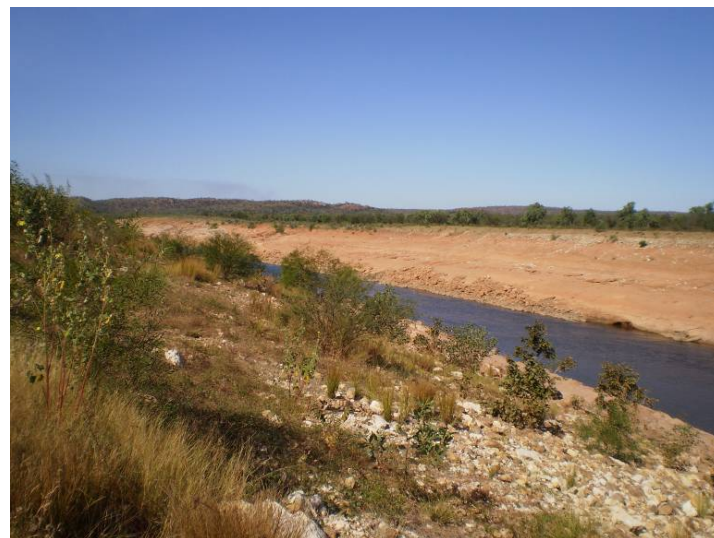
Plate 13

Photographic comparisons of an area along the upper section of the McArthur River diversion that is currently undergoing revegetation. The photographs show the progressive establishment of vegetation on the mine side of the river diversion from 2008-2011. This is a positive outcome for the diversion rehabilitation; however, more revegetation works downstream and on the opposite bank are required in coming years. (All photos by the Independent Monitor).

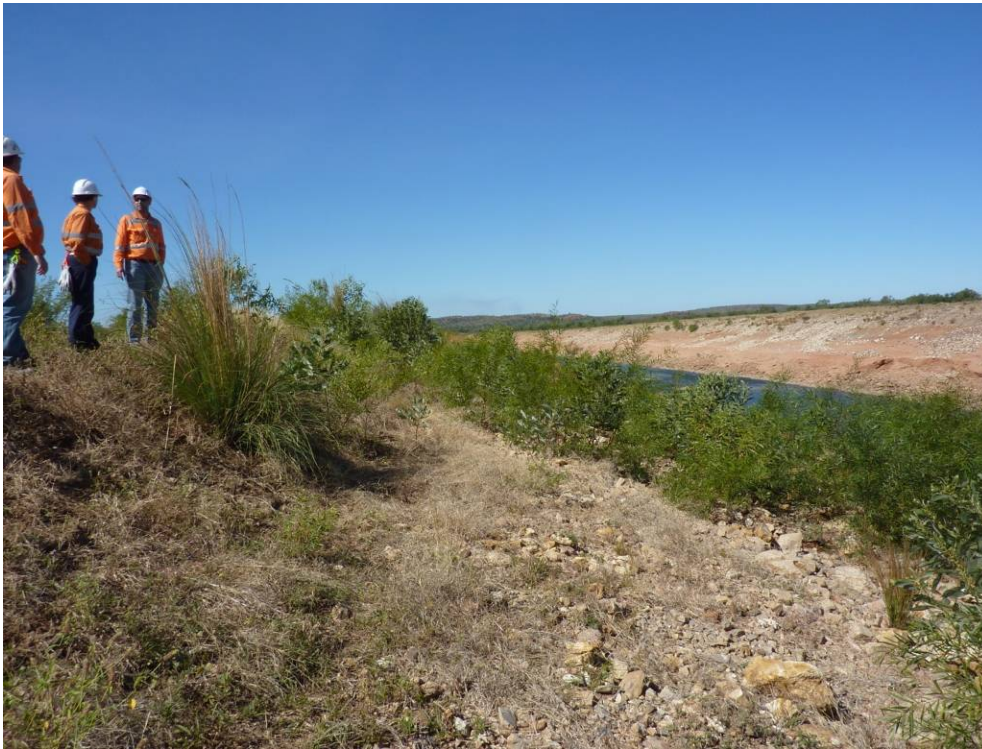
Plate 14 Revegetated bank of the upstream McArthur River diversion (mine-side), inspected by the Independent Monitor team, May 2011. Photo: Independent Monitor.

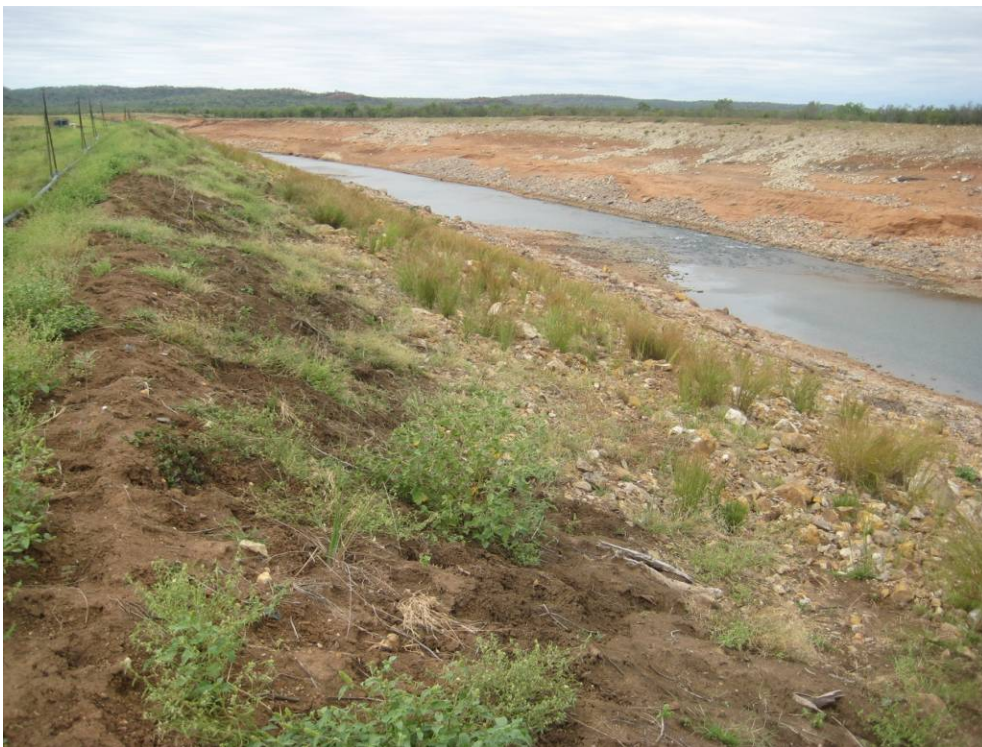
Plate 15 McArthur River diversion Channel as inspected by the Independent Monitor team, May 2010. Photo: Independent Monitor.

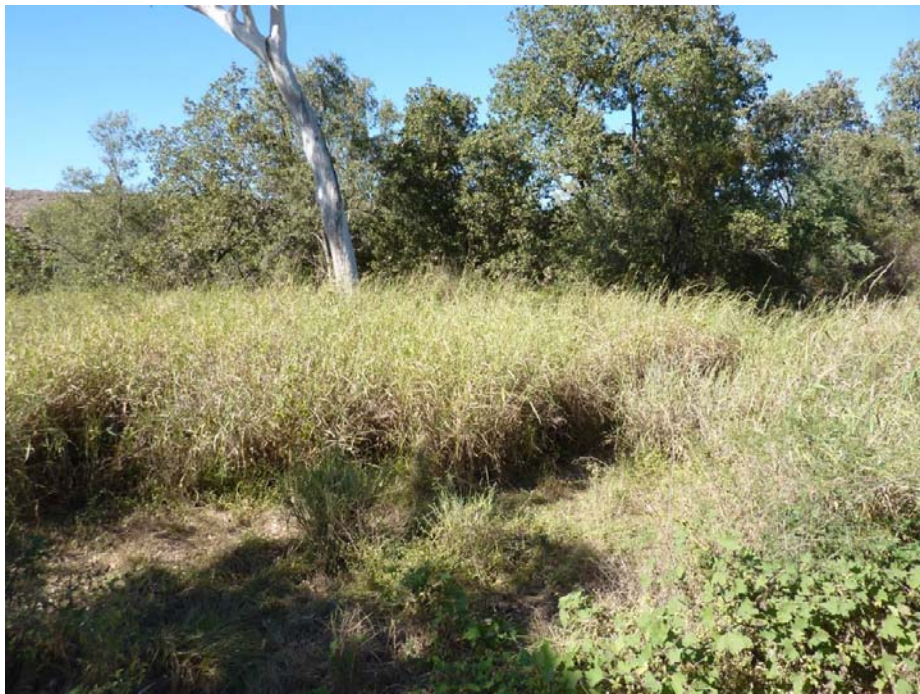
Plate 16 Cane grass stands adjacent to Barney Creek diversion. The original Barney Creek corridor is in the background. Photo: Independent Monitor.

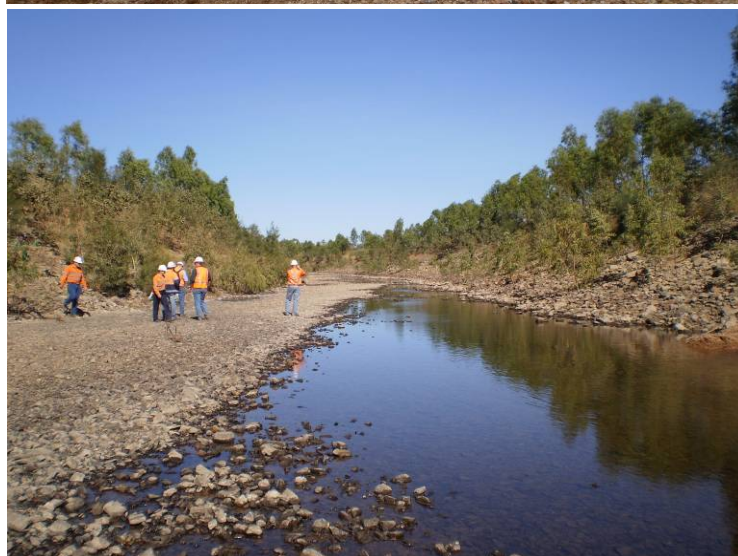
Plate 17 Photographic comparisons of the same revegetated area of the Barney Creek diversion taken in 2009, 2010 and 2011 by the Independent Monitor.

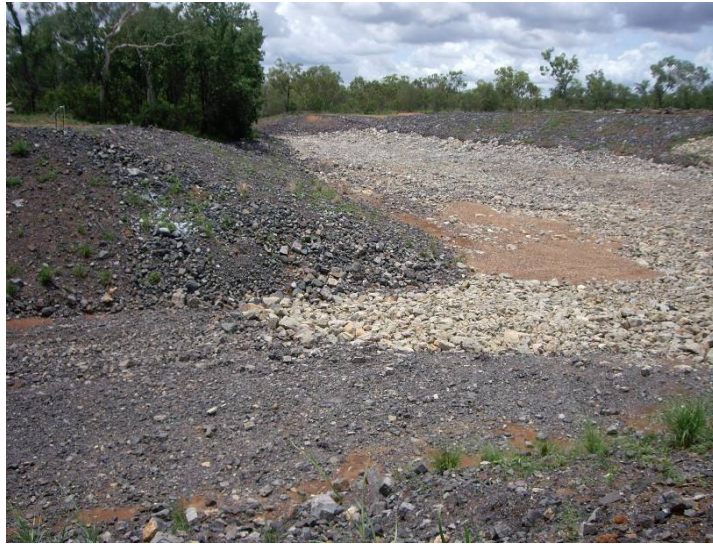
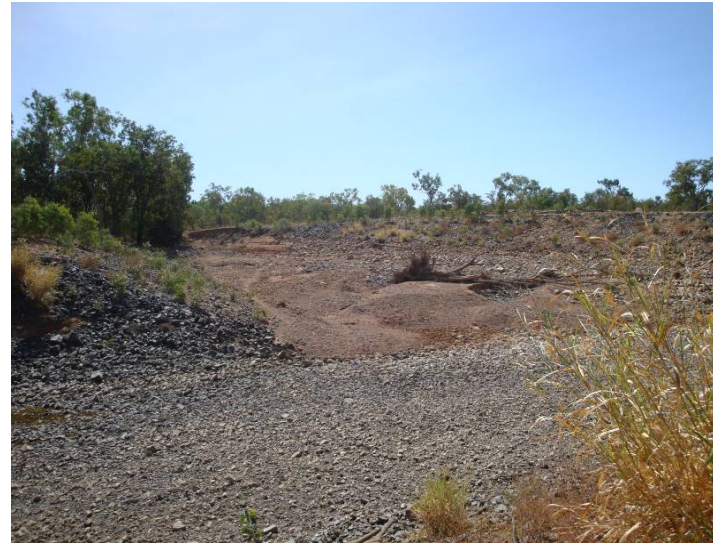
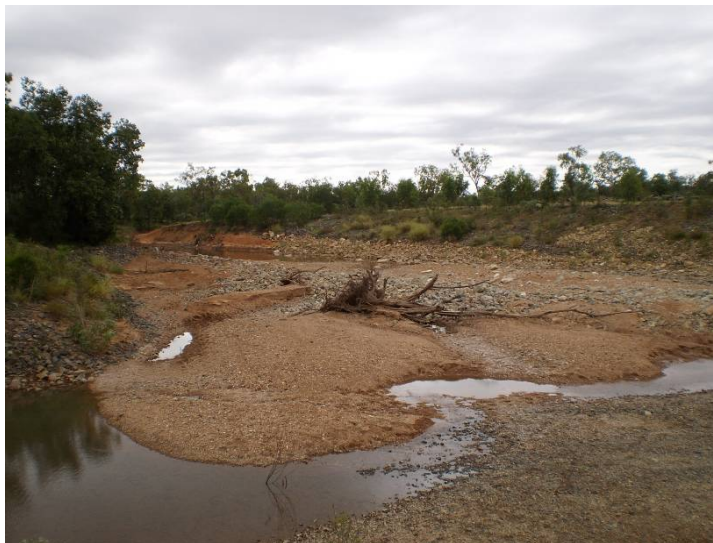
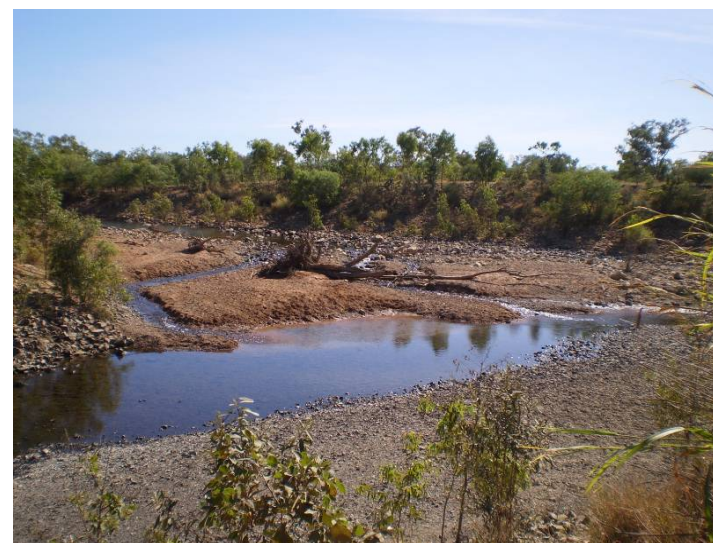
Plate 18 Photographic comparisons of the Surprise Creek confluence with Barney Creek taken by the Independent Monitor from 2008-2011. Photographs show the improvement in revegetation over the four year period. Photos: Independent Monitor.

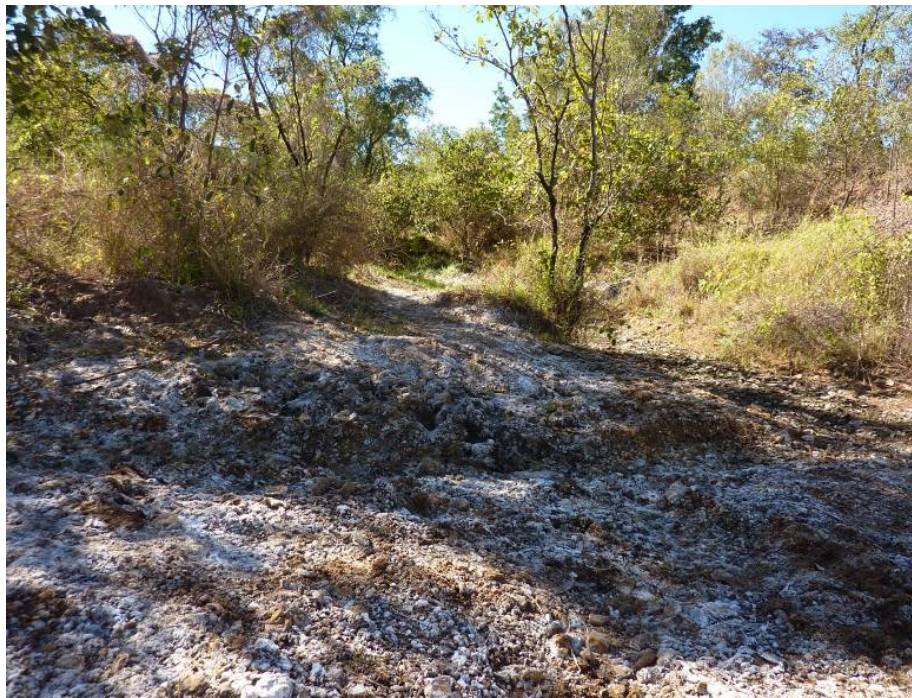
Observations made during the 2011 site inspection indicated that vegetation dieback from seepage on the northern side of the TSF has not increased when compared to the previous year. This may either be due to the long duration of the wet season, which may have diluted the seepage; or effective mitigation measures, including the recovery bore, sump and capping on TSF Cell 1, or a combination of these two factors. The Independent Monitor understands that the TSF is likely to continue to seep for some time and that negative consequences have been observed in fauna downstream in Surprise and Barney Creeks (these are discussed in section 9.7.4).

Plate 20 Salts from tailings leachate seeping into Surprise Creek. Photograph: Independent Monitor.

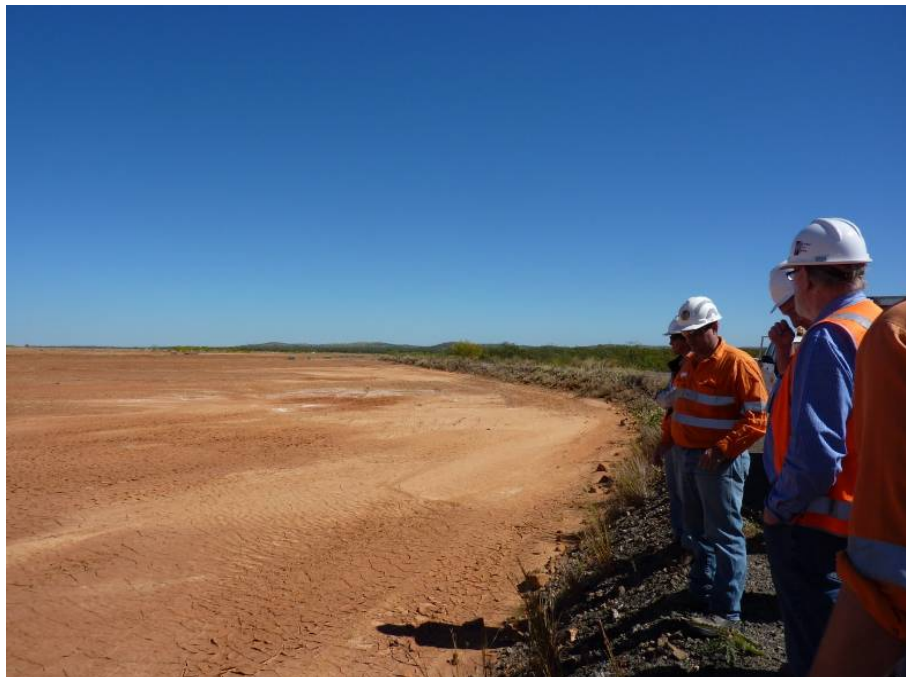
Some grasses and acacia species have been established on the clay cover of Cell 1 with limited success, possibly due to poor seed viability. MRM have not undertaken any other revegetation of this clay cap, which is being used as a temporary dust suppression method only, before subsequent layers are added as part of the staged rehabilitation of TSF Cell 1. Given the acid migration upwards an alkaline capillary break will be required underneath the final growing medium.

The Independent Monitor understands that the purpose of the current clay capping on TSF Cell1 is for tailings dust suppression, however wind erosion can still affect the cap during the dry season due to its lack of vegetation cover. MRM have indicated that trials with specific plants and techniques will be undertaken in order to prepare for the rehabilitation of Cell 1, which is scheduled for 2014/2015, after the third and final clay capping is completed (MRM 2010c pg 209, Crawford, J pers. comm. 2011).

Plate 21 Clay capping of TSF Cell1. Photograph: Independent Monitor.

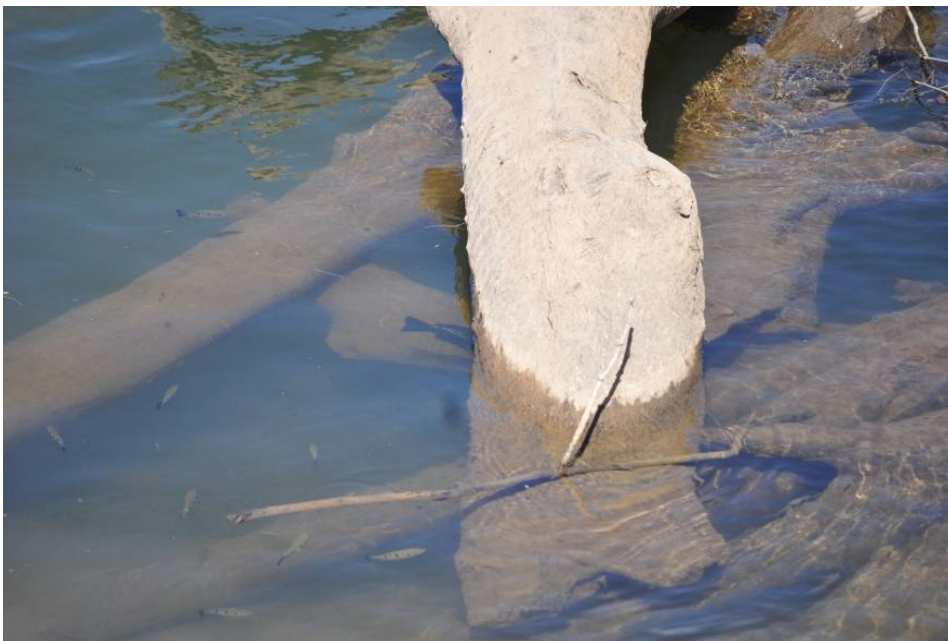
The main recommendation of the fish reports and last year's Independent Monitor report was for the addition of large woody debris into the MR diversion to provide fish habitat. This has been carried out and recorded by MRM (2010c).

In the September 2010 Interim Fish report (Indo-pacific Environmental 2010b) and personal communications with Dean Thorburn from Indo-pacific Environmental, during the May 2011 site inspection, it was indicated that the woody debris is already starting to improve fish habitat. Indeed, the Independent Monitor observed 10 fish species around one of these log jams in the May 2011 site inspection (Plate 23).

Plate 23 Large woody debris along the McArthur River diversion. Photo: Independent Monitor.

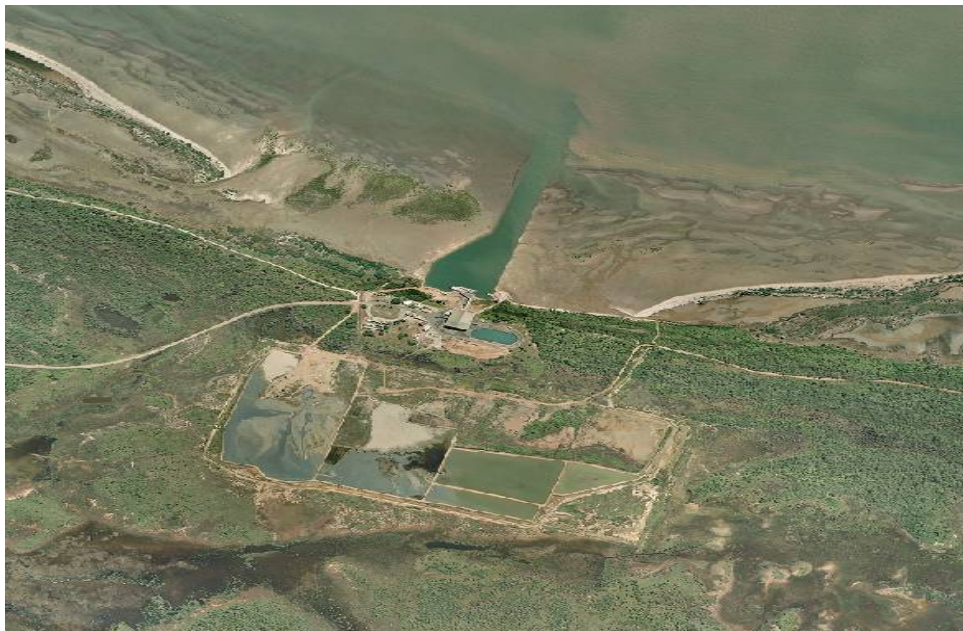
An orthophoto of the dredge pond area, the surrounding dieback area and mangroves was submitted to the Independent Monitor, however no interpretation has been made by MRM (See Plate 24). Furthermore, no formal ground truthing has been carried out to determine the composition of species on the spoil, particularly weeds, or to monitor vegetation dieback of surrounding vegetation.

Plate 24 Orthophoto of Bing Bong Port facility, sourced from Environmental Monitoring Manual I005 Rev 0, MRM 2010.

The impact by salt discharge is being monitored by salinity analysis of the soil around the dredge ponds and this should be continued.

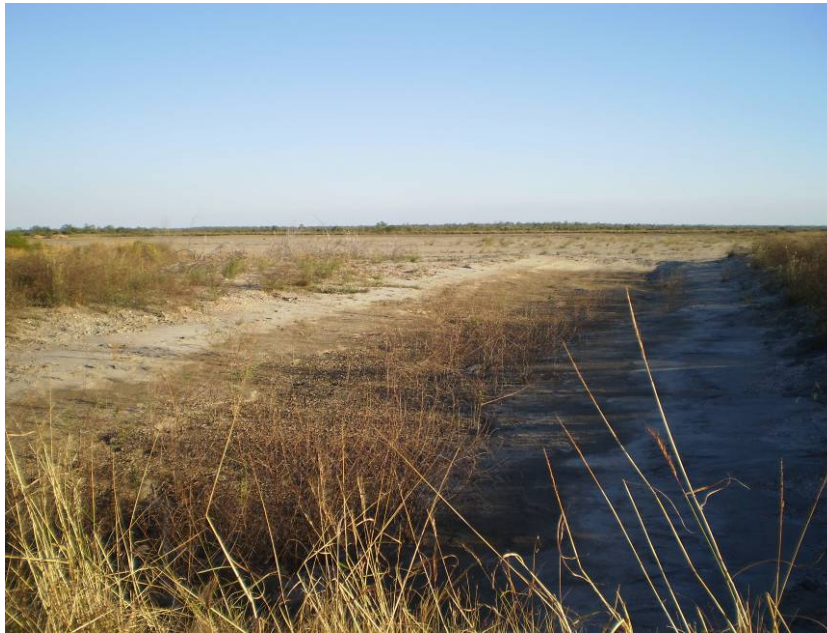
A PhD student from Charles Darwin University (CDU) was scheduled to undertake a plot trial study on the site to investigate the potential for future vegetation rehabilitation of the dredge spoils at Bing Bong Port facility. In preparation for this study, MRM had constructed a number of plot trial areas within an area of the dredge spoil, each consisting of shaped areas of swales and higher ridges (See Plate 27). These were inspected by the Independent Monitor during this year's site inspection.

Plate 27 Plot trial area of the Bing Bong dredge spoil, constructed by MRM. Photo: Independent Monitor.

Unfortunately, MRM staff confirmed that the CDU PhD revegetation study did not commence as planned due to the student pulling out. The lack of this vegetation trial created a gap in MRM's monitoring commitments and no firm strategy is in place to rectify this issue, although MRM are aware of the situation and are looking for alternatives such as contracting the work (Taylor, G, pers. comm. 2011).

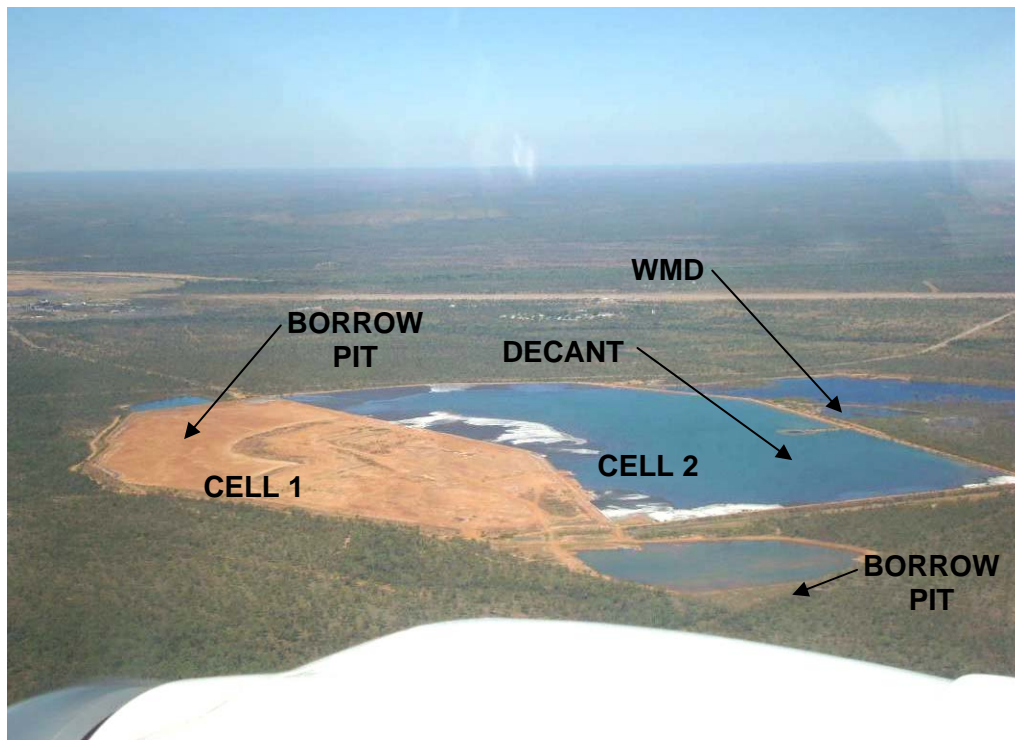
At the time of inspection, Cell 1 of the tailings storage facility had been decommissioned, and rehabilitation of the top surface had commenced. Active deposition of tailings was occurring into TSF Cell 2, with water from the top surface of Cell 1 being stored in the water management dam. An aerial view of the TSF is presented in Plate 29.

Plate 29 Aerial view of tailings storage facility (TSF) and water management dam (WMD). Photo: Independent Monitor.

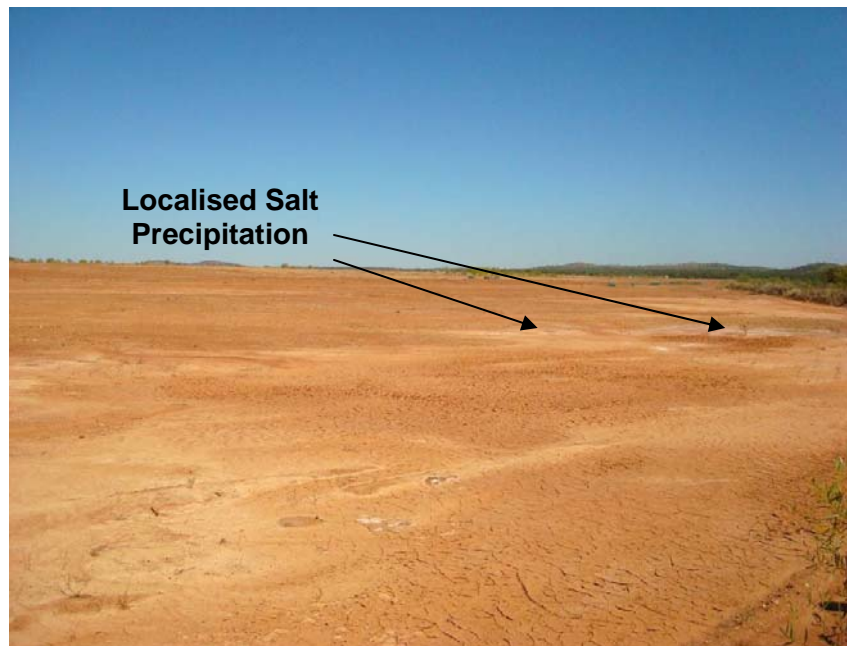
During the Independent Monitor Audit visit, the top surface of TSF Cell 1 of the tailings storage facility was inspected and found to have been completely covered with a layer of compacted soil. Based on a visual inspection of the soil material, it appears to be a lateritic clayey sand with gravel (see Plate 33). This capping was being conducted during the previous operating period audit and, having now been completed, should act to reduce infiltration of rainfall into the tailings surface and, although it will eliminate fugitive dust emissions from tailings surface, it will not eliminate dust all together.

Minor scouring of the surface of the soil layer was evident, but no tailings were visible. Localised salt precipitation was visible on the surface, potentially as a result of the capillary rise of salt through the cover system and/or due to evaporation of surface waters off the cover (Plate 33).

Plate 33 Top Surface of Cell 1 showing soil cover in place, note localised salt precipitation of surface. Photo: Independent Monitor.

Based on the inspection visit, no major concerns or issues from a geotechnical perspective were raised regarding the top surface of TSF Cell 1, however more robust erosion control and sediment collection systems, such as rock, check dams could be considered if continuing scouring of the top surface occurs.

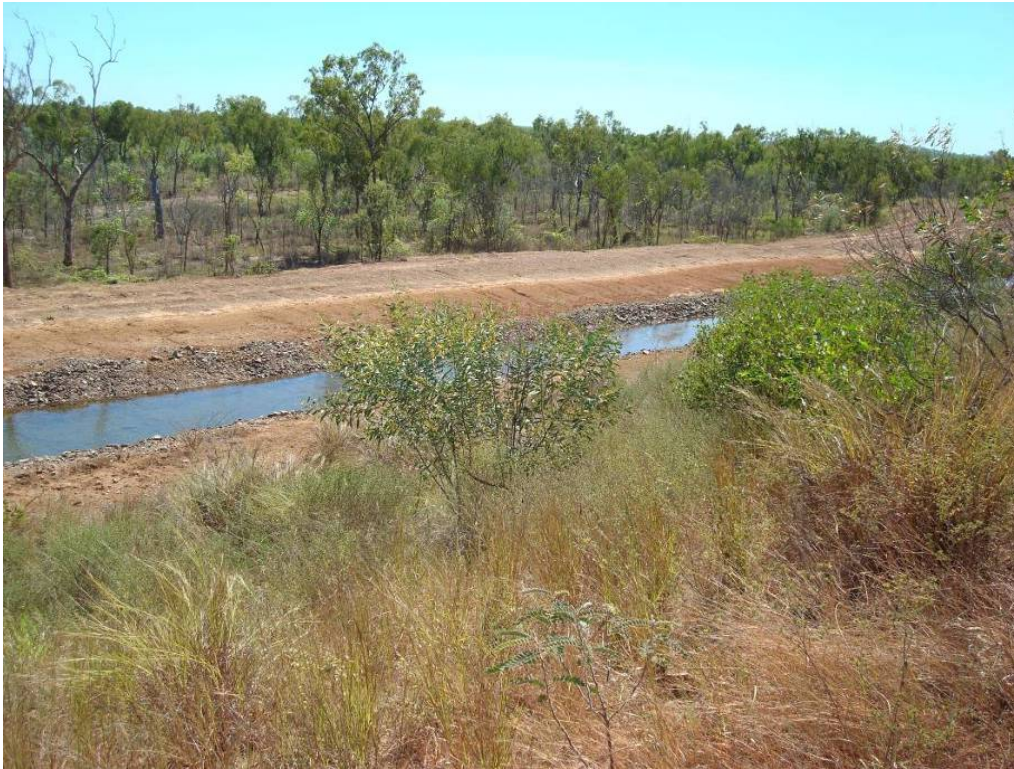
Plate 37 Western seepage collection drain at toe of TSF Cell 2. Photo: Independent Monitor.

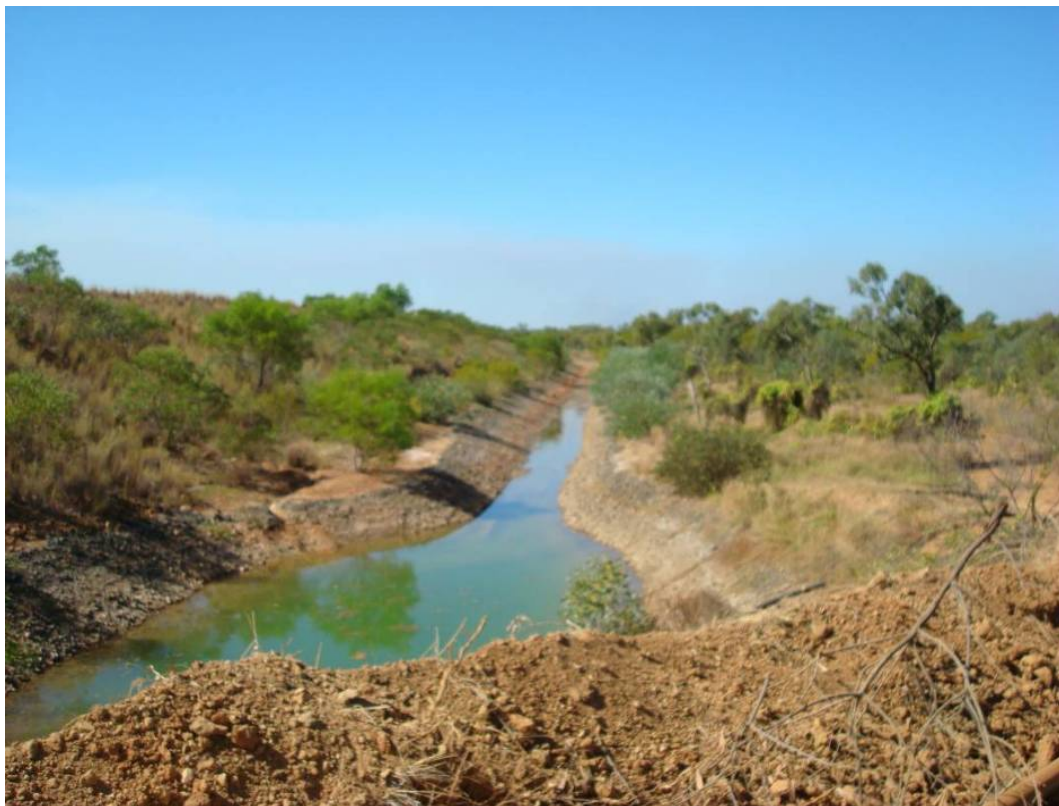
Plate 38 Eastern seepage collection drain at toe of TSF Cell 2. Photo: Independent Monitor.

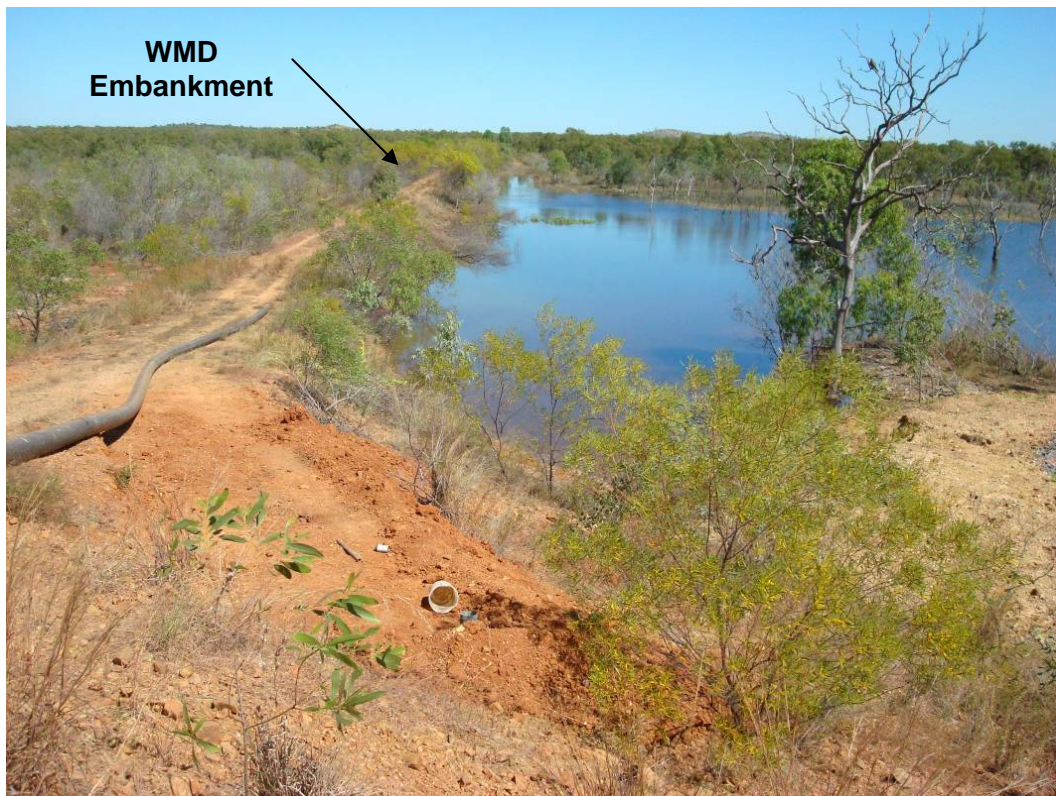
Plate 39 Pond at inlet to Little Barney Creek diversion to north-east of TSF Cell 2 and upstream of the water management dam. Photo: Independent Monitor

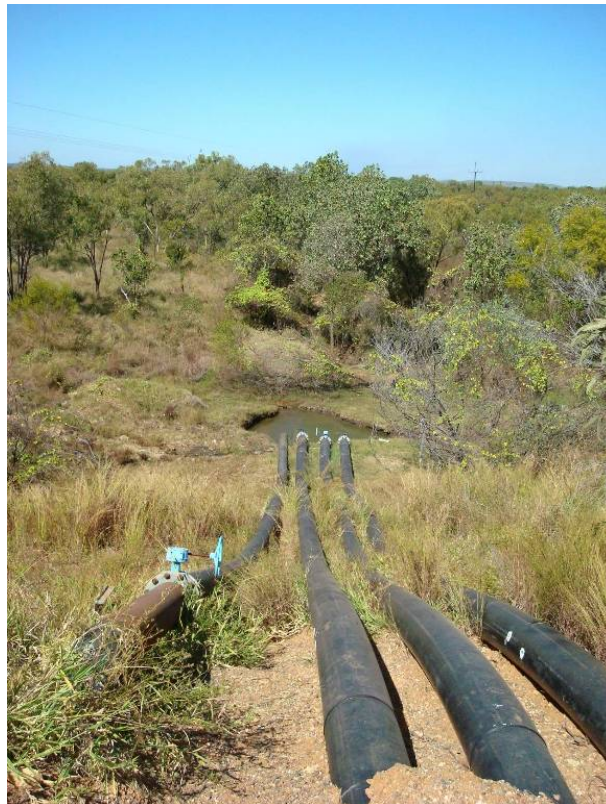
Two spillways were inspected, one of which was a concrete lined spillway and the second was excavated to bedrock. Both spillways had an invert level of 42 m RL and were in good condition. There was a pumped decant and a siphon discharge system installed in the water management dam but, at the time of inspection, they were not being operated (see Plate 40 and Plate 41).

Plate 40 Siphon discharge system at WMD. Photo: Independent Monitor

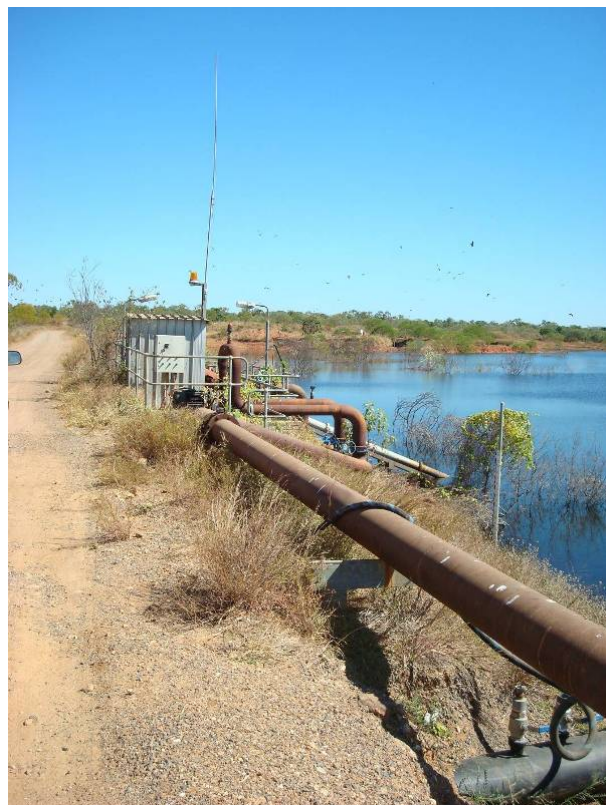
Plate 41 Pumped decant system at WMD. Photo: Independent Monitor.

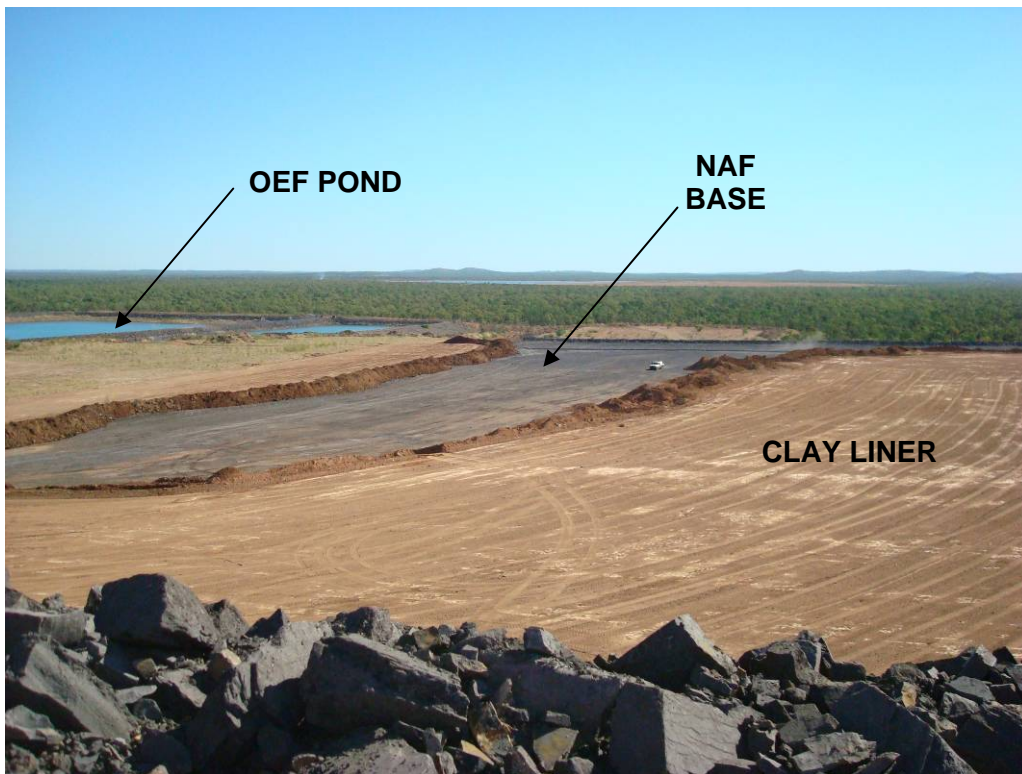
A large area of NAF base and clay base liner had been constructed so that it extended several hundred meters from the front of the active tip face. At the time of inspection, the clay was exposed to the elements and, therefore, likely to be desiccating (see Plate 43). A large area of clay cover on the western batter of the OEF was exposed to the elements. This clay cover showed signs of erosion and gully formation where rainfall runoff had been flowing over the clay cover.

Plate 43 Prepared basal NAF layer and clay liner layer at OEF, as viewed from the top surface of the OEF.
Photo: Independent Monitor

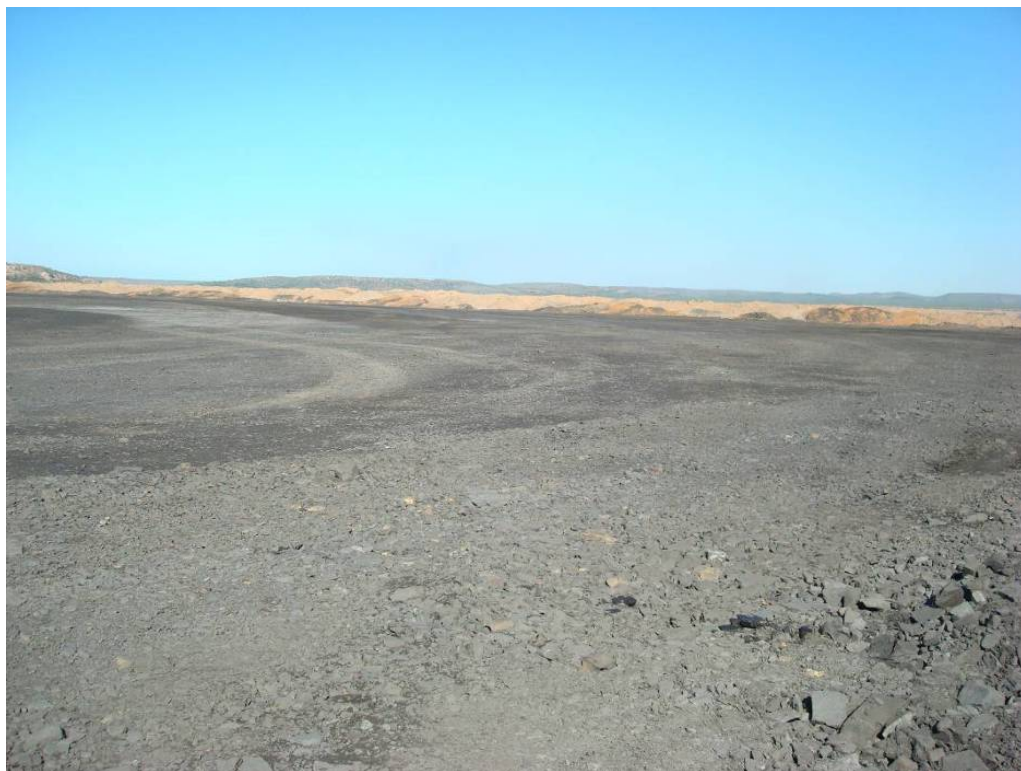
Some clay covering had been placed on the top surface of the OEF (Plate 44) time of the site inspection; however, much of the surface PAF material was still exposed.

Plate 44 Top surface of OEF (PAF waste in foreground and an area clay covering in the background).
Photo: Independent Monitor

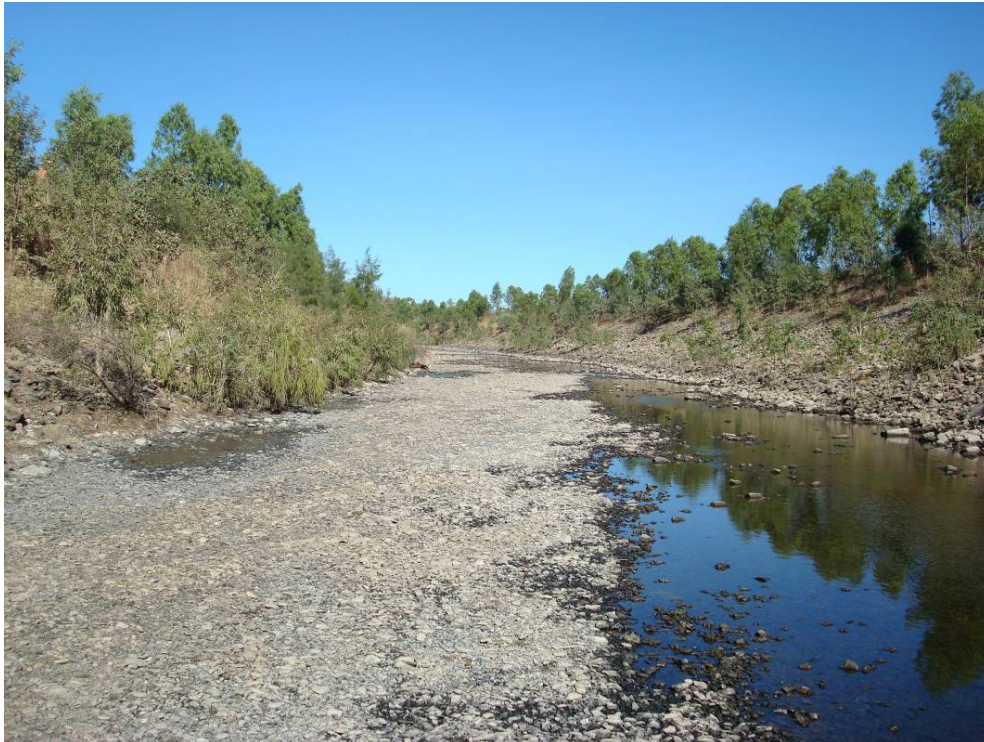
From a geotechnical perspective, the Barney Creek diversion was generally in good condition (see Plate 45), however, minor batter erosion was evident in the Barney Creek diversion upstream of the bridge to the OEF (see Plate 46). The erosional feature in the Barney Creek diversion, which was reported in the previous audits, had been repaired satisfactorily with large rock placed to limit the likelihood of ongoing erosion.

Plate 45 Barney Creek diversion channel. Photo: Independent Monitor

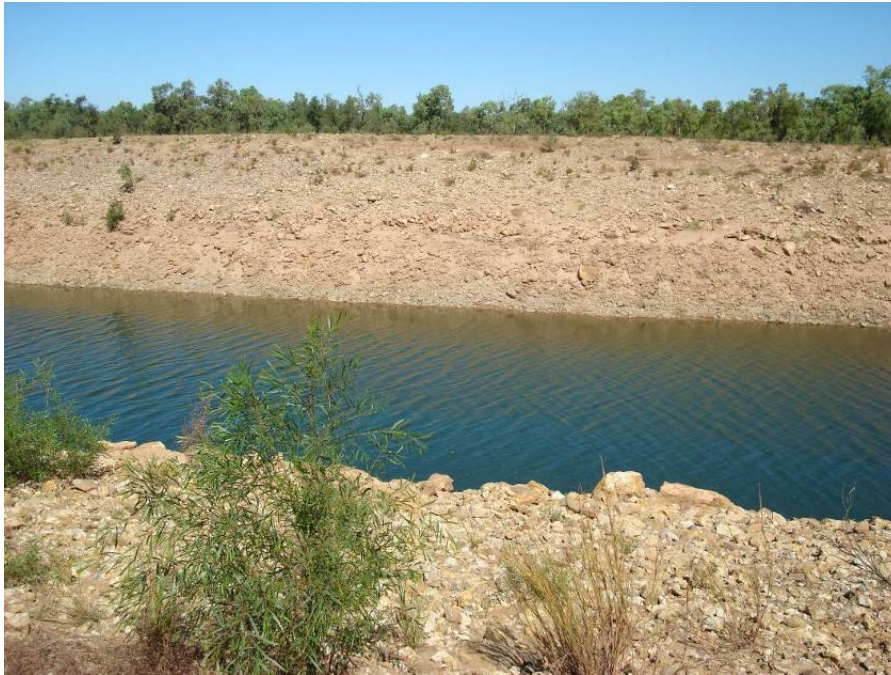
From a geotechnical perspective, the McArthur River diversion was also in generally good condition, (see Plate 47 and Plate 48).

Plate 47 Plate 18: McArthur River diversion 100 m downstream of inlet. Photo: Independent Monitor

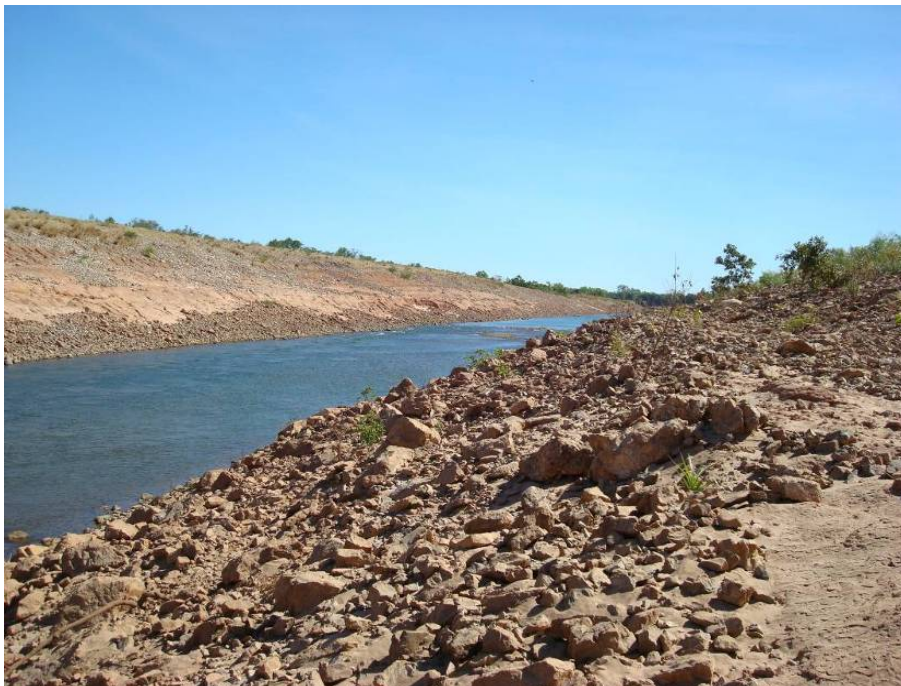
Plate 48 McArthur River diversion 500 m downstream of inlet. Photo: Independent Monitor
