INDEPENDENT MONITOR'S AUDIT OF THE MCARTHUR RIVER MINE FOR THE 2010 OPERATIONAL PERIOD

ENVIRONMENTAL EARTH SCIENCES VIC

**REPORT TO THE MINISTER FOR PRIMARY INDUSTRY FISHERIES AND
RESOURCES**

OCTOBER 2011

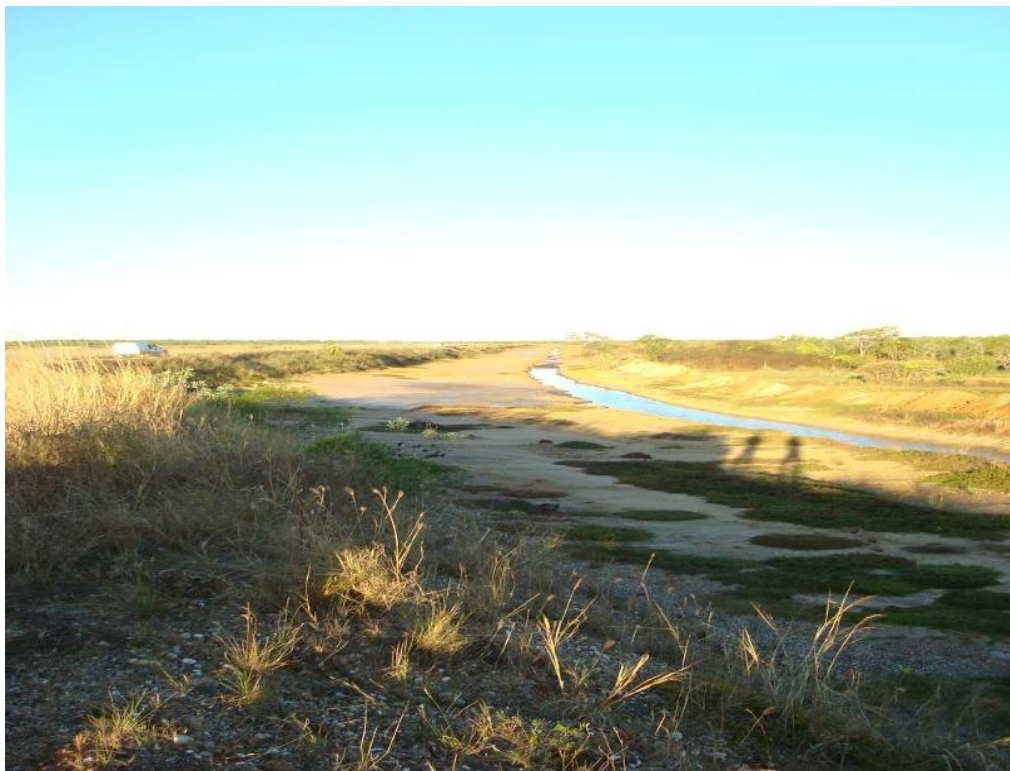
Plate 55 Lateral drainage channel at the dredge spoil cells. Photo: Independent Monitor

The existing drain around the facility needs to be cleaned out to allow the free flow of water (see Plate 55). In addition, an engineered spillway should be designed and constructed to allow water to be drained out of the ponds in a safe manner after prolonged or heavy rainfall or dredging activities.

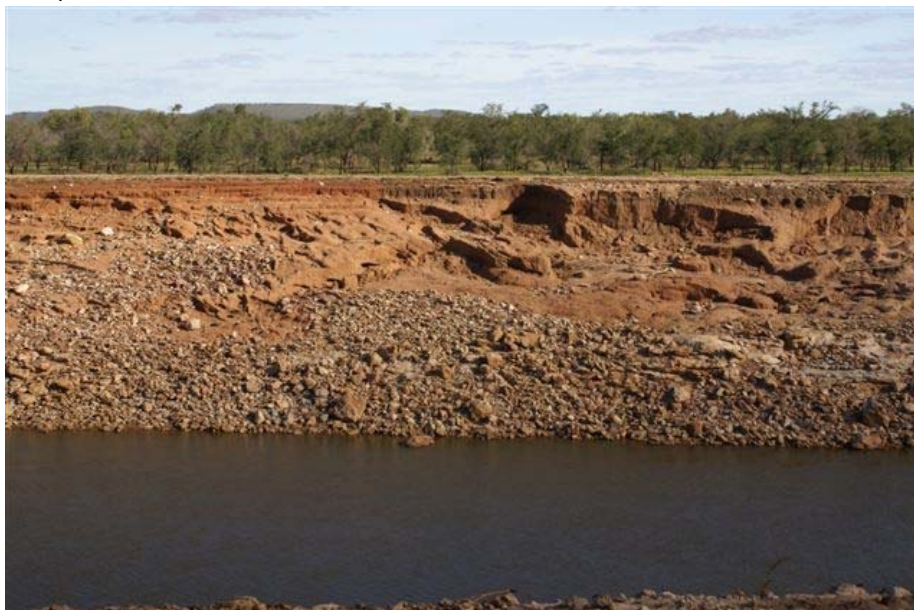
Despite the volume of photographs which were taken after each of the past several wet seasons, we note that none of these historic records have been used in this audit period to document and comment on instances of McArthur River diversion channel bank erosion. For example, see Plate 56 and Plate 57, which demonstrate just one instance of the significant change in batter conditions. A similar comment to this was also made in the previous Independent Monitor Audit report.

Plate 57 View of eastern batter slope scour at river channel chainage 1750m; taken March 2010. Evidence of significant scour during 2009/2010 wet season flows compared with the 2009 photograph, see Plate 56). Photo: Independent Monitor

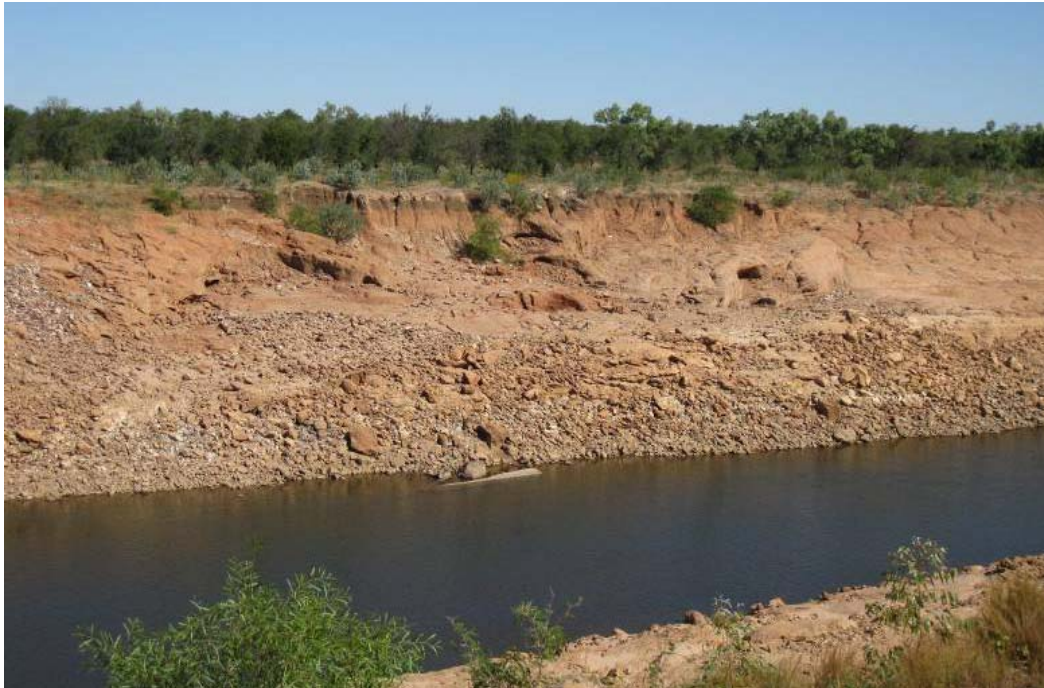
During the inspection, MRM staff advised that, although the total rainfall during the 2010/2011 wet season had been much greater than during the 2009/2010 wet season, the peak flood flows were not as high in the 2010/2011 wet season. Not surprisingly, the erosion of the eastern batter of the channel was similar to what was observed during the May 2010 visit. This is depicted in the standard series of 250 metre interval photographs taken from the western channel edge. For example, Plate 58 shows the similarity between the May 2011 eastern batter conditions near chainage 1750 m and those photographed in March 2010. Plate 60 also shows only minor changes as a consequence of the 2010/2011 wet season.

Plate 58 View of eastern batter slope scour at river channel chainage 1750 m; taken June 2011. There is very little change as a result of 2010/2011 wet season flows (compared with 2010 photograph, see Plate 57). Photo: Independent Monitor

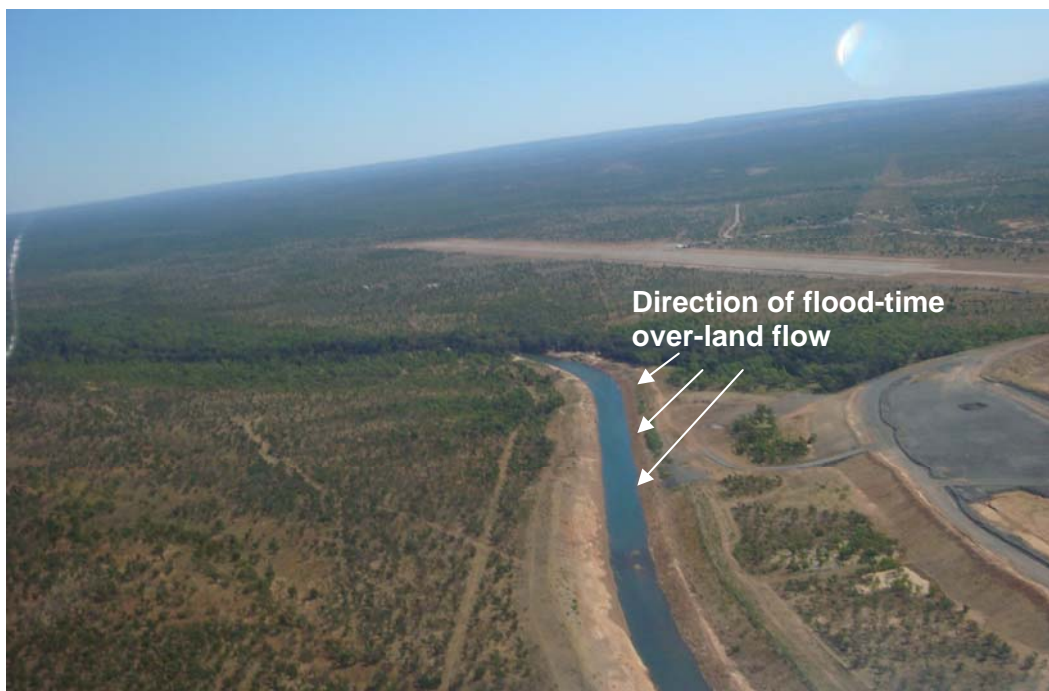
Works were undertaken during 2010 to address extensive scouring issues associated with the overland flow path between the Old McArthur River channel and the diversion channel at approximate chainage 500 m – 600 m, see Plate 59. Works also addressed some localized scouring on the western overbank area, approximate chainage 300 m, all of which was documented in an April 2010 MRM internal memo prepared by Garry Taylor. The areas covered by these works, which consisted of significant rock emplacement, were again inundated during the 2010-2011 wet season. During the May 2011 inspection it was noted that:

Plate 59 Aerial view of the McArthur River diversion channel showing the direction of the overland flood flow path from the old river channel to the diversion channel. Post 2010/2011 wet season scour was observed at the toe of the mine levy and over the area over which the water passed. Photo: Independent Monitor

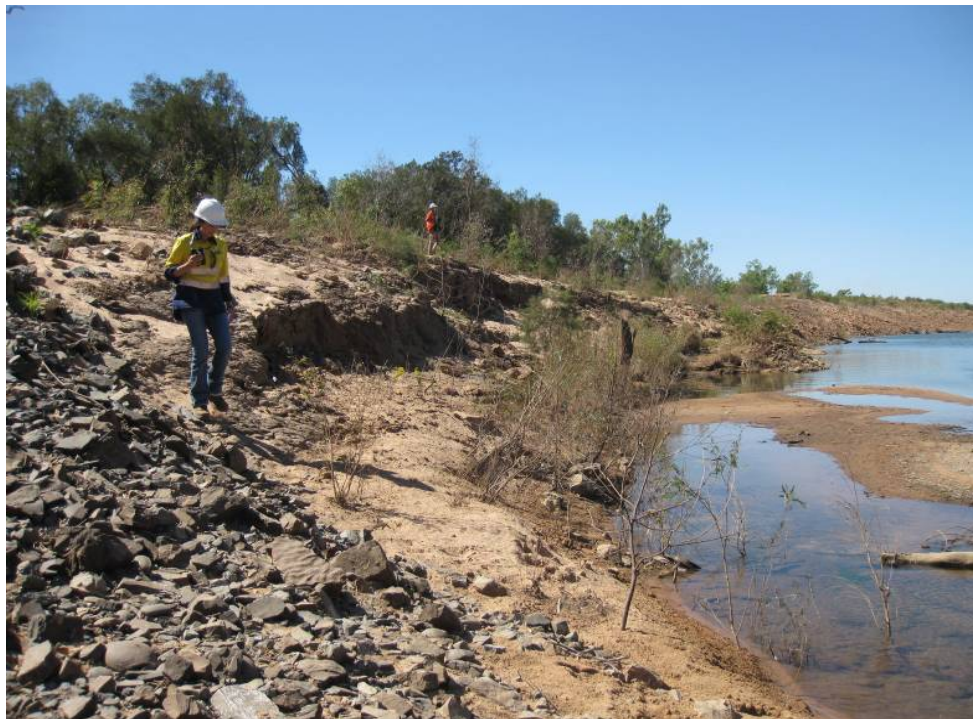
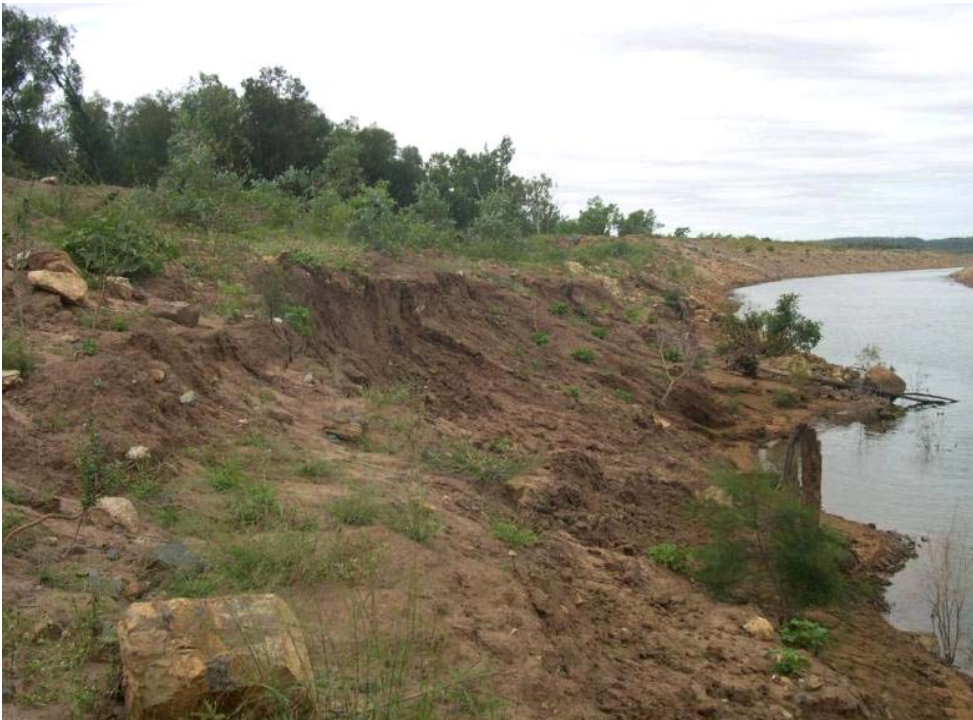
Plate 60 Example of relatively minor bank erosion in the McArthur River diversion channel taken at the same location in 2011 (top) and 2010 (bottom), showing little change). Photos: Independent Monitor.

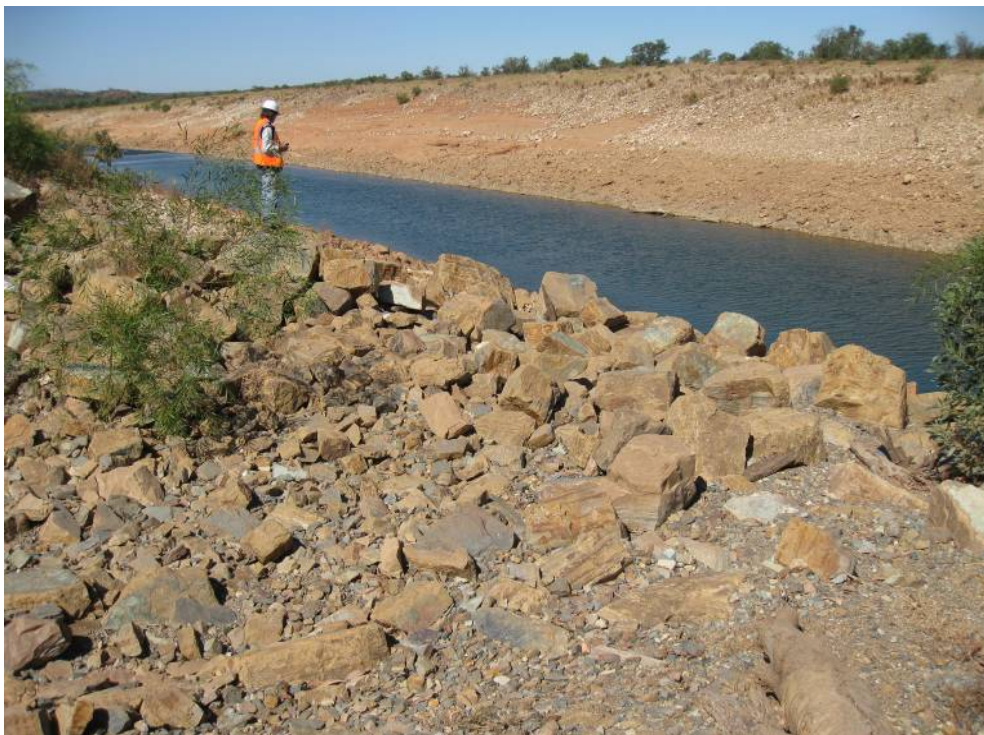
Plate 62 View of rock-lined chute at the diversion channel built as part of 2010 works to address scour along the flow path from the old McArthur River channel to the new diversion channel. Photo: Independent Monitor

While the as-built chute works at the point of spill back into the diversion channel coped well with the 2010/2011 flows, see Plate 62, it is unknown how much larger flows the chute works will be able to cope with.

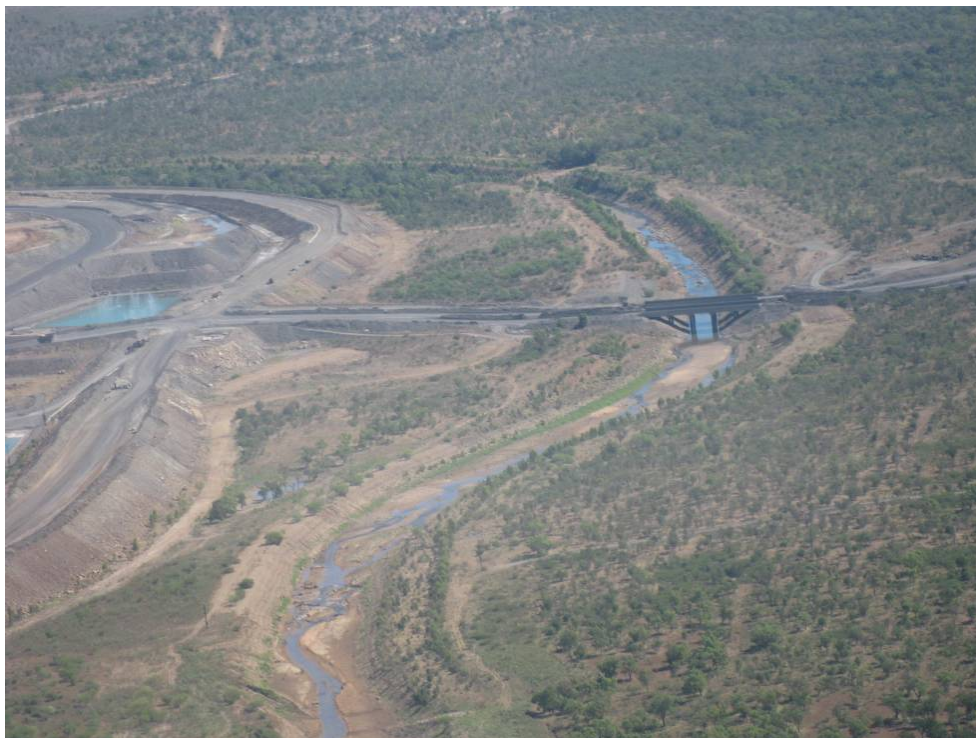
Plate 65 June 2011 view looking upstream along the Barney Creek diversion channel. Photo: Independent Monitor

The Barney Creek diversion channel, see Plate 65, was inspected from its upstream end to the point where the MRM OEF haul road crosses the channel. No signs of any erosion were observed and the 2010 dry season rock works had successfully addressed the batter slope erosion which had occurred opposite the Barney Creek/Surprise Creek confluence, see Plate 66.

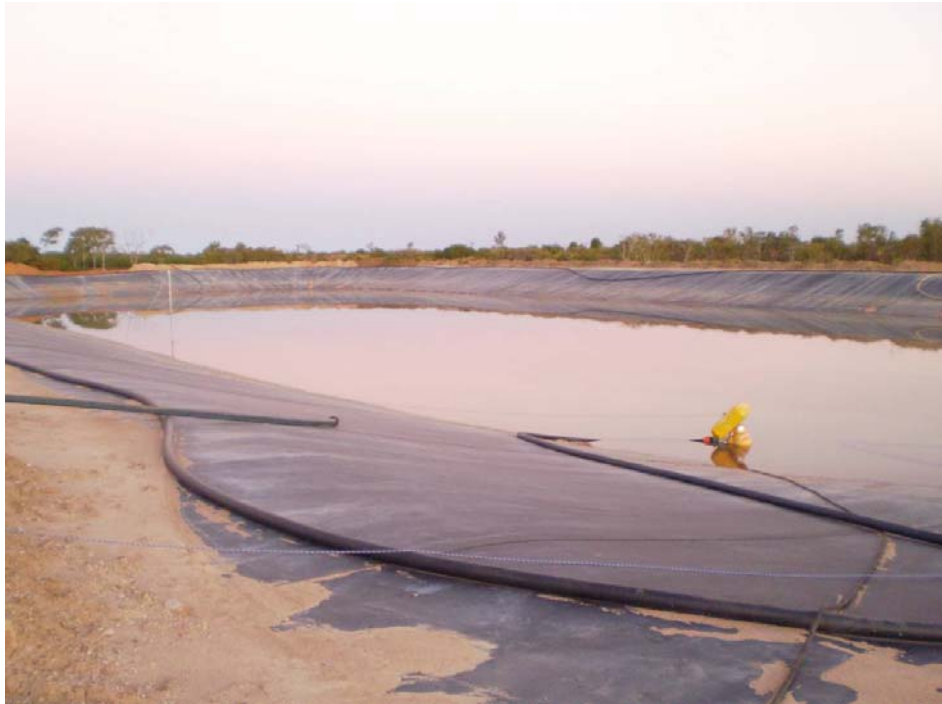
During the May 2010 inspection, the Independent Monitor inspected an additional surface runoff pond being installed adjacent to the existing Bing Bong surface runoff pond. This extra storage pond was initially constructed as a matter of urgency during the 2009/2010 wet season to cope with the excess runoff being collected at the facility.

This year, the final construction of the additional Bing Bong surface runoff pond was inspected. It is noted that this storage pond also proved useful in the 2010/2011 wet season, as unusually high rainfall meant that above average volumes of runoff were collecting in both ponds. Despite this, MRM were forced to truck runoff water from Bing Bong to the TSF to prevent an overflow of the ponds.

Plate 70 Additional surface runoff dam constructed at Bing Bong Port. Photo: Independent Monitor.
