INDEPENDENT MONITOR AUDIT OF THE MCARTHUR RIVER MINE FOR THE 2011 OPERATIONAL PERIOD

ENVIRONMENTAL EARTH SCIENCES VIC
REPORT TO THE MINISTER FOR MINES AND ENERGY
1 OCTOBER 2012
VERSION 1

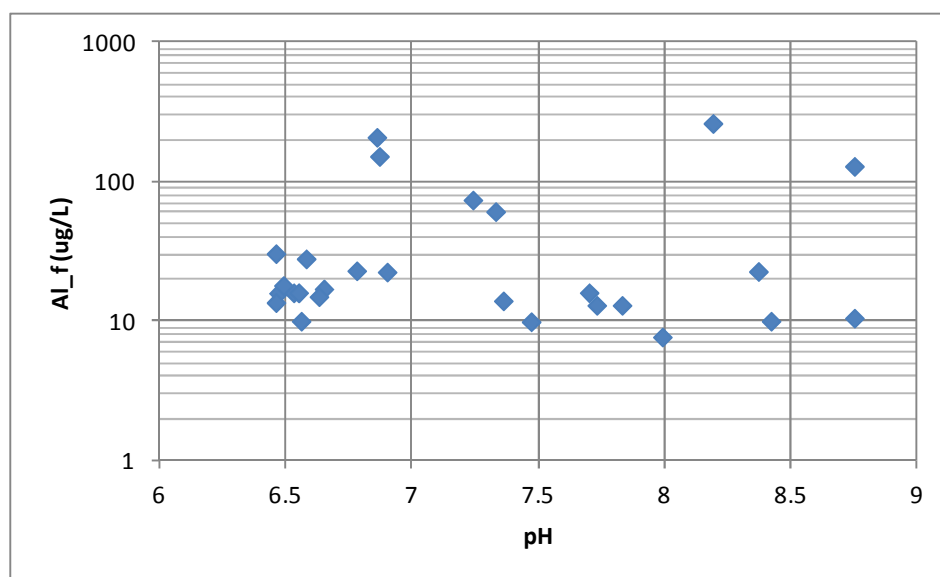
Figure 3 Relationship between dissolved Al and pH, DME EMU 2011 sampling (note logarithmic scale on y-axis)

- dissolved Al results for the pH range measured strongly suggest an error with filtration of samples prior to acid preservation:
 - Al is insoluble in the pH range of 5.5-8.5, and as Figure 3 below demonstrates, this is not the case for the 2011 DME EMU data-set. Therefore sample collection, filtration and preservation practises for dissolved metals analysis require assessment and review;

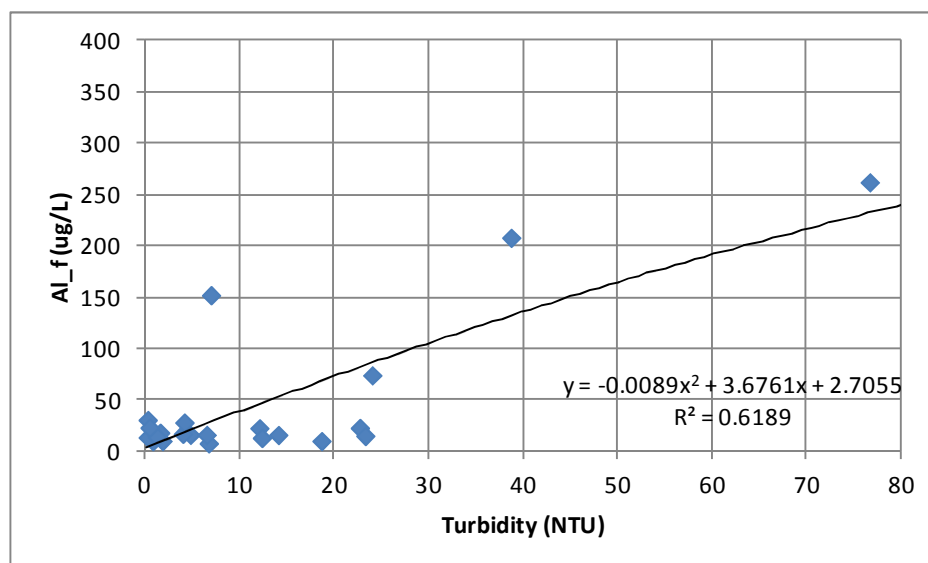
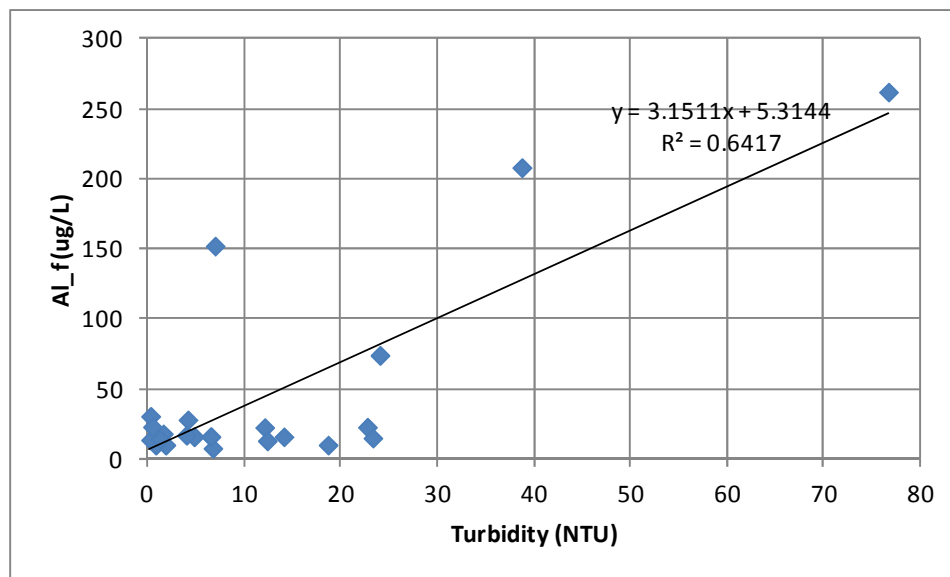
- it is considered likely that the problem relates to attempts to filter turbid samples, which seems to be supported by Figure 4 and Figure 5 below, which shows that a relationship exists between turbidity and dissolved Al. Hence, in addition to filtering in the laboratory (all the better if this is a mobile site laboratory), samples can be placed on a bench and the suspended sediment allowed to settle, then a sample of supernatant subsequently obtained from the top of the sample bottle for filtration; and

Figure 4 Relationship between dissolved Al and turbidity, DME EMU 2011 sampling

Figure 5 Relationship between dissolved Al and turbidity, DME EMU 2011 sampling (outlier removed)

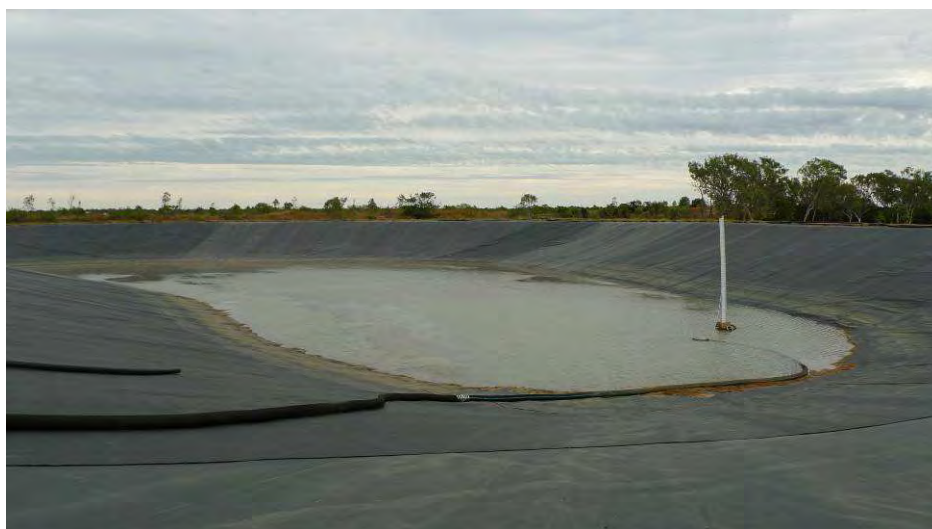
- the significant increase in surface water run-off storage capacity through the addition of a third surface water runoff pond;
- construction of the concentrate storage shed water monitoring and discharge system (Plate 3 b); and
- maintenance of the dredge spoil pond perimeter bunding, including a geotechnical testing program using a Cone Penetration Test (CPT) method (Plate 3 a).

Plate 2 A third surface water runoff pond has been installed since 2011. This additional storage pond increases MRM's capacity to store potentially contaminated surface runoff water at the Bing Bong Port facility through the Wet Season.

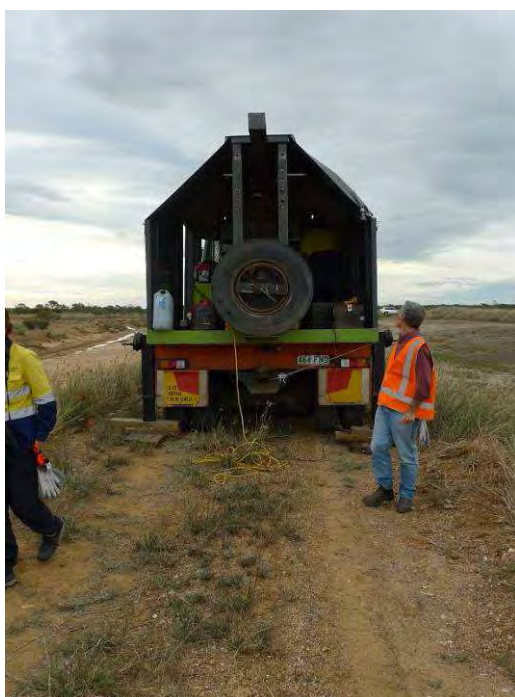
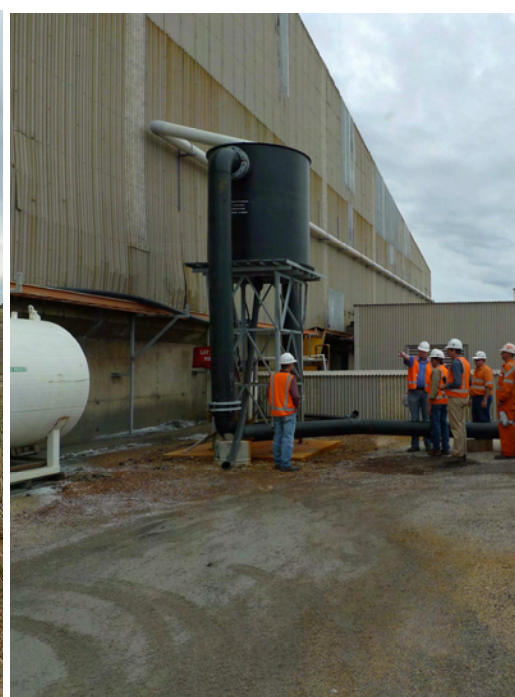
Plate 3 Bing Bong surface water management improvements: **a)** geotechnical testing of the Bing Bong dredge spoil walls to gain an understanding of the material makeup of the walls, and thus, the potential for saline seepage through the walls; and **b)** tanks have been installed around the Bing Bong concentrate storage shed to capture clean rain water and divert it to sea, rather than to onsite storage during the Wet Season.

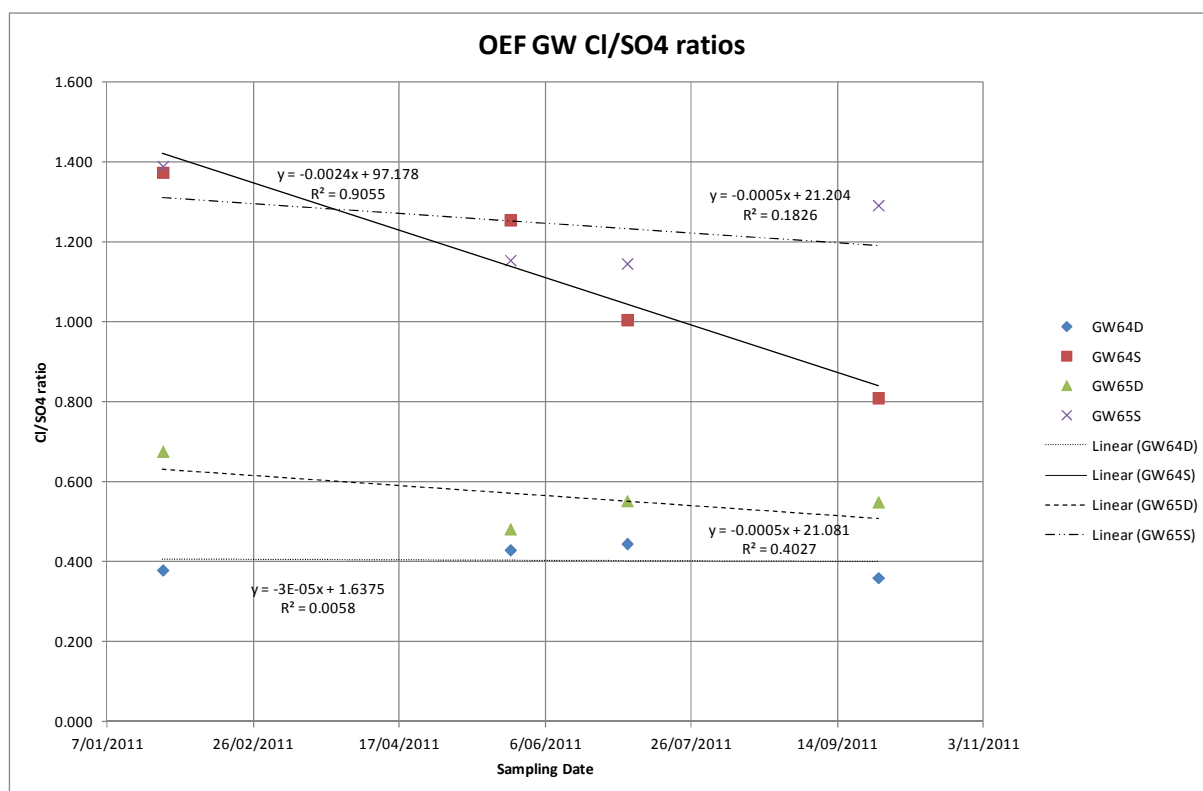
Figure 11 Chloride to sulfate ratios in groundwater in the vicinity of the OEF.

- the following comments are made on the analytical results observed for the 2011 monitoring period for bores about the OEF:
 - sulfate (SO₄) is elevated in GW64D and GW65D in particular, whilst the Cl/SO₄ ratio is also rapidly declining in GW64S (see Chart 1 below), suggesting that influences of neutral mine drainage may be apparent in these bores, with the relative influence of SO₄ on groundwater anion chemistry increasing over time (see Figure 11 below);

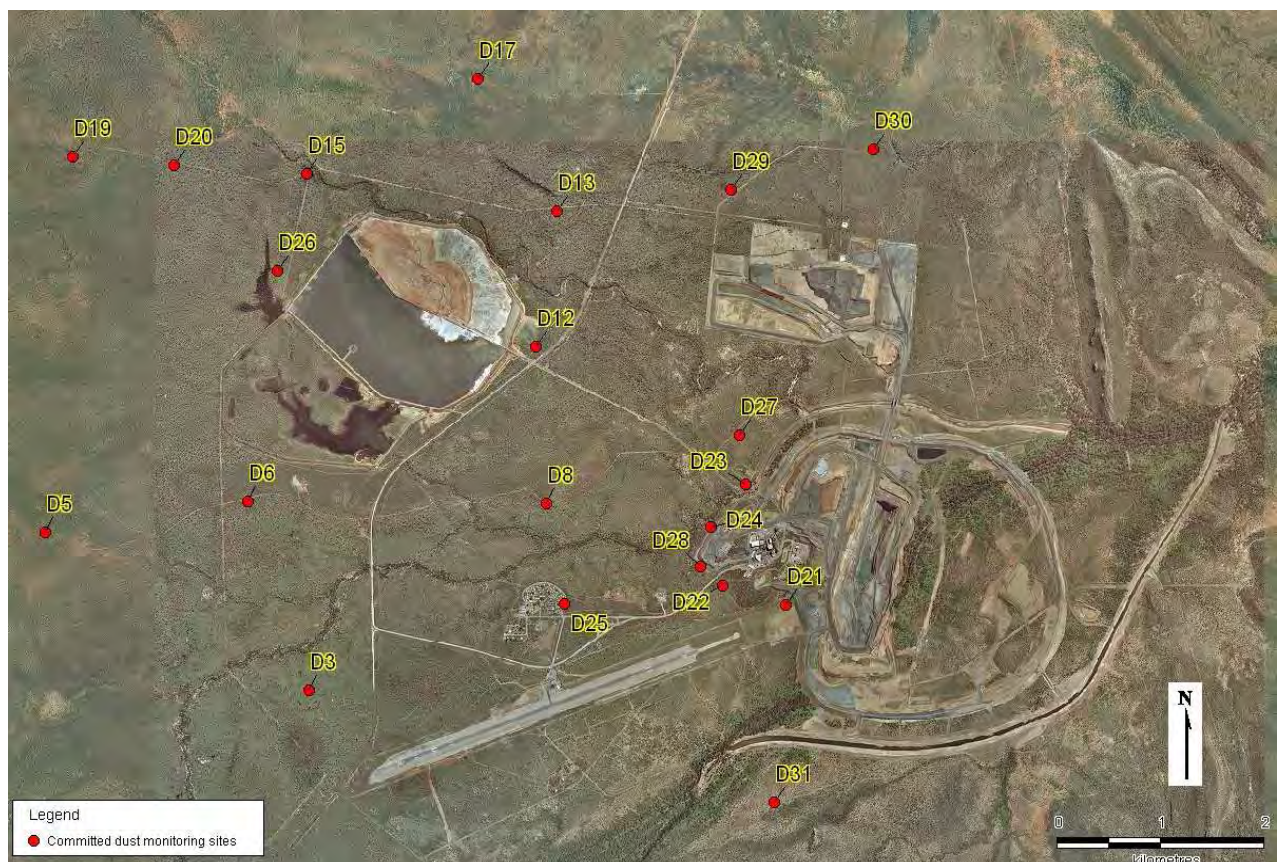
Figure 12 Dust Monitoring Locations at MRM (Figure Sourced from the 2011/2012 MMP)

The Independent Monitor observed that the number of mine-site monitoring locations in the 2011/2012 MMP (21 locations) does not match the number of monitoring locations shown in the November 2011, MRM Environmental Monitoring Manual (15 location), with the following monitoring locations being absent: D21, D20, D17, D3, D5 and D19. Further, within the MRM Environmental Monitoring Manual, a depositional dust gauge is referred to as “active dust monitor”, although the gauge uses a passive method. Consistency between these documents should be maintained in future. It is also noted that the Environmental Monitoring Manual often refers to the AS3580.10.1-1991, which has since been superseded by AS/NZS 3580.10.1:2003.

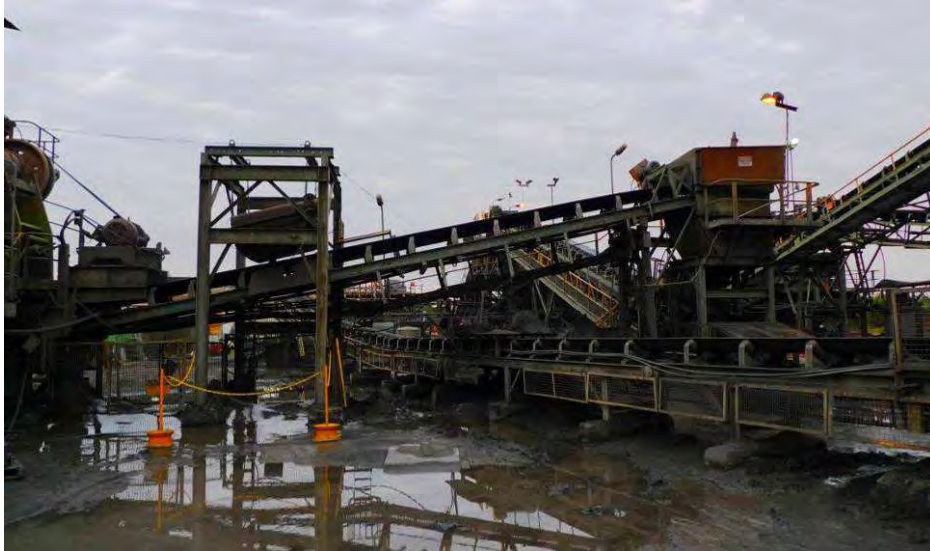
Considerable improvements were observed by the Independent Monitor team during the May 2012 site inspection with respect to dust generation at the PACRIM ore crushing area. In general, less concentrate dust was observed overlying the surrounding area, or visibly emanating from the plant than in previous years, which is a positive improvement. This result has been achieved through increasing dust suppression sprays over the PACRIM conveyor system (Plate 5).

Plate 5 PACRIM crushing plant located on the ROM Pad at the mine site. Note the area is kept moist with sprays on the conveyor belts to limit dust generations.

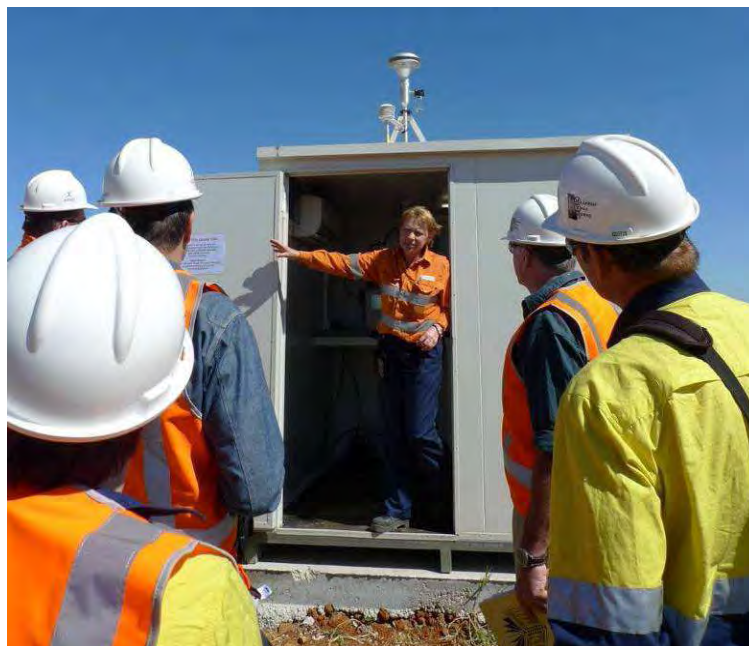
The Independent Monitor inspected a recently-installed real-time air monitoring. Housed in a small shed at the north-western perimeter of TSF Cell 1 (Plate 6), this monitoring system has been set up to provide real-time alerts to the Environment team when dust levels exceed criteria. MRM have advised that they are preparing to install a second monitoring shed downwind of the PACRIM crushing area, which has been the primary source of contaminated dust generation.

Plate 6 New real-time air monitoring shed positioned at the upwind perimeter of TSF Cell 1.

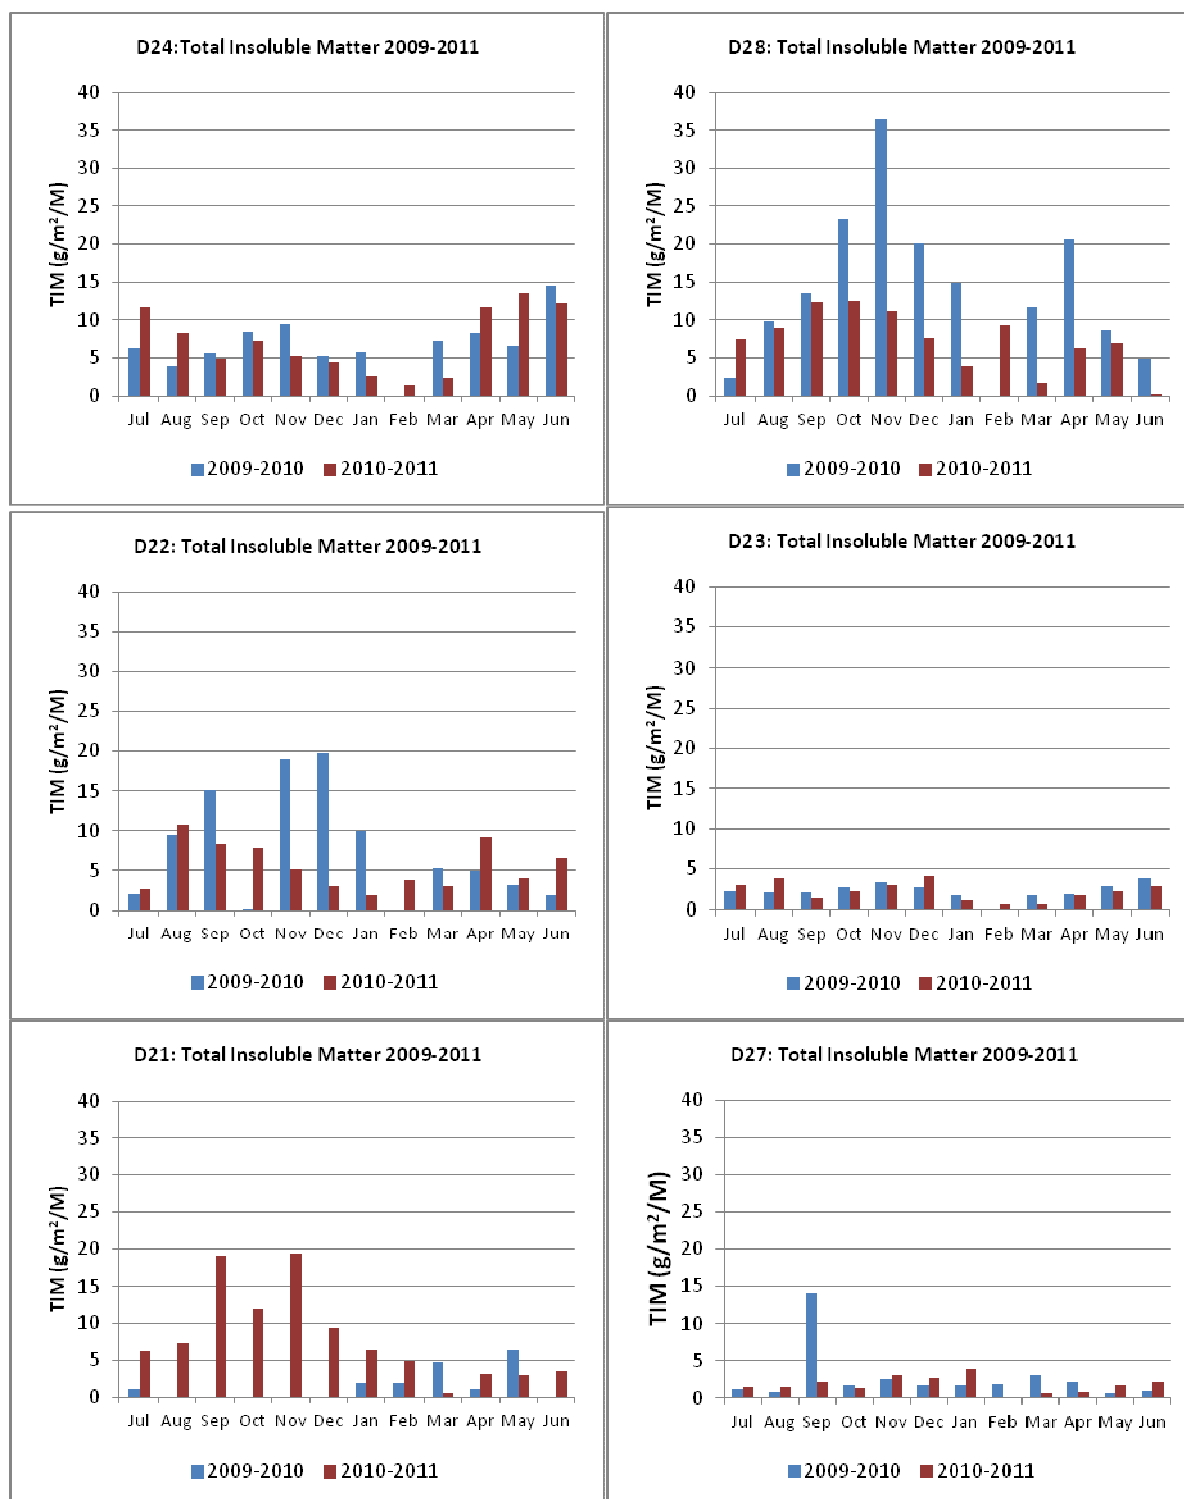
Figure 14 TIM levels in locations at locations within 1km from the PACRIM / ROM pad.
(Figure source: 2011/2012 MMP)

Figure 14 has been provided to show the TIM levels in locations near the PACRIM / ROM pad. Note the decrease in TIM levels since 2009.

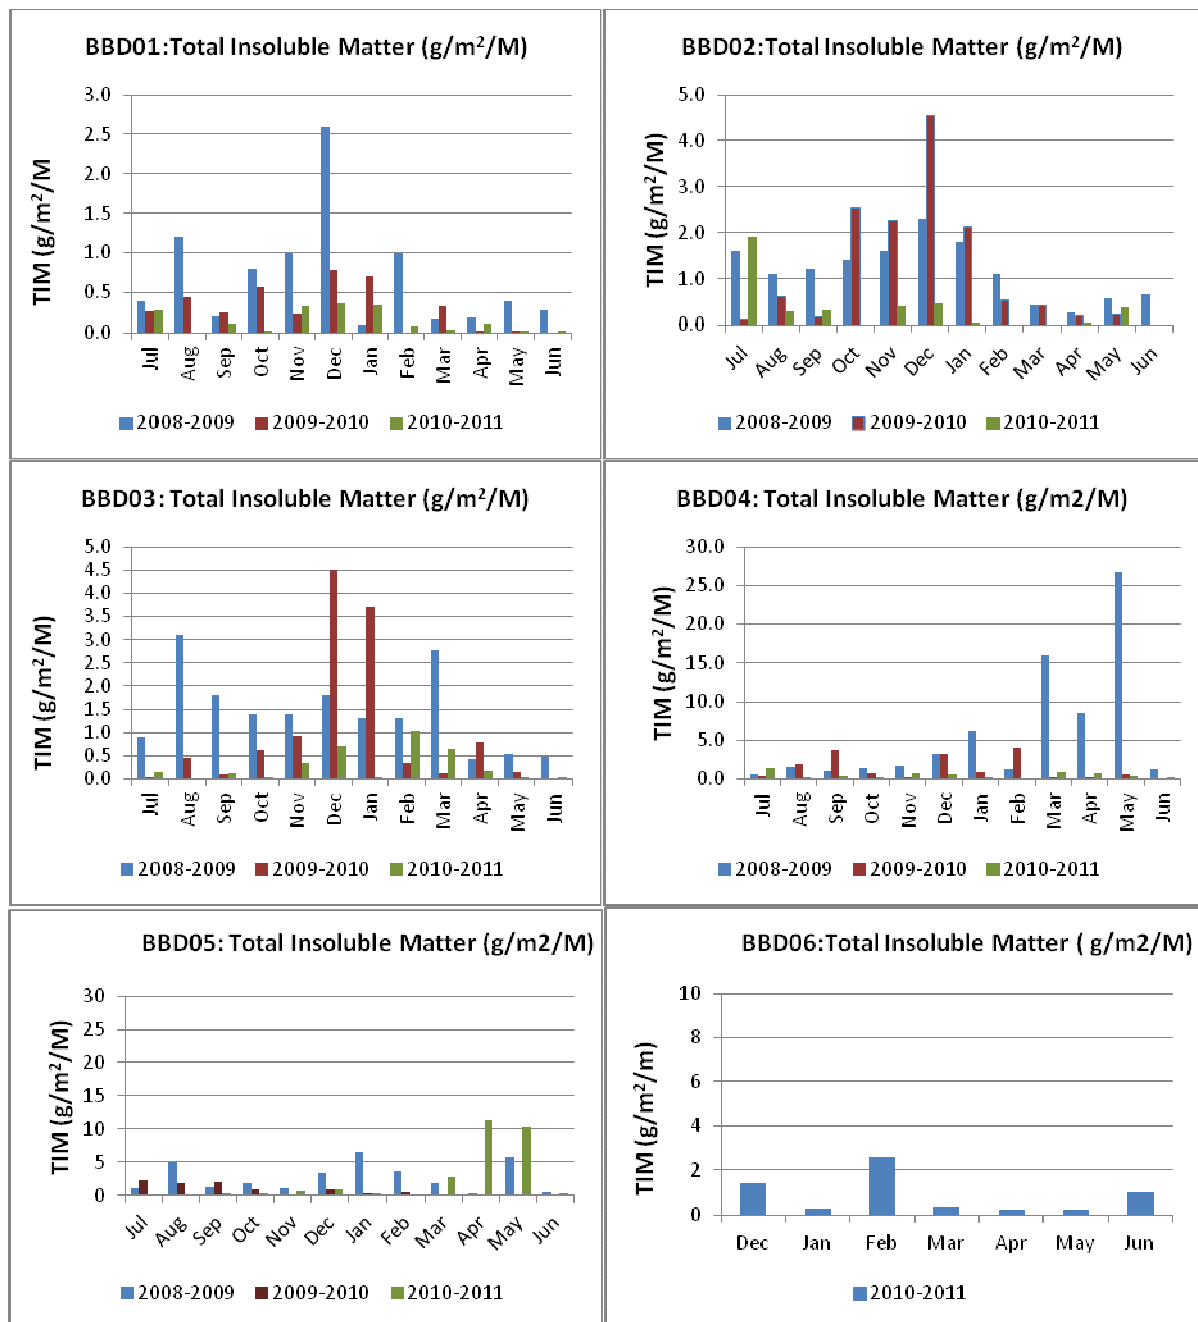
Figure 15 TIM levels in Bing Bong locations. (Figure source: 2011/2012 MMP)

A notable decrease in TIM levels since 2009 has been observed for locations BBD01, BBD02, BBD03 and BBD04 (see Figure 13). The Independent Monitor is pleased to see that dust mitigation measures employed by MRM appear to have been effective for controlling dust emissions at these areas. It is nevertheless suggested that vigilance be kept in location BBD02, which showed a total zinc result of almost $500\text{mg/m}^2/\text{month}$ for July 2011.

It is understood that MRM changed the analysis of total solids (TS) for TIM and that these parameters are not comparable; thus, only two years of data are presented in trend charts. The Independent Monitor however reiterates that the analysis of total Pb and Zn mass and concentrations has not changed thus these results could be presented in future MMPs particularly for problem areas (i.e. PACRIM and Bing-Bong). Figure 15 shows the TIM levels in locations at Bing Bong. Note the decrease in TIM levels since 2009.

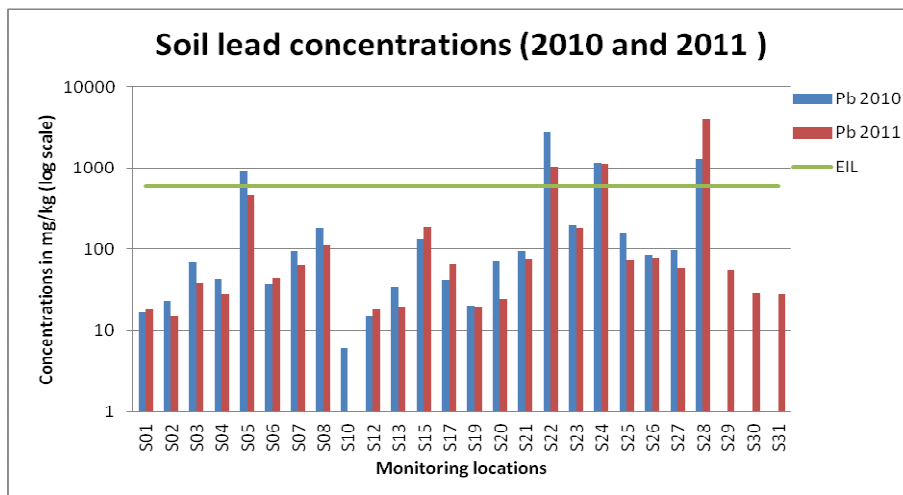
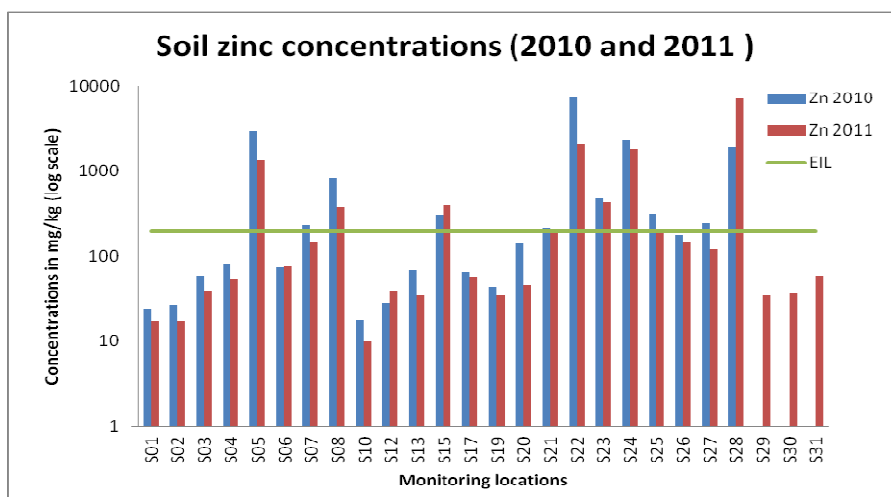
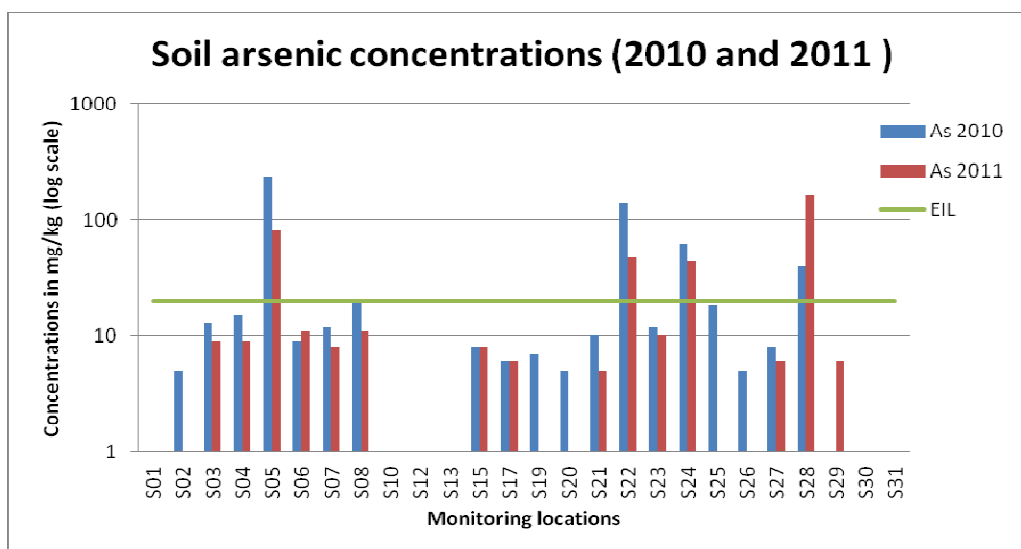
Although elevated levels were noted at the locations detailed in Table 10, a comparison of lead, zinc and arsenic concentrations between samples collected in 2010 and 2011 revealed that concentrations have generally decreased (see Figure 18 to Figure 20 below). Only monitoring location S28 showed an increase, however this can also be due to using the $>2\mu\text{m}$ fraction analysed in the latest monitoring program (2011) data and hence total concentrations in location S28 are generally lower.

These decreases in metal concentrations are considered positive, however since MRM have not undertaken any remediation this also poses the question as to fate of contaminated soil (i.e. is this being transported to nearby creeks or other areas?). The potential transport of contaminated soil offsite is not considered acceptable, although evidence in the delta indicates transportation of lead dust from the mine site was occurring in 2007 (as reported in the Independent Monitor's audit report for the 2007 Operational Period).

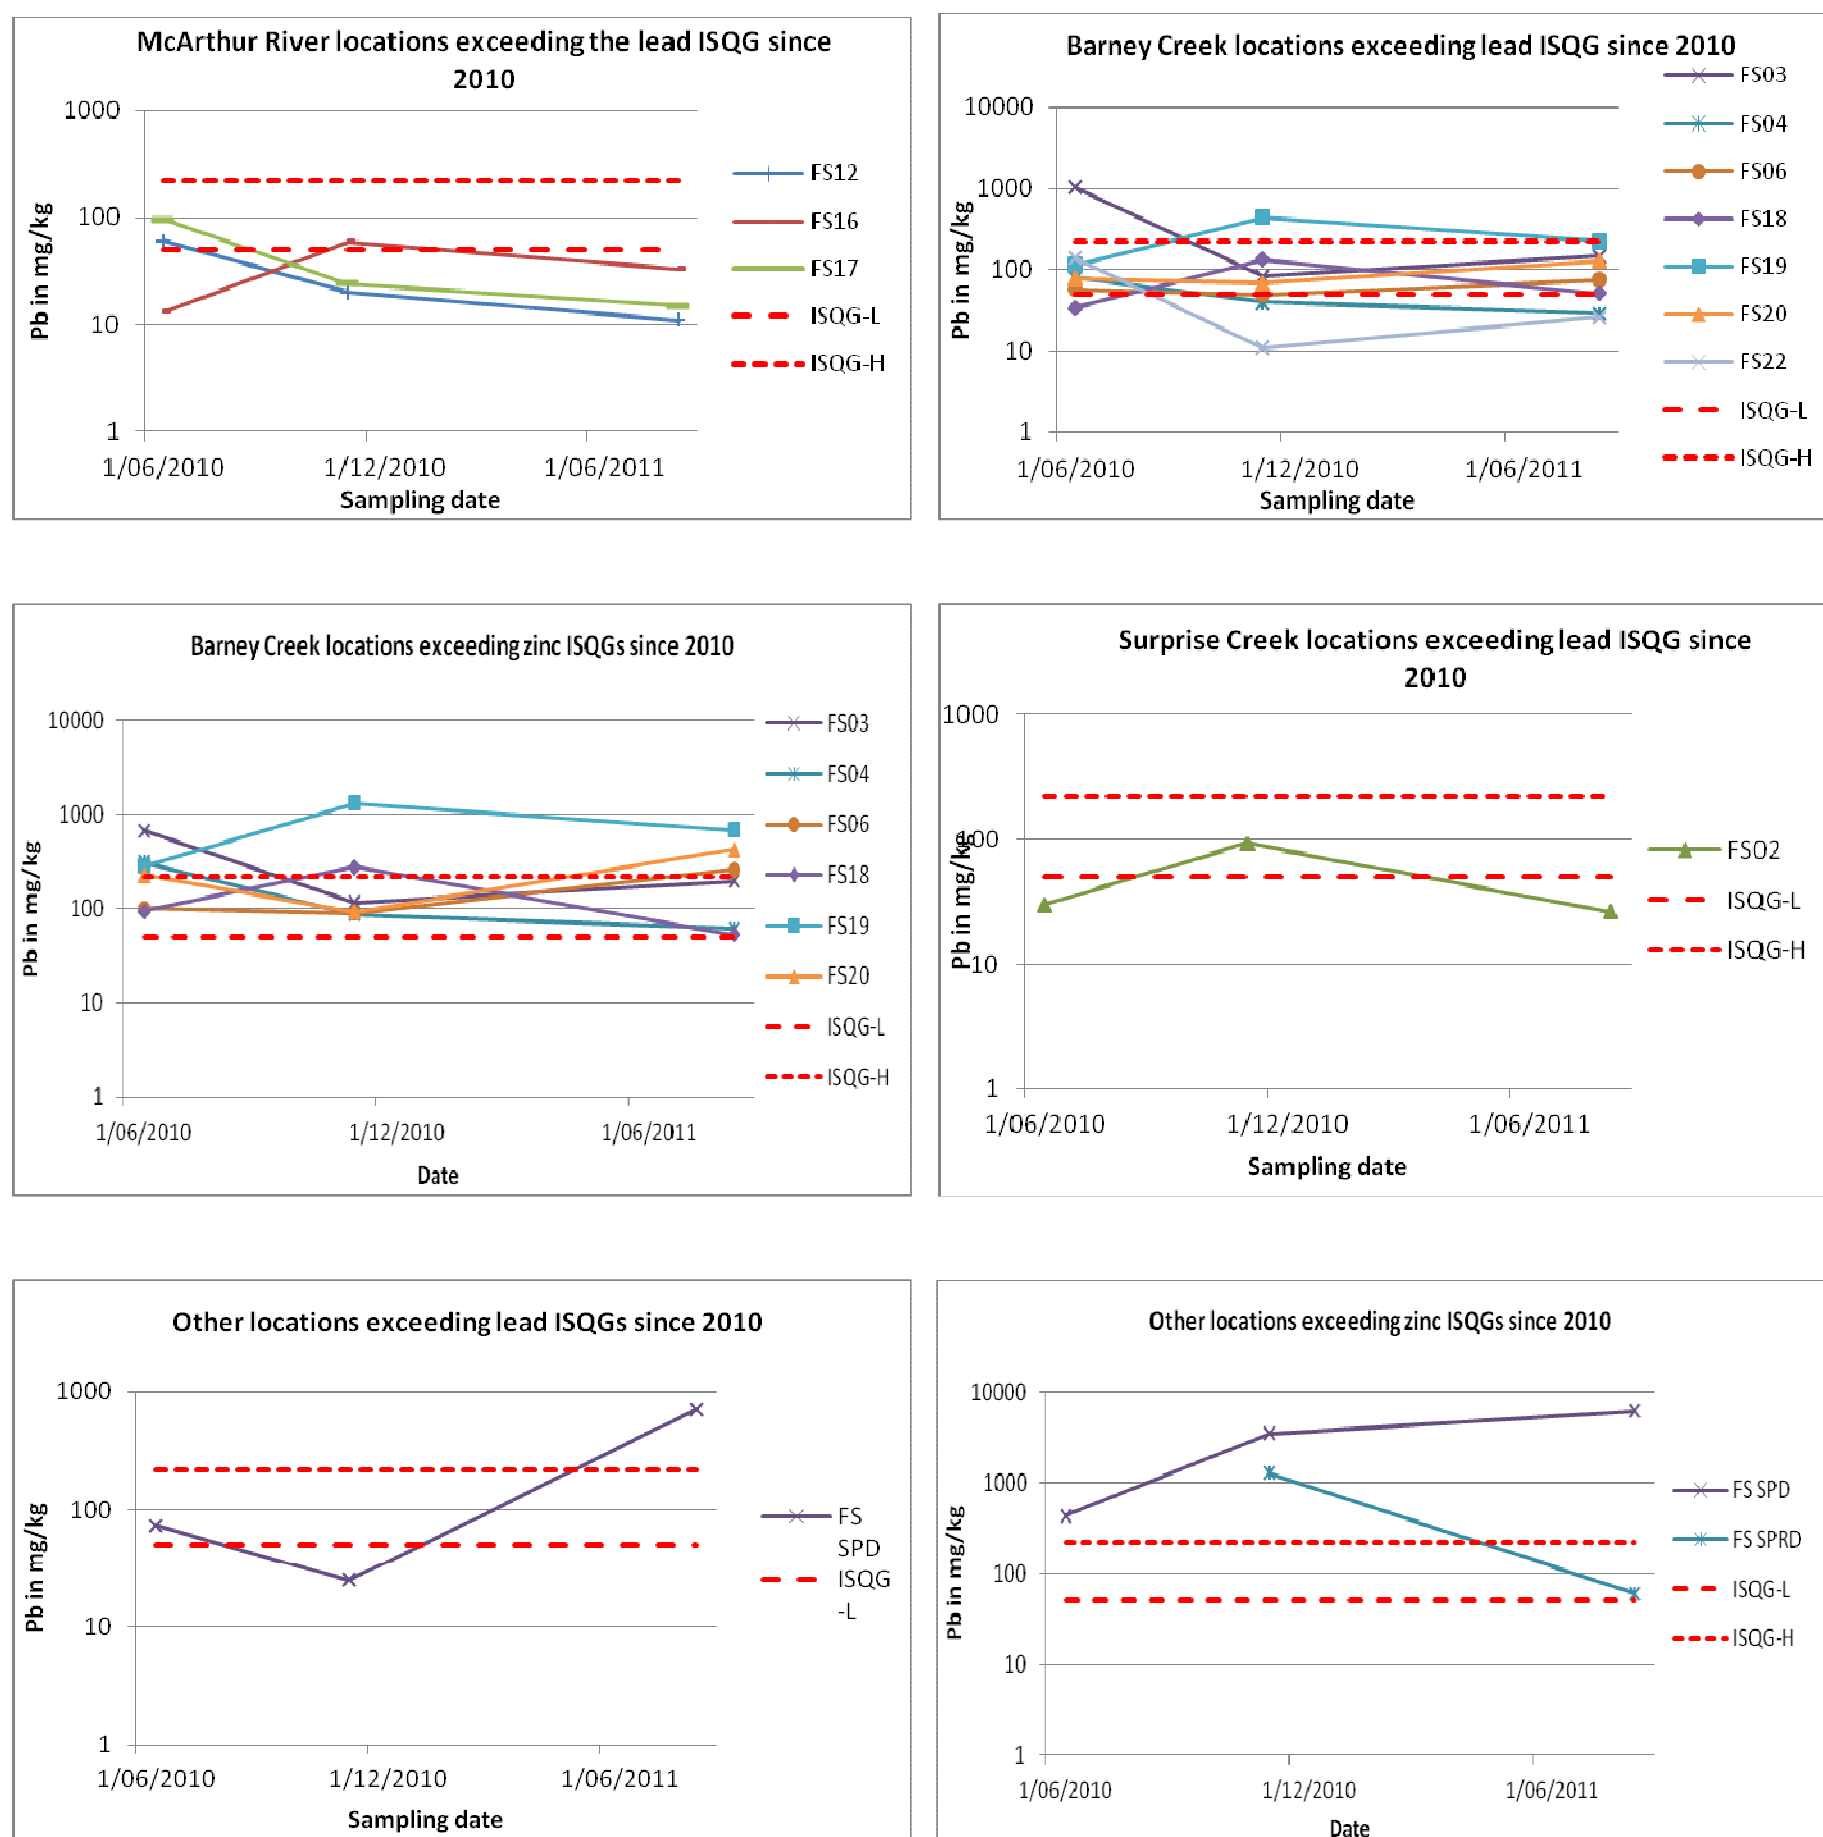
As expected, the highest metal concentrations for the 2011 monitoring were found in sediment samples from Barney Creek locations directly opposite and/or downstream of the mine site. Elevated lead and zinc concentrations were also found in one of the dams associated with the NOEF (monitoring point FSSPRD). Monitoring locations recording lead and zinc values above the ANZECC/ARMCANZ (2000) ISQG trigger values since 2010 are shown in the Figure 22 .

Figure 22 Fluvial Sediment Monitoring locations recording lead and zinc values above the ANZECC/ARMCANZ (2000) ISQG trigger values since 2010

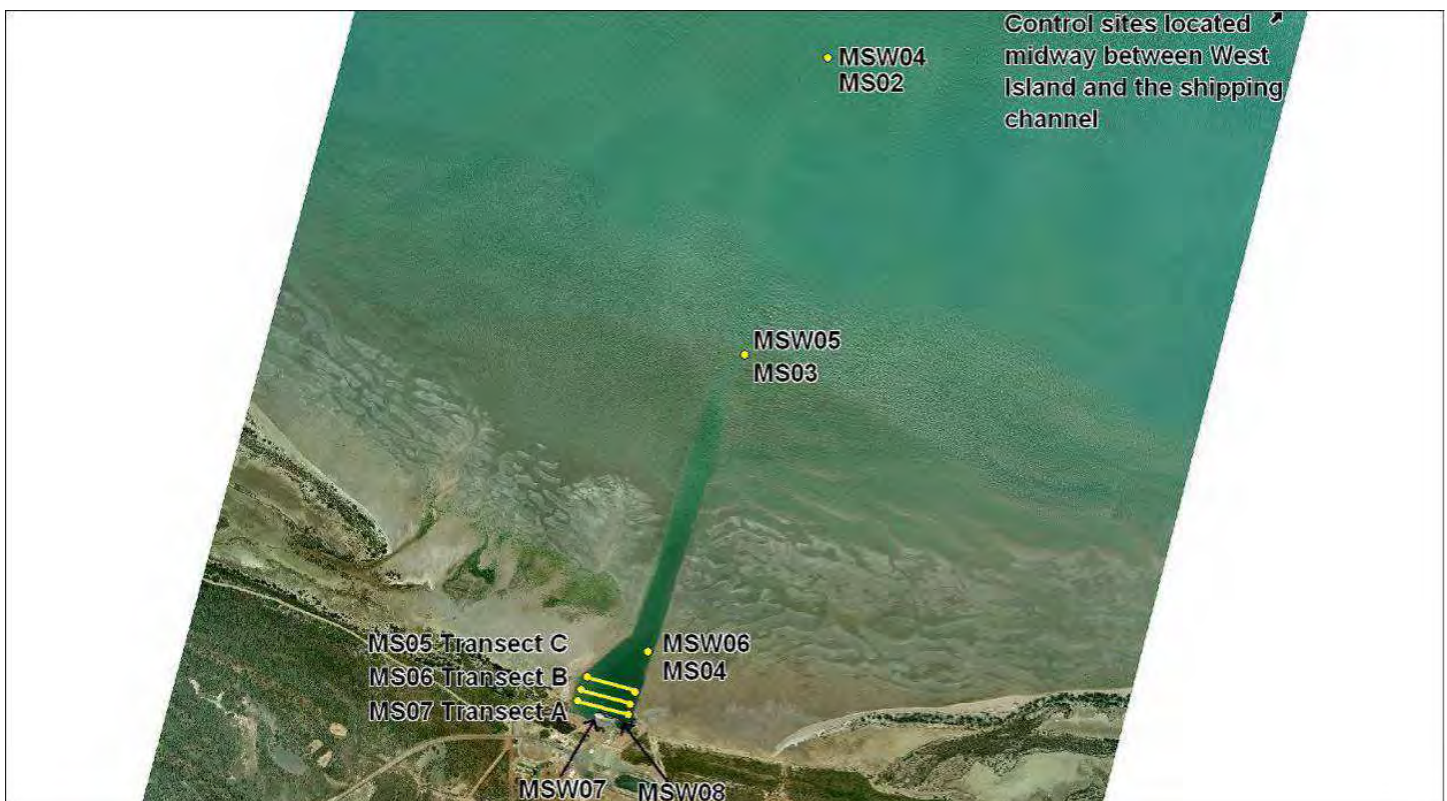
Figure 24 MRM sampling locations for seawater and sediment at Bing Bong Port. (Figure sourced from 2011/2012 WMP).

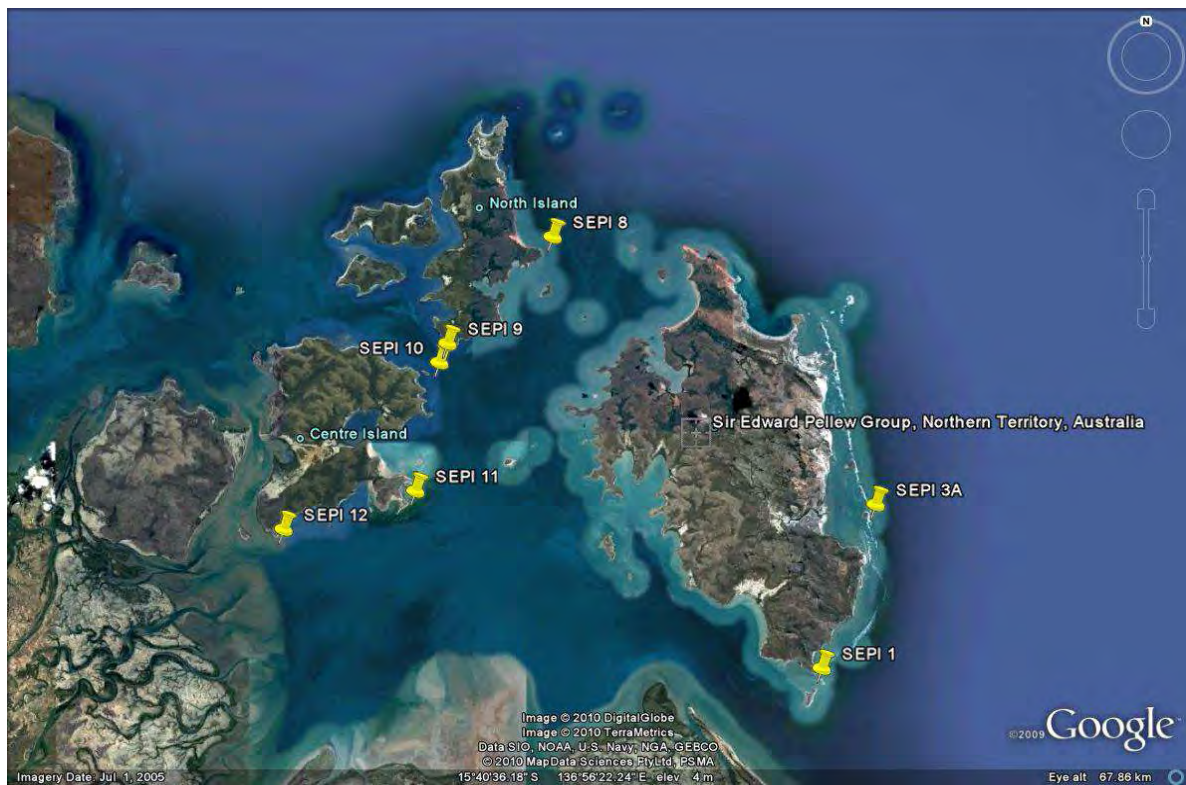
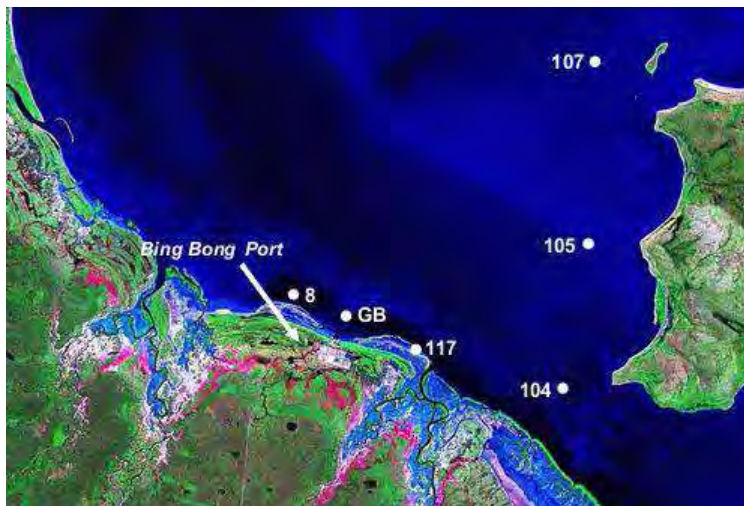
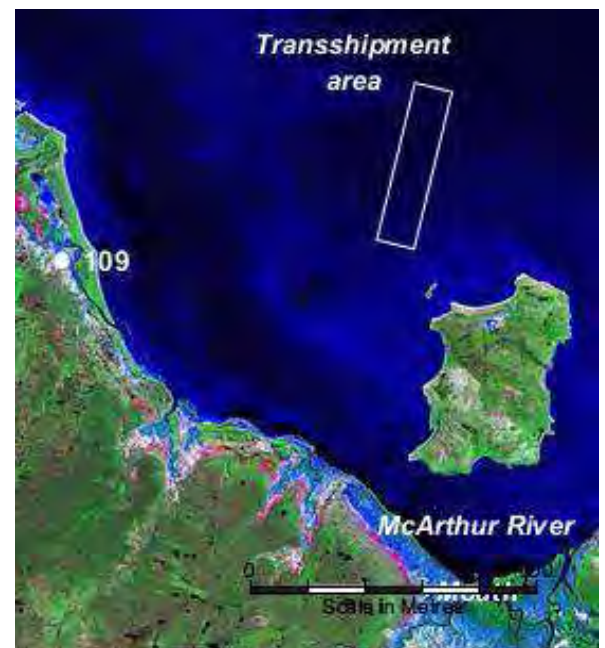
The number and location of seawater and sediment monitoring locations is deemed appropriate, however, the Independent Monitor also notes once again the program does not consider the collection of samples from transects outside the swing basin.

Figure 25 Annual AIMS seawater and marine sediment sampling locations. (All figures sourced from *MRM Annual Marine Monitoring Program 2011 Report*, AIMS, April 2012)

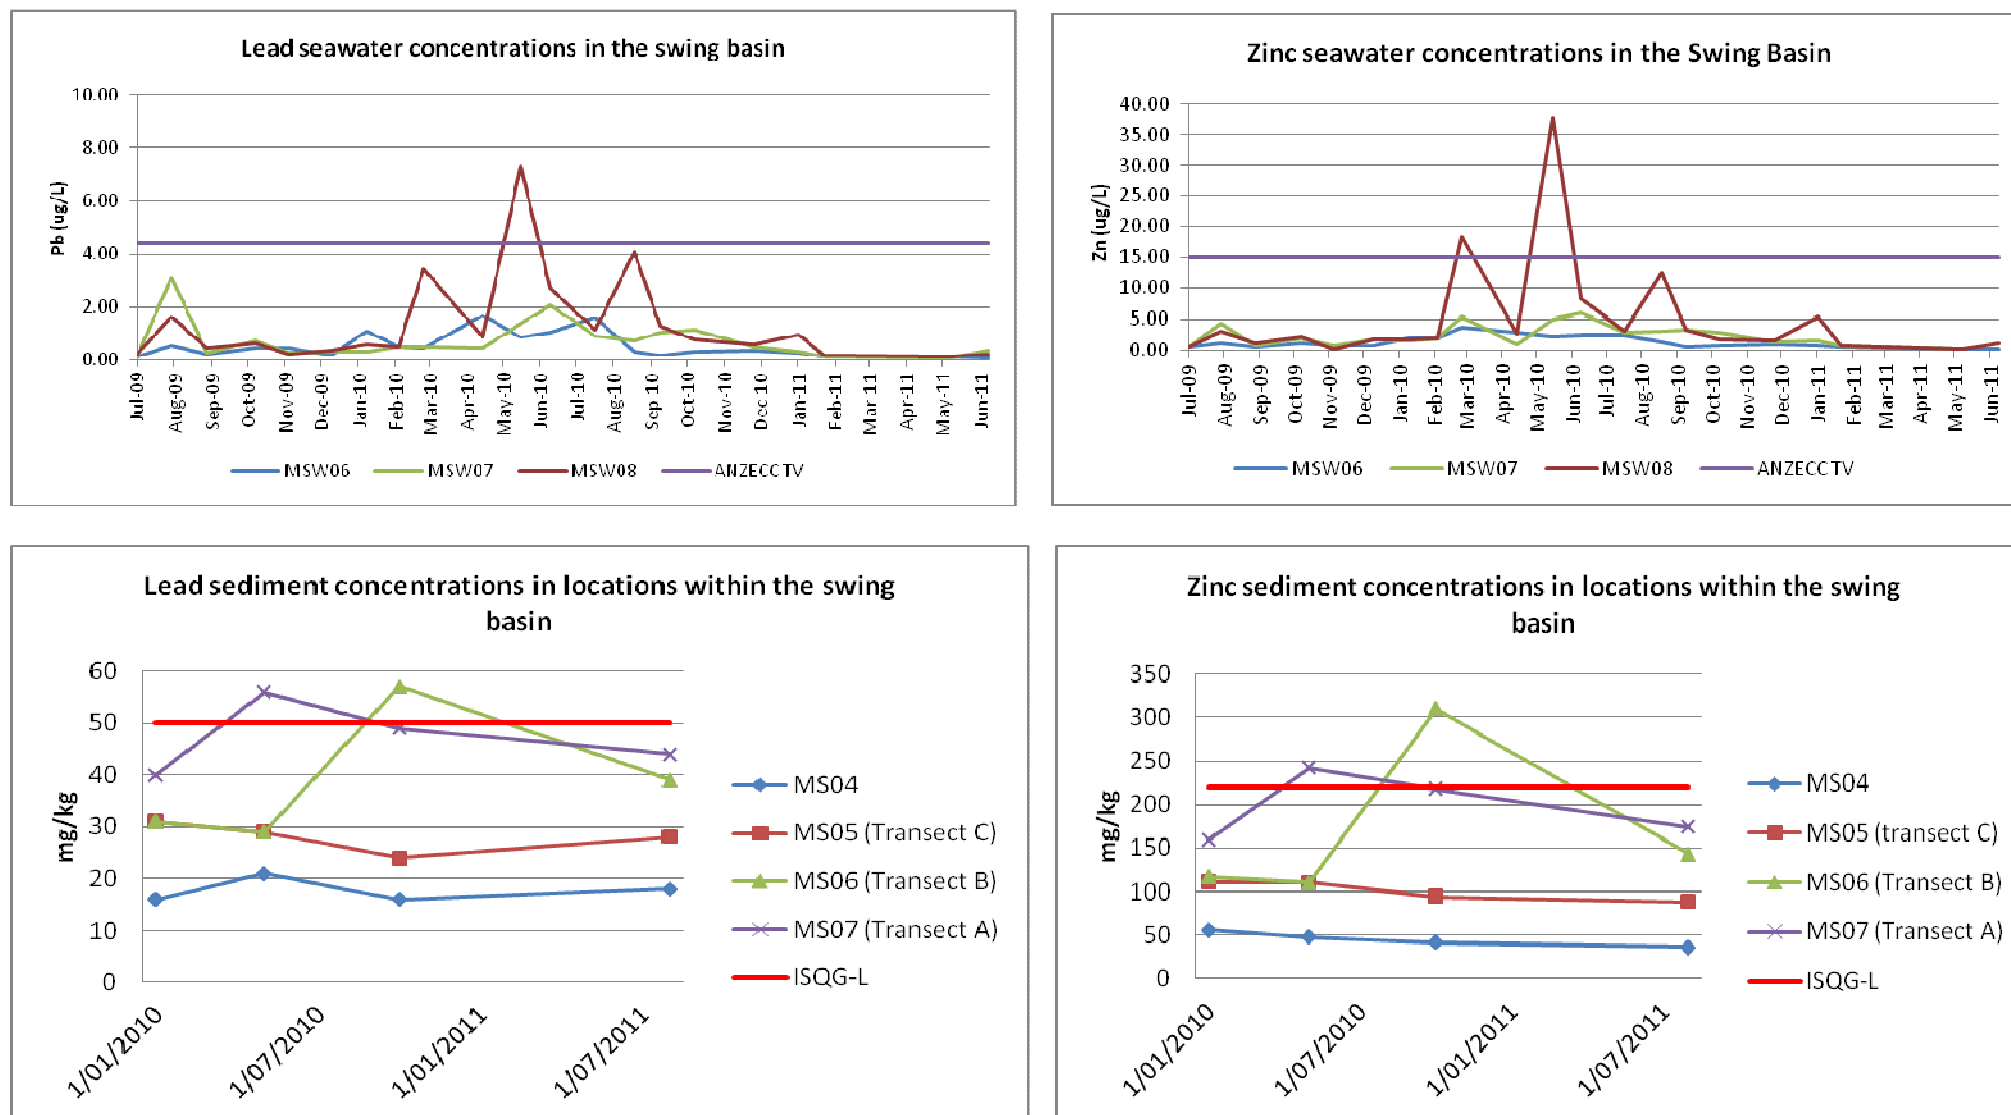
Figure 26 Temporal charts showing seawater and sediment concentrations at locations near the swing basin at Bing Bong Port.

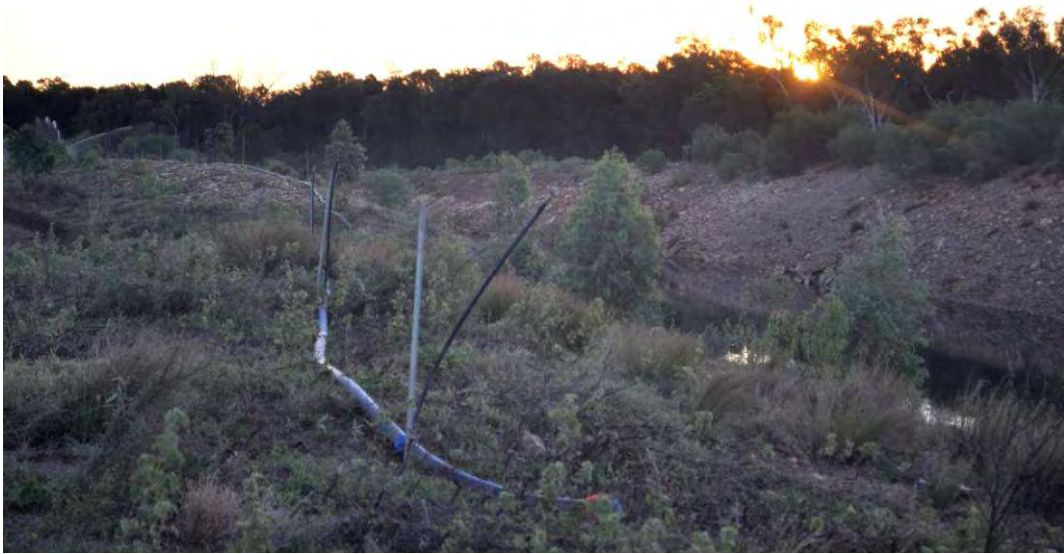
The McArthur River diversion was visited by the Independent Monitor at the end of May 2012, with a greater area inspected than in previous years. The Independent Monitor observed significant improvement of the vegetation community along the diversion particularly along the opposite bank where MRM have dedicated substantial efforts in rehabilitation (Plate 7).

Plate 7 Photograph taken during the May 2012 site inspection showing sled watering system and good vegetation cover on the opposite bank of the McArthur River diversion. Photo: Independent monitor.

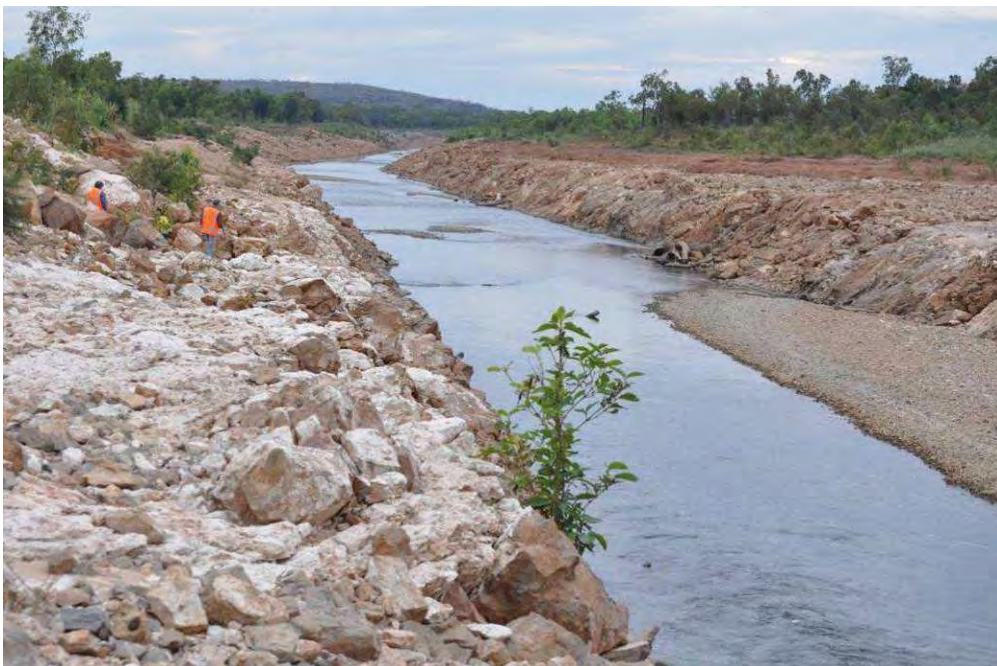
Good vegetation cover was observed at the top of the slopes along the mine-side of McArthur River diversion towards the McArthur River/Barney Creek confluence. No direct seeding or planting has occurred here and MRM informed the Independent Monitor that the vegetation cover is likely a result of seed being washed downstream from rehabilitation works by MRM further upstream (J. Crawford, pers. comm, 2012). (Plate 8)

Plate 8 Downstream area of McArthur River diversion in 2012 with vegetation coverage above batter on mine side in background. Vegetation growth likely due to seed being washed downstream from rehabilitation areas further upstream. Photo: Independent monitor.
