INDEPENDENT MONITOR AUDIT OF THE MCARTHUR RIVER MINE FOR THE 2011 OPERATIONAL PERIOD

ENVIRONMENTAL EARTH SCIENCES VIC
REPORT TO THE MINISTER FOR MINES AND ENERGY
1 OCTOBER 2012
VERSION 1

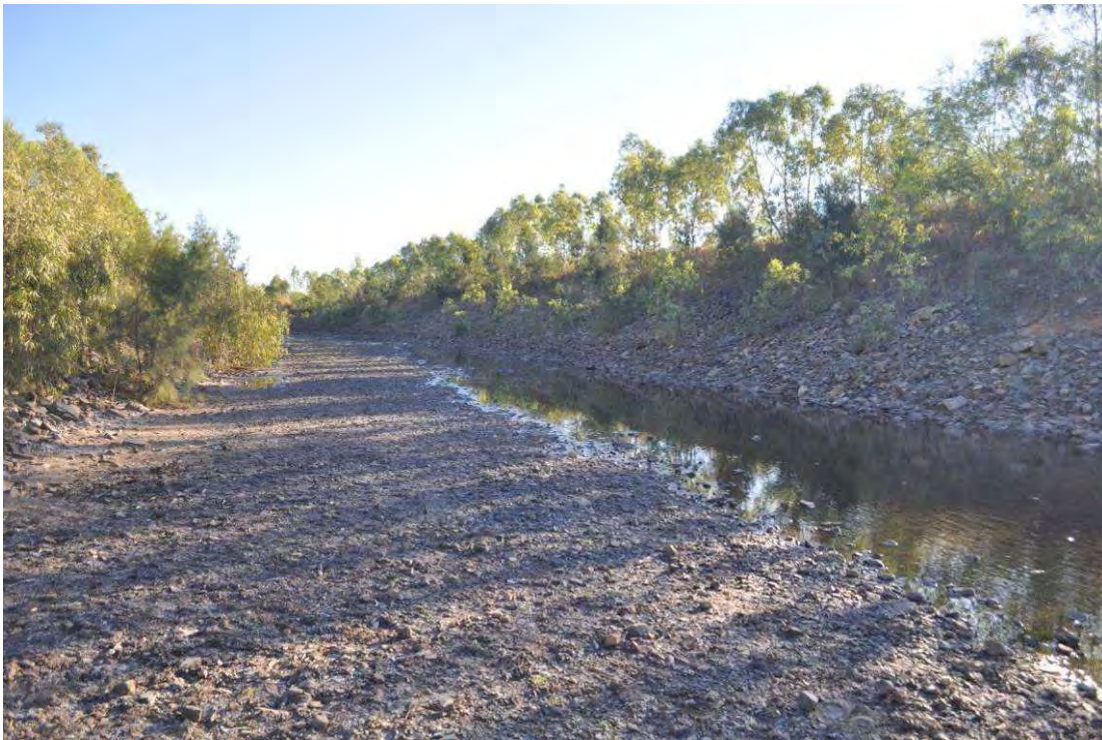
The vegetation on the Barney Creek diversion continues to progress, exhibiting good vegetation cover with, in particular, tall *E. camaldulensis* observed (over 10 metres tall) and a vegetation community of varying maturities (Plate 11 and Plate 13)

Plate 11 Upstream view of Barney Creek/Surprise Creek confluence, May 2012.
Photograph: Independent monitor

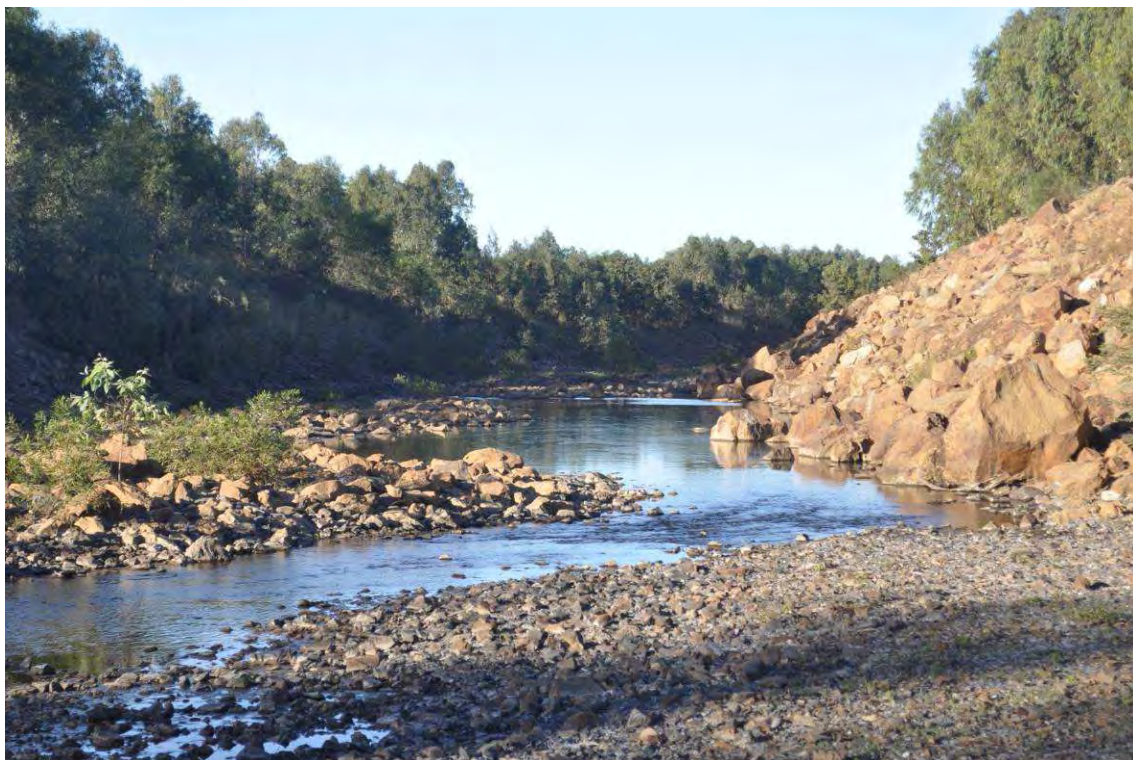
Plate 14 Downstream view of Barney Creek/Surprise Creek confluence, May 2012.

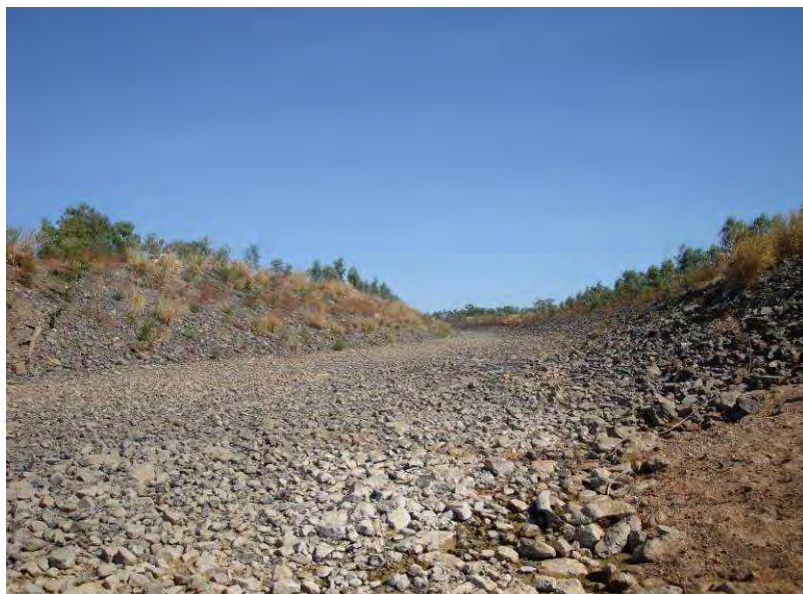
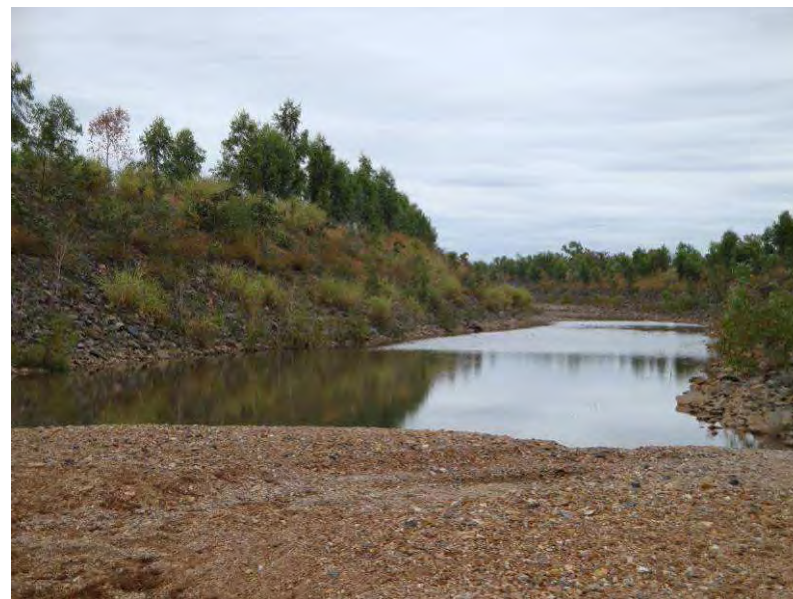
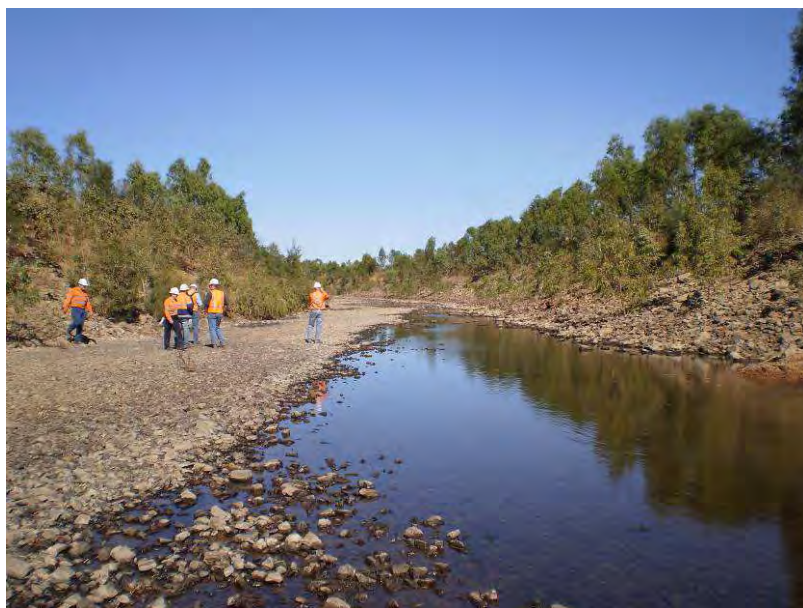
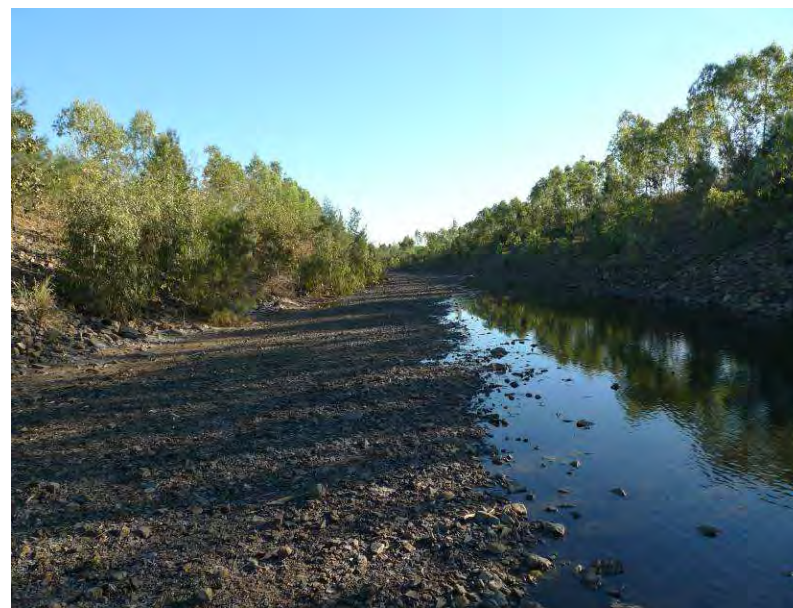
Plate 15 Photographic comparisons of revegetation along the upstream area of the Barney Creek diversion channel (facing upstream). Photographs taken by the Independent Monitor in 2009-2012 during the annual Dry Season mine site inspections.

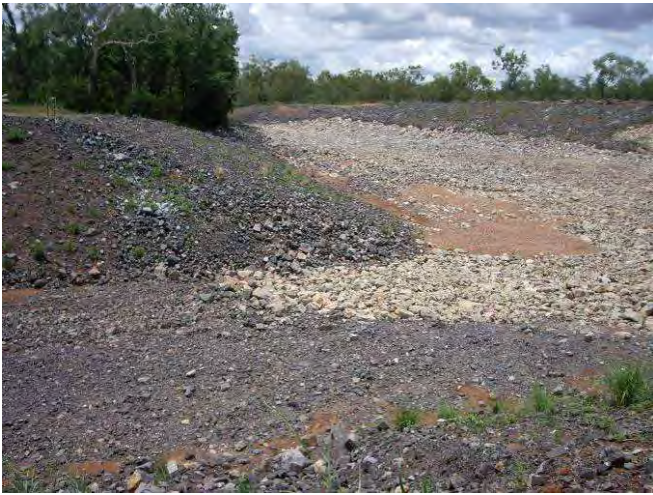
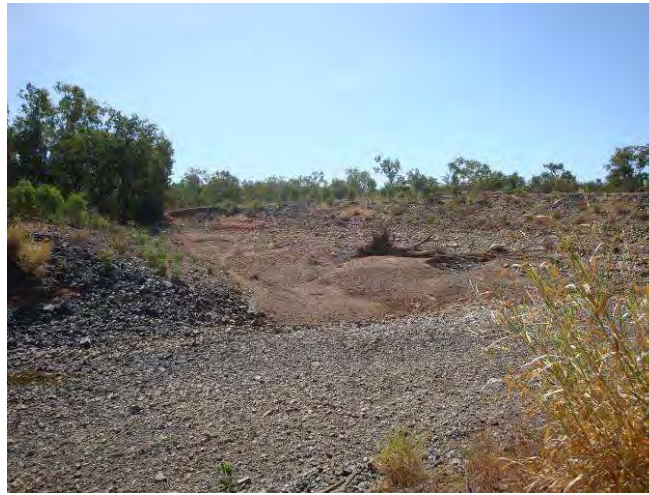
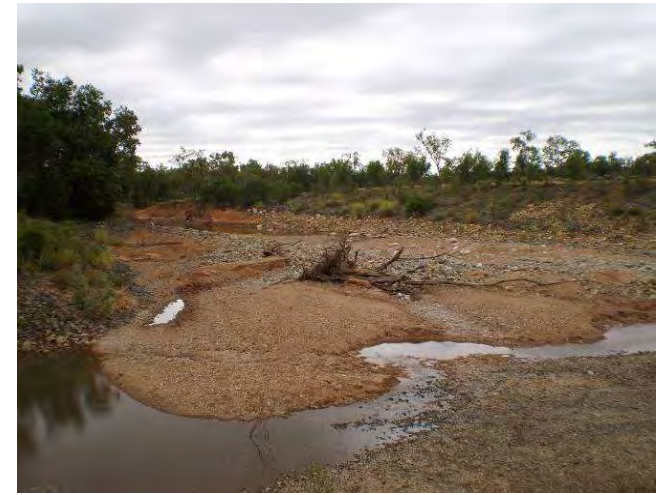
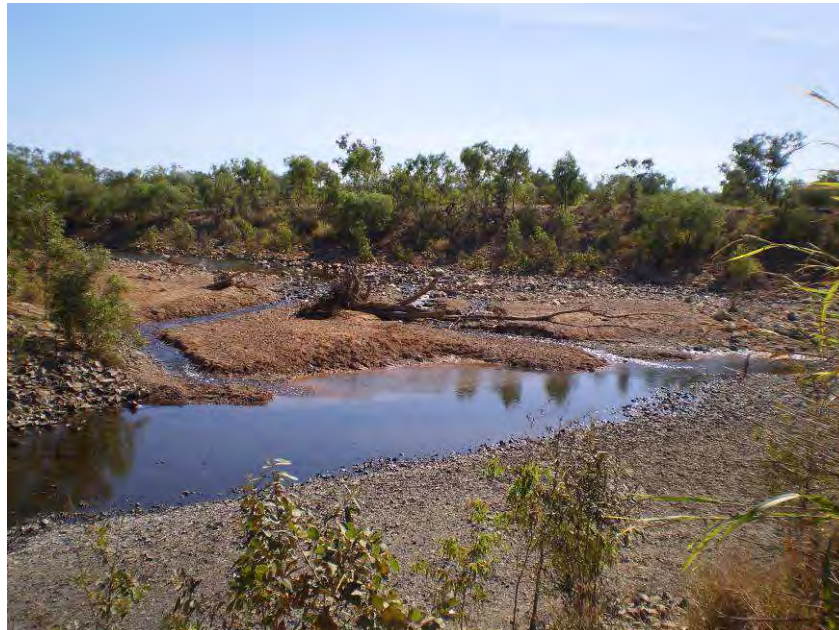
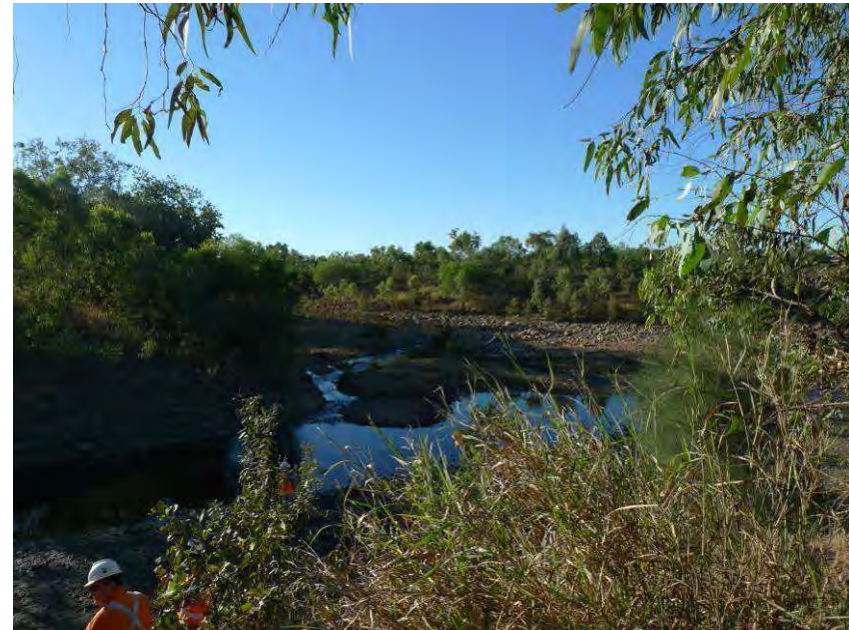
Plate 16 Photographic comparisons showing five years of revegetation Barney Creek Diversion – Surprise Creek confluence.

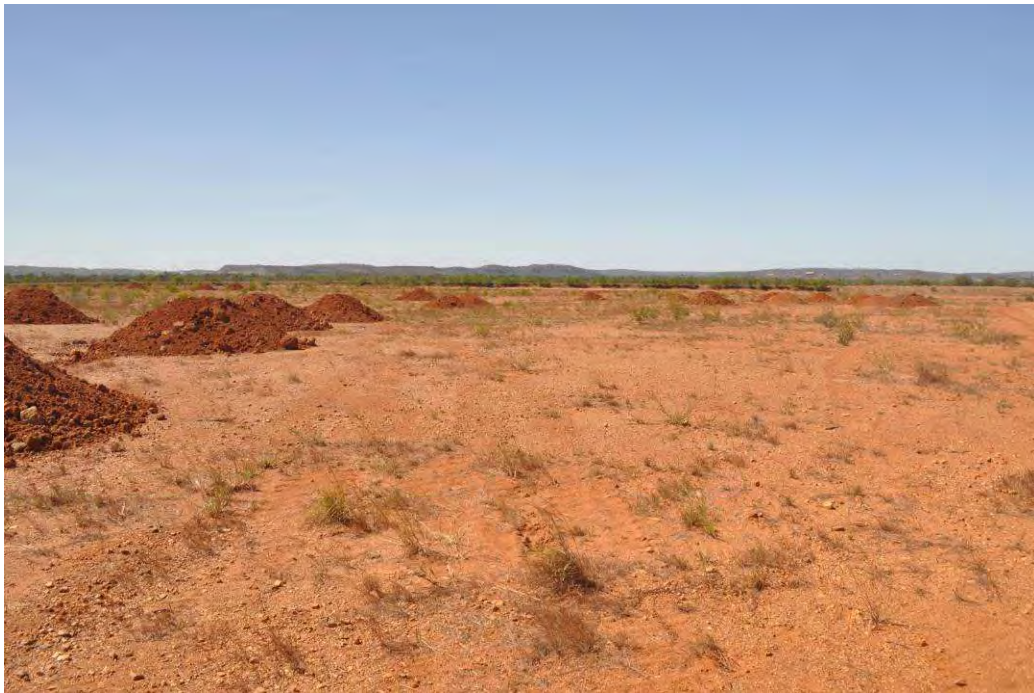
Direct seeding of grass species Black Speargrass (*Heteropogon contortus*) and Spider grass (*Brachyachne convergens*) of TSF cell 1 was carried out in February 2011 by MRM with the help of sub-contractors from the Seven Emus property (MRM, 2011d) (Plate 19). A second area at the far end of TSF cell 1 was seeded with native grasses at the end of 2011.

Plate 19 Area of TSF cell 1 hand-seeded in 2011 by MRM and sub-contractors from Seven Emus property as observed at site inspection in May 2012.

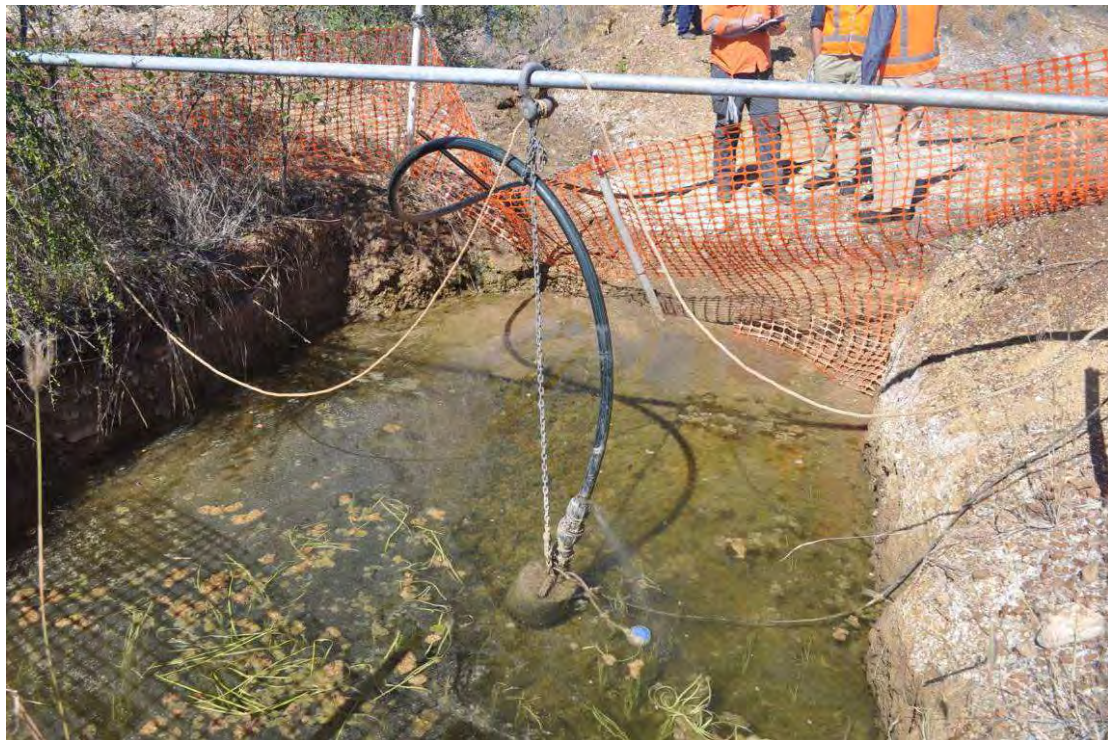
Salt deposition was again observed at Surprise Creek as a result of seepage from the TSF and does not appear to have decreased substantially (Plate 21). Despite this, a frog and macrophytes were observed during the May Independent Monitor inspection within the seepage recovery sump (Plate 22), which is a possible indicator of improved water quality of the seepage.

Plate 22 Seepage recovery pond at Surprise Creek where a frog and macrophytes were observed within the pond.

The Independent Monitor recommends that bi-annual vegetation surveys are conducted at Surprise Creek to monitor effect of tailings seepage on vegetation. Ideally, surveys should be timed to monitor wet season and dry season leachate impacts on vegetation separately (for example early dry season for wet season and late dry season for dry season).

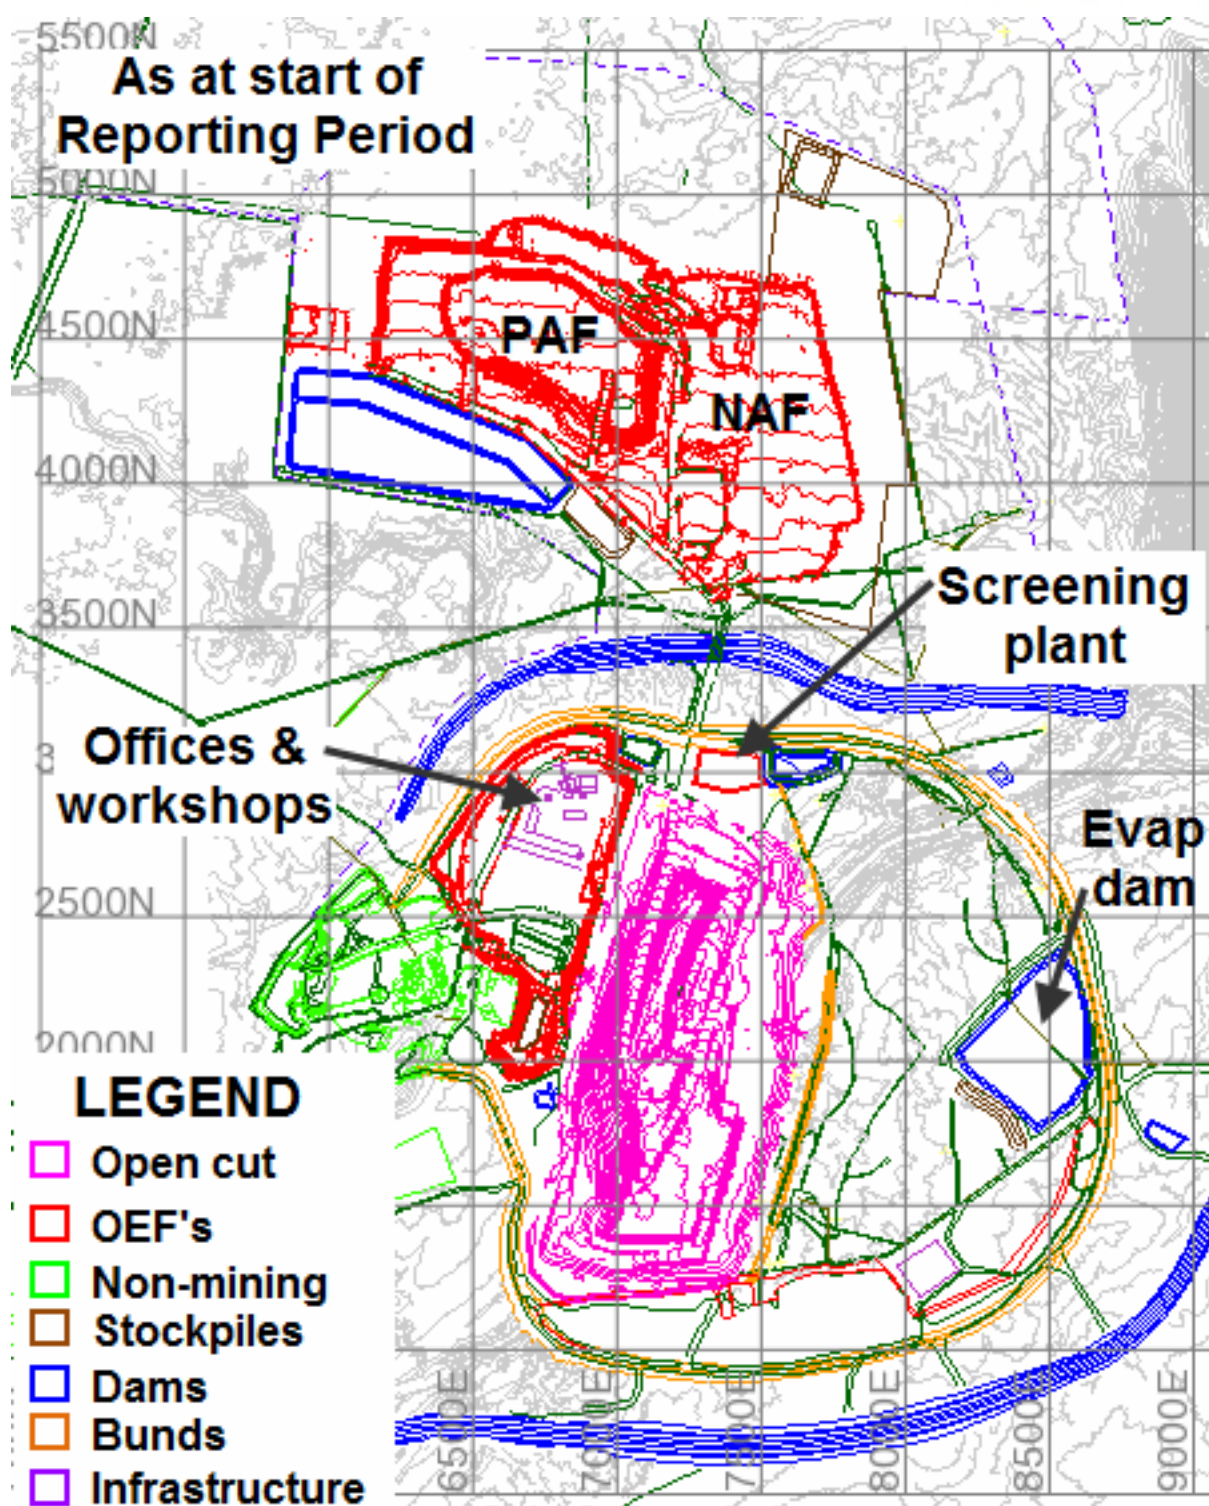
In the 2011/2012 MMP, MRM has included a topsoil management section. This section provides more information than seen in previous MMPs including information on where topsoil will be sourced from (section 4.1.7.7), where the topsoil will be stockpiled and where it is destined for (section 4.1.1.1), as per Independent Monitor recommendation (EES, 2011). Figure 4.1. in the 2011/2012 MMP illustrates the locations of topsoil stockpiling (Figure 31). Map should be improved as it is difficult to determine where topsoil stockpiles are located.

Figure 31 Map showing location of topsoil stockpiling at the McArthur River mine. Topsoil is labelled as stockpiles and is represented by brown lines . (Figure sourced from 2011/2012 MMP)

- expand information regarding rehabilitation in Table 3.1 in 2011/2012 MMP to include areas which will require rehabilitation in the future; and
- improve topsoil map to make it clearer where topsoil is stockpiled.

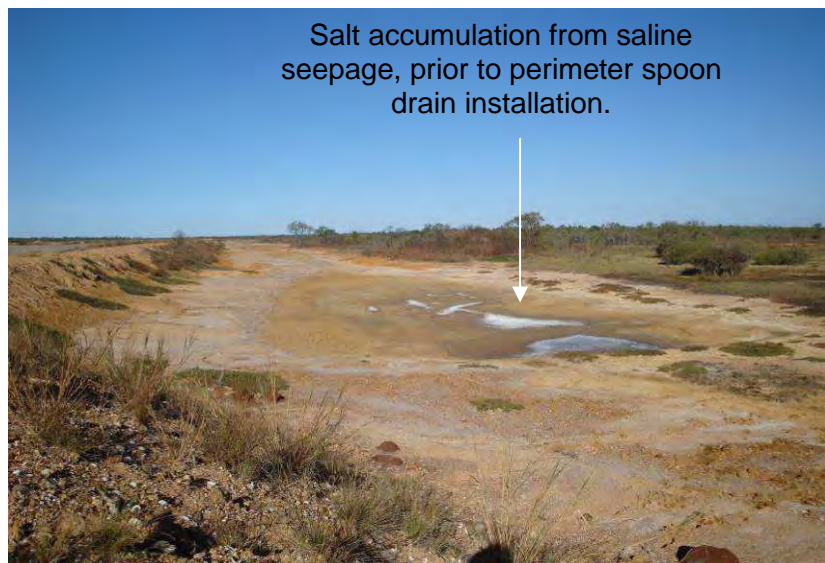
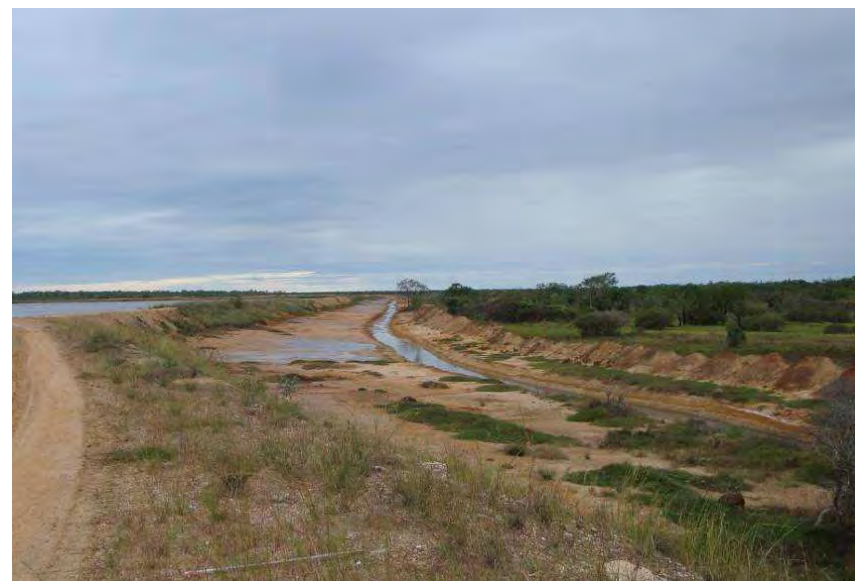
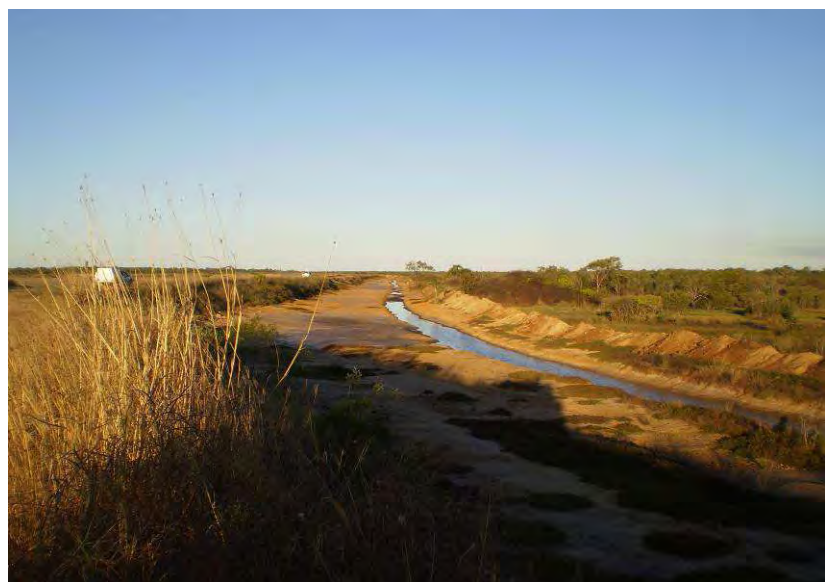
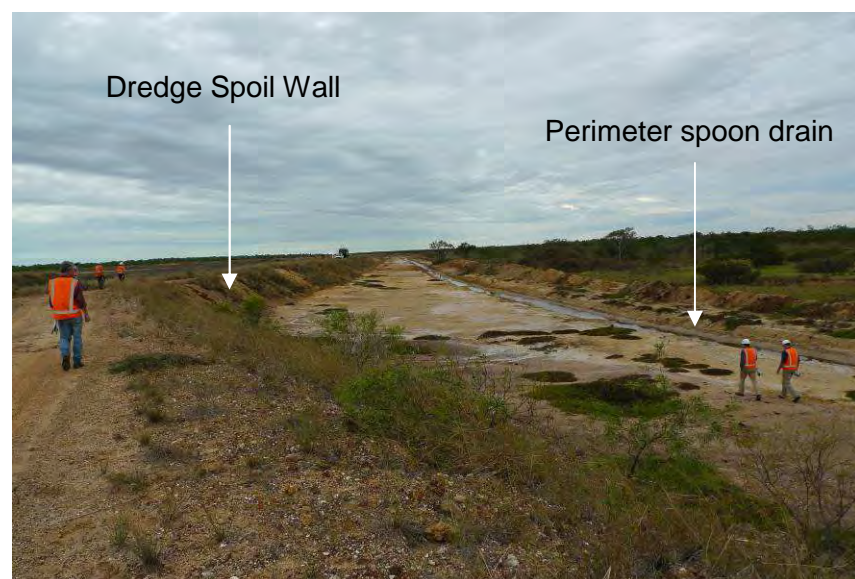
Vegetation dieback is still occurring outside of the dredge spoil spoon drain, although improvements can be seen since the addition of the spoon drain (Plate 27). Monitoring of the vegetation in these areas would provide valuable information on the health of the vegetation and steer rehabilitation and control efforts.

Plate 25 Photographic comparisons showing the outer toe of the Bing Bong dredge spoil ponds and spoon drain, which was installed in late 2009 to divert saline leachate seeping from the spoil ponds away from the surrounding vegetation and out to sea.

The drain at the dredge ponds was excavated in November 2011 to repair areas of damage due to erosion and cattle crossing. Damage was observed during the May 2012 site inspection mainly from repeated cattle crossing. It is recommended that the drain is again excavated prior to the onset of the wet season in 2012 and repeated annually.

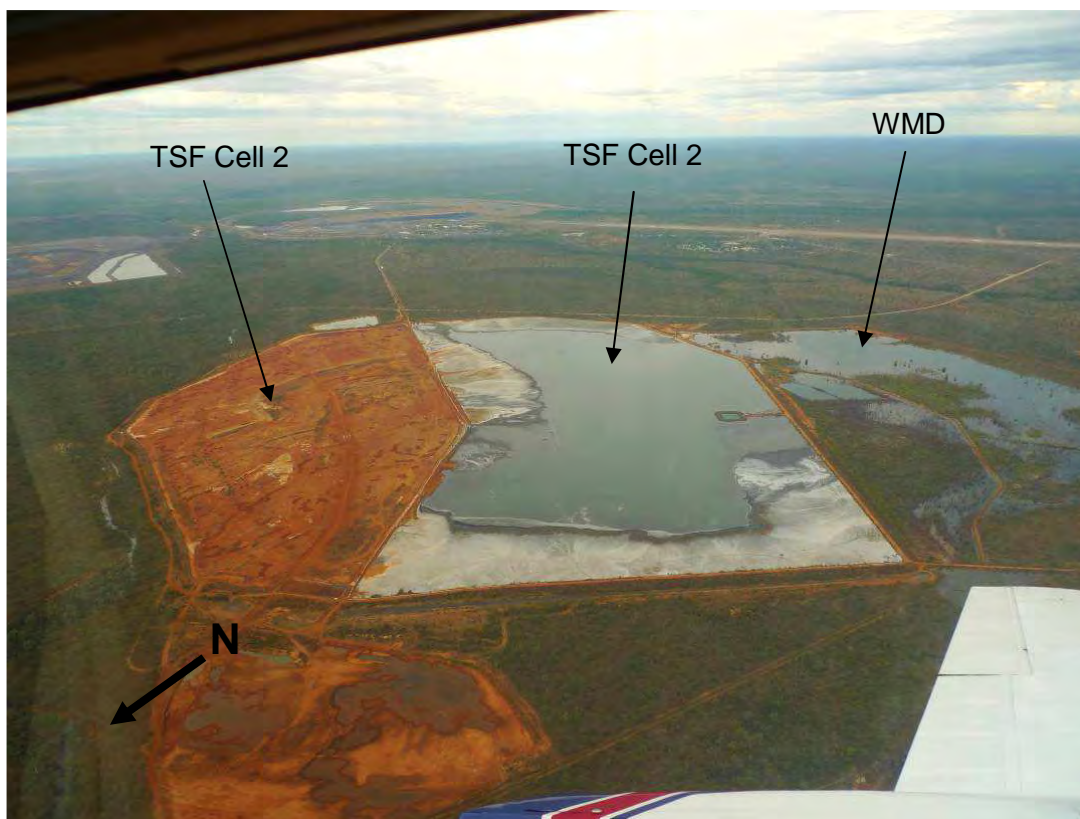
Plate 32 Aerial View of the Tailings Storage Facility, showing Cell1 (covered with a clay layer) to the left, and active Cell 2 to the right. May 2012.

Within the 2010, 2011 and 2012 Independent Monitor audits, the Independent Monitor has expressed significant concern with a large supernatant pond formed within TSF Cell 2, (see Plate 32), which touches the southern TSF Cell 2 embankment for much of its length. The length of the embankment wall exposed to the pond has been reduced in 2012, and tailings was being deposited along the southern wall (see Plate 33) at the time of inspection. The following comment from the 2011 Audit report still stands this period:

| Previous audit comment | Update on action from MRM |
|--|---|
| The tailings storage facility should not be used to store excess water: | Although slightly improved when compared to the observations made during the 2011 Audit, there are still significant volumes of water stored in Cell 2 and against the embankment. It is pertinent that all efforts are made to increase tailings deposition along the (southern) embankment walls and move the stored water away from the embankment (refer Plate 32). |

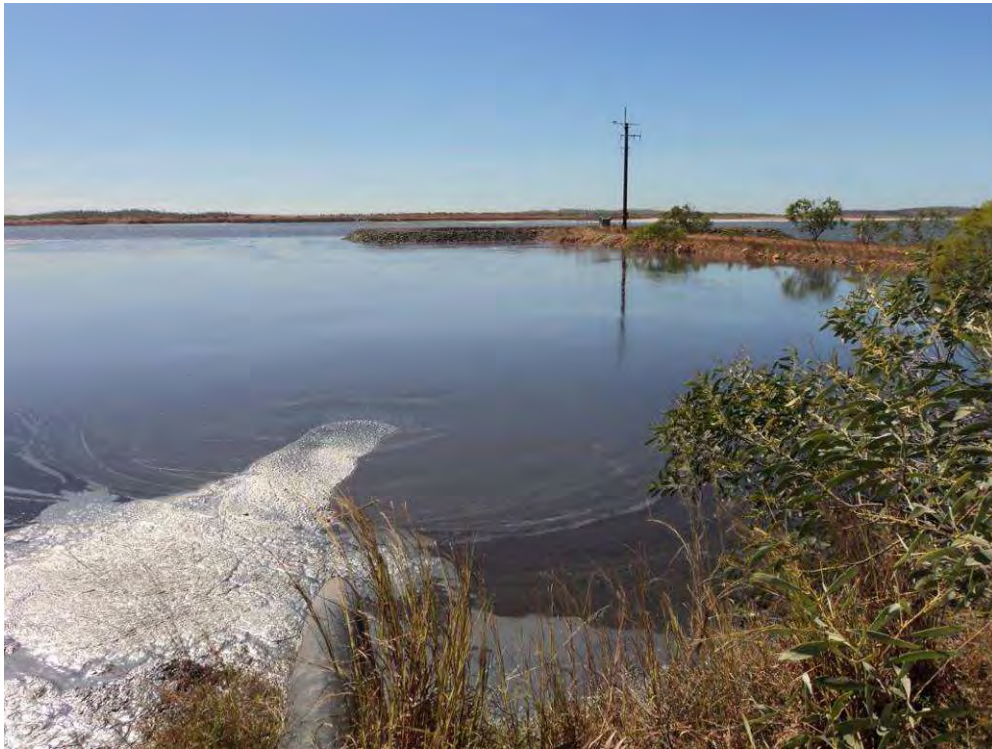
During the May 2012 site inspection, Cell 2 was being used for active tailings deposition. Deposition is via spigot deposition with Current deposition was concentrating on the southern wall of the facility with the aim to move water away from the embankment wall towards the centre of the Cell (see Plate 33). In spite of this current effort, the volume of water and the surface area of water is still exceedingly large (see Plate 32) and concerns with regard to storage capacity for tailings, storage capacity for storm water and stability related issues remain very much relevant and current.

Plate 33 Tailings deposition along southern embankment of Cell 2.

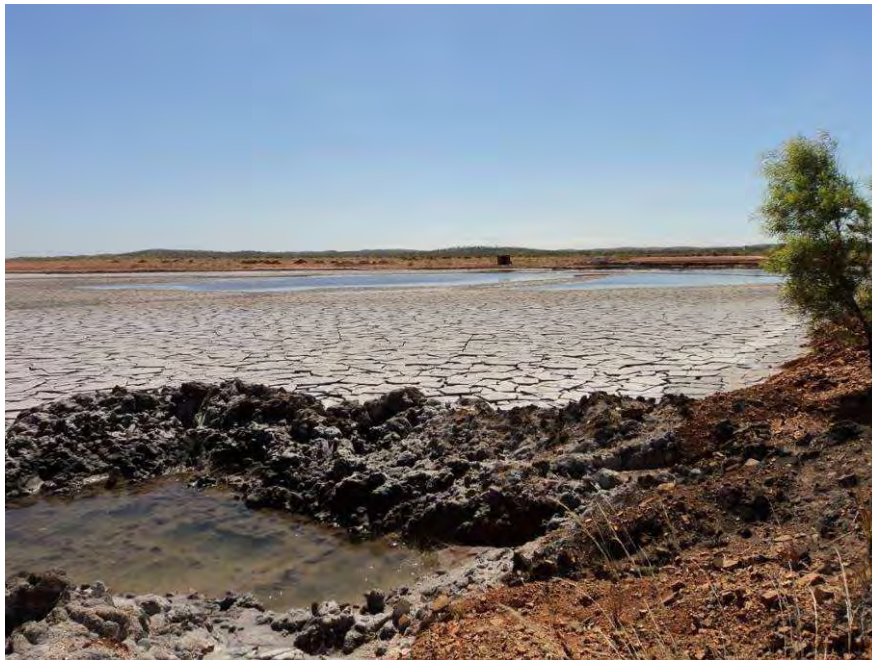
The Independent Monitor observed that *In-situ* geotechnical testing within Cell 2 (using cone penetration test (CPT) methods) has been undertaken in May 2012 (see Plate 34).

Plate 34 Recently (6 months) deposited tailings along eastern wall, which had recently been disturbed because of geotechnical testing (CPT).

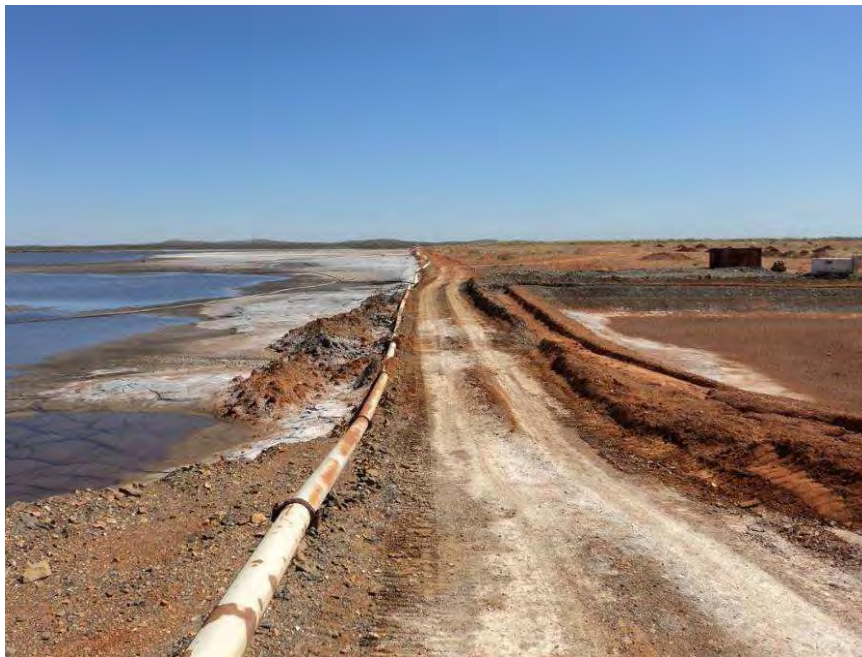
The surface of Cell 1 was sloped down to the perimeter embankment and directed to a sump at the south east and north west limits of the facility adjacent to the divide wall with Cell 2. The sumps had been used to pump water to the WMD during the wet season but no pumping was active at the time of inspection. The south eastern sump was equipped with a spillway, across the berm road, to allow excess water to discharge to Cell 2 if pumping capacity was exceeded (see Plate 35).

The west and east wall of the facility had tailings deposited up to November 2011. Reasonable drying and desiccation of the tailings beach is being achieved, as evident by deep desiccation cracking on the tailings beach (see Plate 35). The tailings along the western wall (six month since deposition) appeared still wet.

Plate 35 Sump at south eastern limit of the facility between Cell 1 and Cell 2

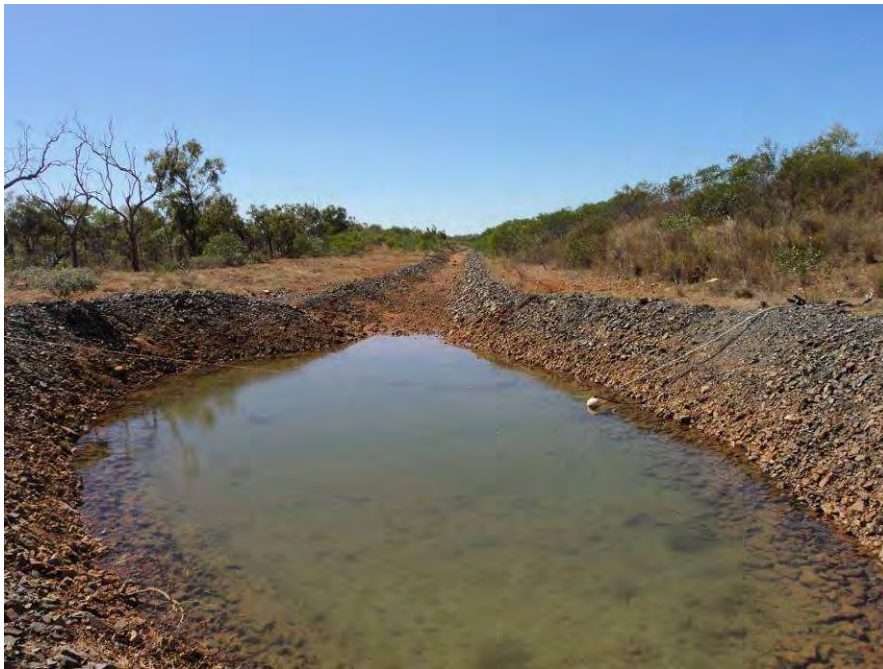
- the temporary bund constructed in the concrete spillway, noted in the 2011 Audit, was removed;
- the collector drains, along the east and west downstream toe of Cell 2 were observed to be holding water during the 2011 Audit. During the 2012 Audit no flow was observed within the drains. The sump at south eastern corner and little Barney Creek had some standing water (see Plate 36);

Plate 36 Sump and drain along eastern embankment of Cell 2 near Little Barney Creek.

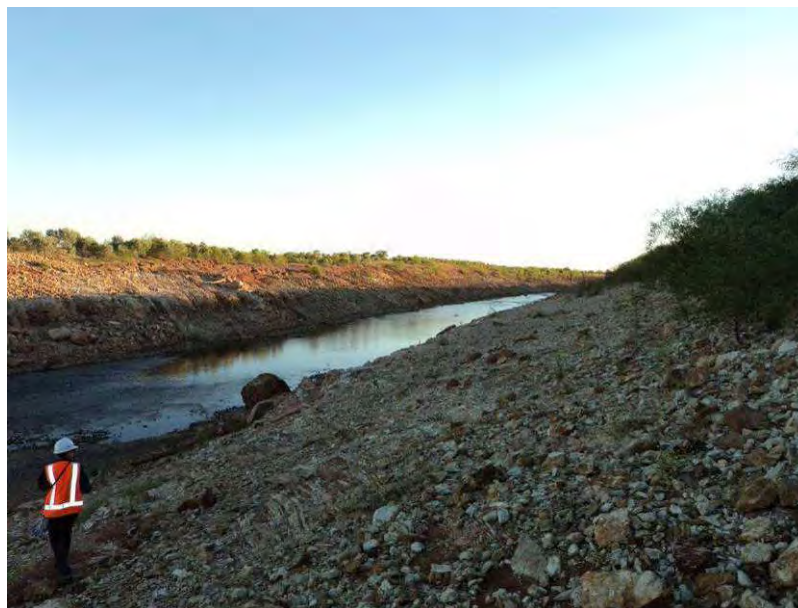
Plate 40 McArthur River Diversion

- the Barney Creek Diversion was generally in geotechnically good condition during the inspection;
- the banks of the McArthur River Diversion was generally in good geotechnical condition (see Plate 40);
- minor erosion of top soil from the pit bund was visible where surface water flows from the old river channel alignment into the diversion channel had occurred, this was also noted during the 2010 visit; and
- minor localised erosion was evident at various locations along the channel where loose uncemented soils were exposed in the diversion channel batter slopes.

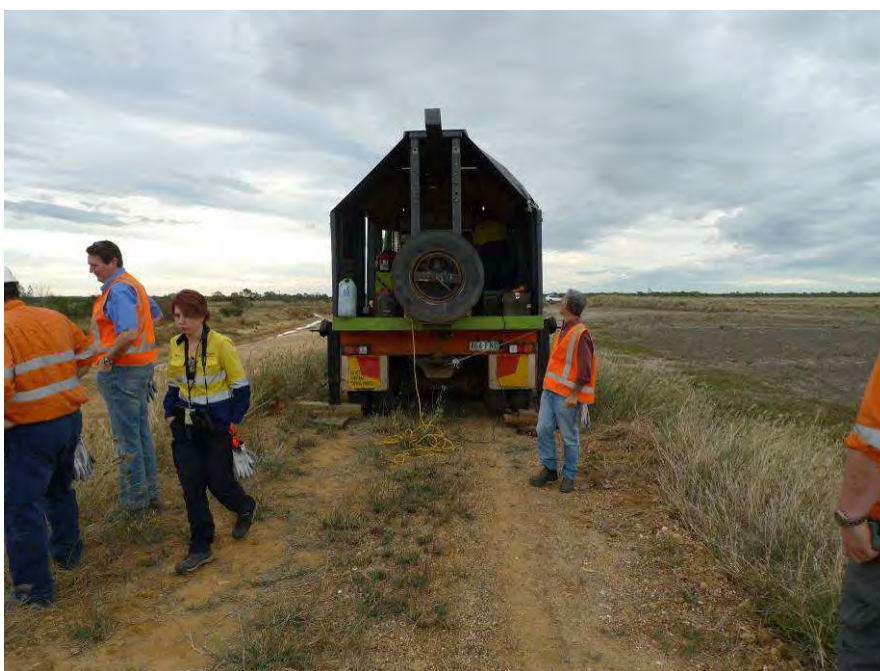
Significant improvements at the dredge spoil ponds have been made recently. We note that *in-situ* geotechnical testing was being carried out during the 2012 audit. Embankments have been reshaped in damaged areas, vegetation is taking hold to stabilise the walls. Also, the surface water management has been addressed to some extent with drainage paths being created from cell to cell.

Plate 41 Cone Penetrating Testing (CPT) geotechnical investigation being undertaken on the Bing Bong dredge spoil walls during the Independent Monitor's May 2012 site inspection.

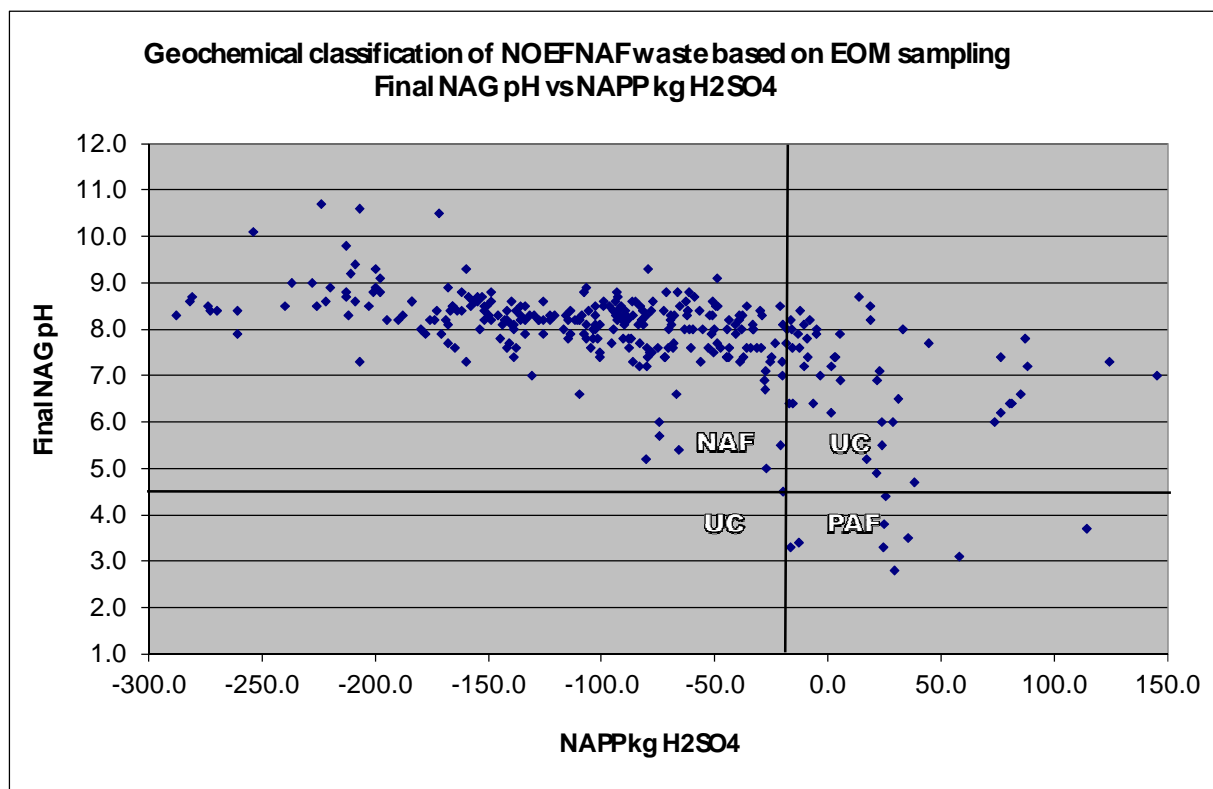
Figure 34 Geochemical classification using NAPP/ NAG pH

The data presented in Figure 34 indicates that only about 10 of a total of 330 samples analysed is classified as PAF based on NAPP/ NAG pH, however a large number of samples (>40) are classed as UC (uncertain) due to elevated NAPP. This is also illustrated in Figure 36, which shows that whilst all of the UC samples in Figure 34 have a NAG pH >4.5, total S is >2.5% (for >20 samples). Regardless of the NAPP classification (which is MPA – ANC), as the definition of PAF relates to the ratio of ANC and MPA the data presented in Figure 35 indicates that >10% of samples analysed are PAF (ANC/MPA <<2).

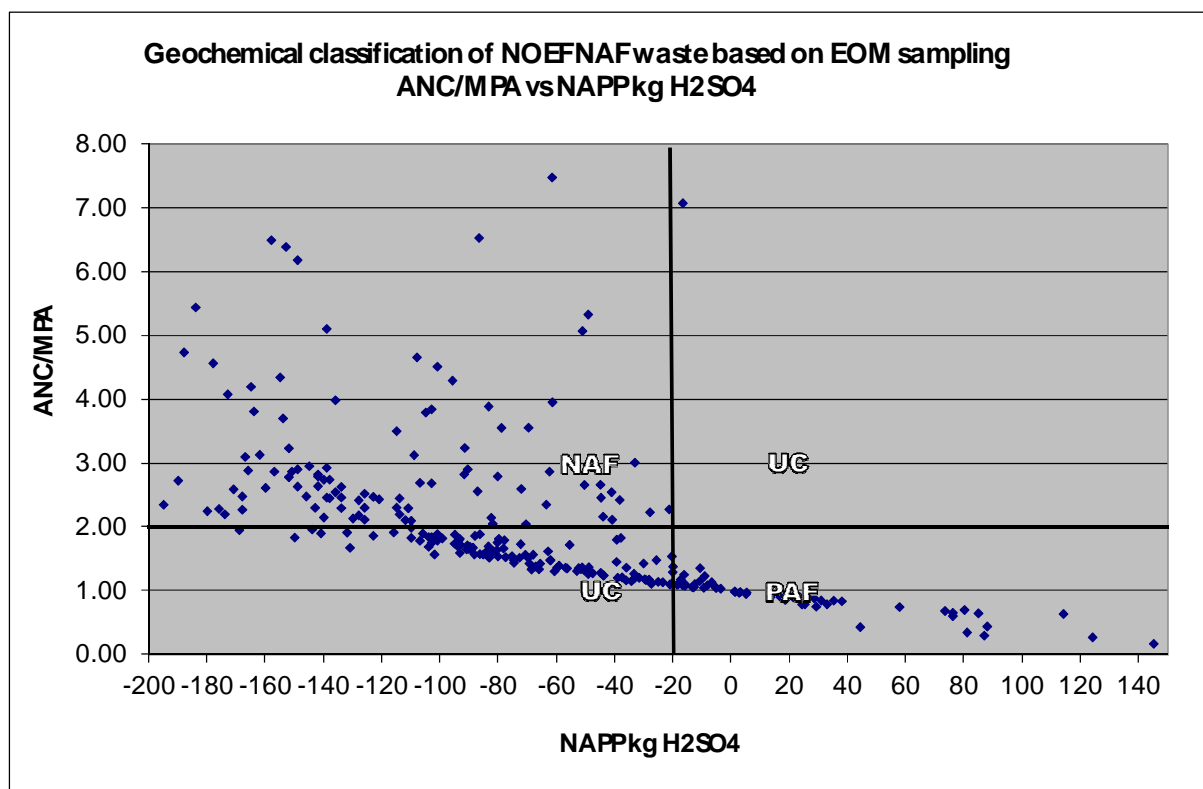
Figure 35 Geochemical classification using NAPP/ ANC/MPA

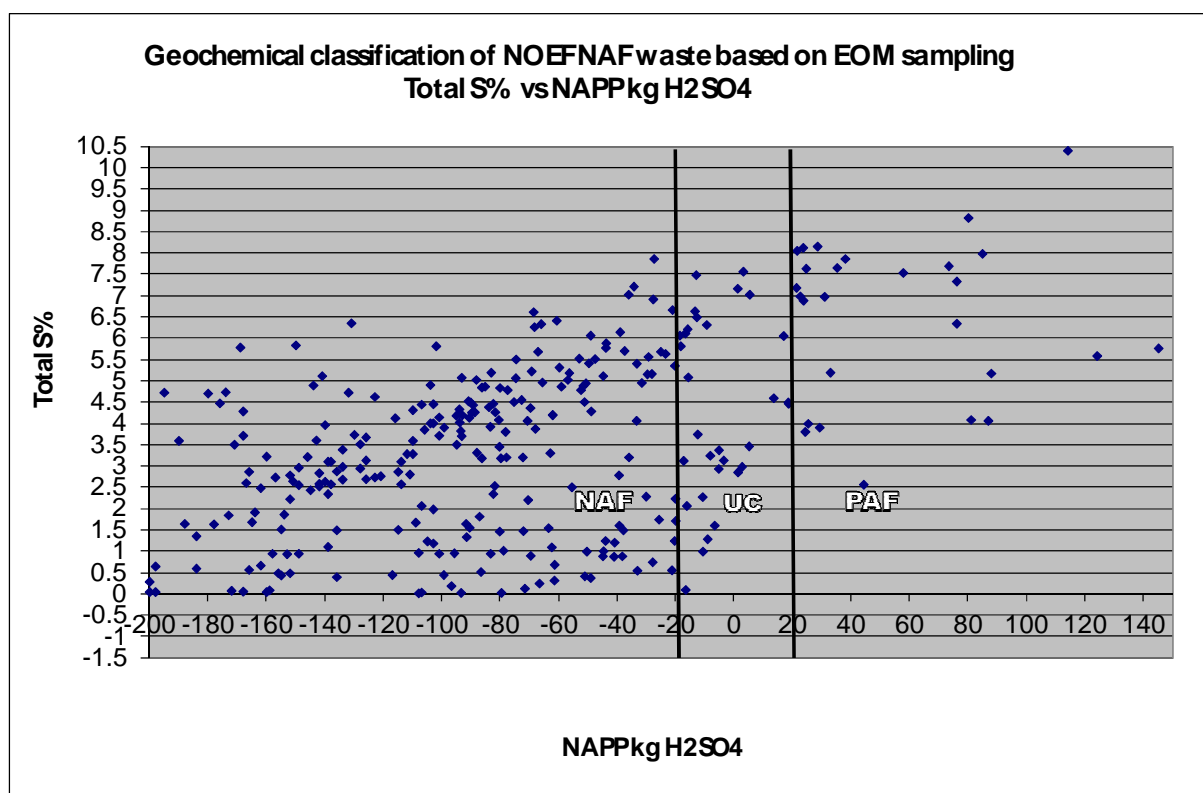
Figure 36 Geochemical classification using NAPP/ Total S%

A review of the classification of NAF waste is required as the sulfur content is very high—often >5% total S (see Figure 36 above). This material generates a neutral pH leachate, but with high sulfate and metals caused by an acid drainage reaction. Due to the low solubility of the carbonates, the acidity from metal sulfide oxidation precedes the dissolution of the neutralising carbonate. There is also the potential for bypassing of the neutralising mineralogy if a difference of particle size or abundance occurs in the heap between acid generating sulfides and neutralising carbonate.

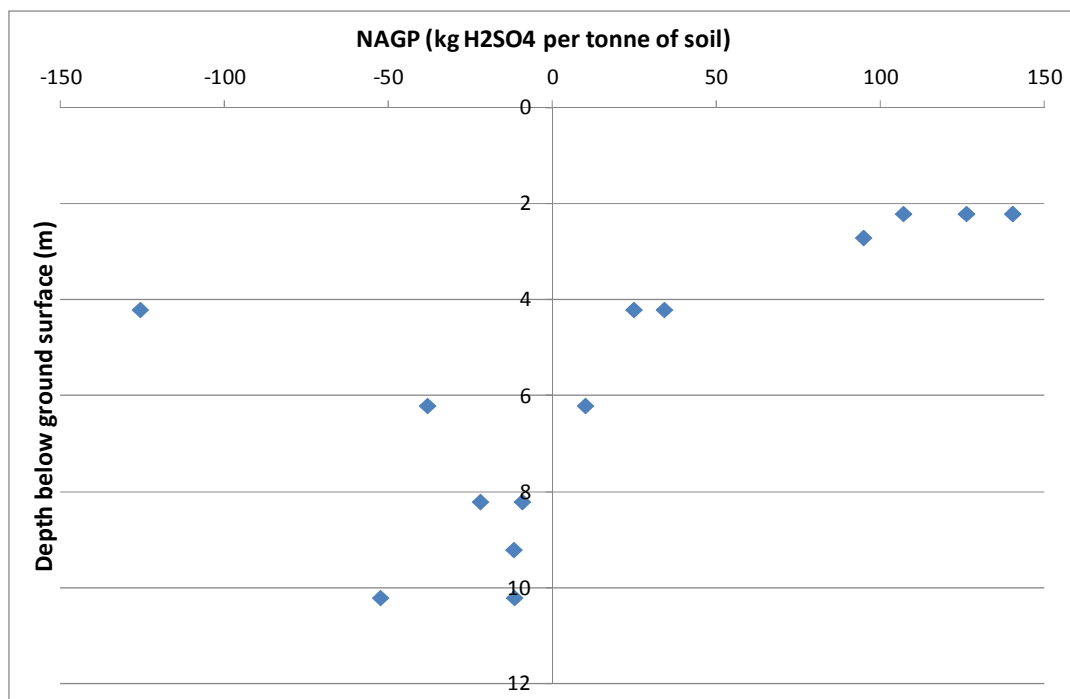
Figure 37 Net Acid Generation Potential calculated from mineral percentage developed from XRD Data provided in Golder (2011, Appendix F).

It is clear that when the tailings were first deposited they would not produce acid leachate (NAGP \leq -9 kg H₂SO₄/T). A change must have occurred in the top 3 metres of tailings, possibly in the composition of the ore, as the tailings deposited during this period have substantially more pyrite (and slightly less dolomite), and will potentially generate substantial acidity when the buffering capacity of the tailings has been depleted. The tailings data indicate two changes in milling, and though the original tailings will not generate acidic

leachate, the tailings deposited over the last five years will. However, both TSF Cells have been designed on the basis that acidic leachate will not occur.

The Independent Monitor agrees with the Golder (2011) recommend that mitigation strategies should be undertaken, including reprocessing the tailings and at the same time undertaking remedial works to create a liner to intercept the seepage.

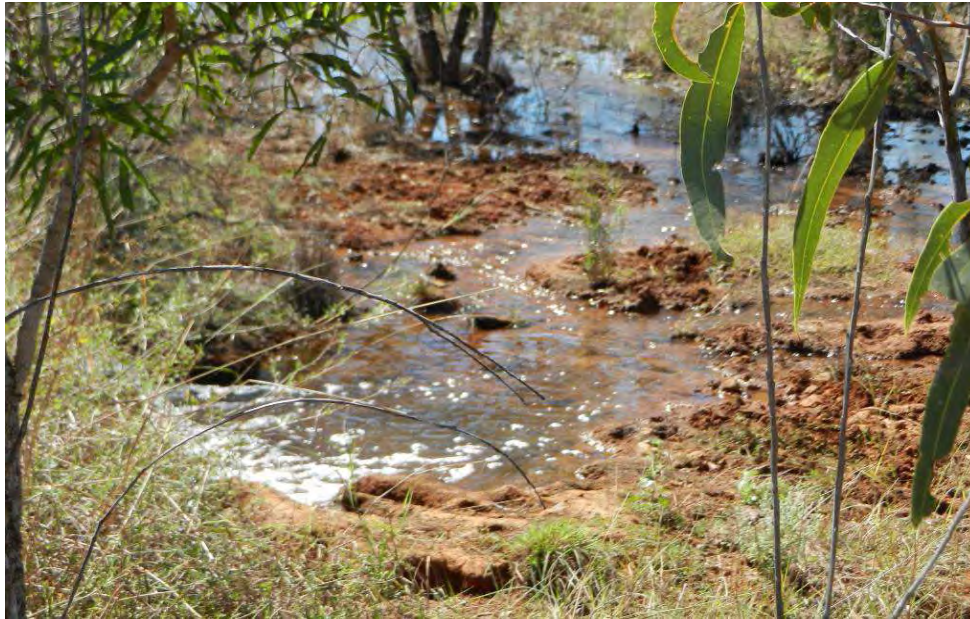
Water levels in WMD are rising. In order to dispose of the water, MRM have increased the evaporation area by creating some internal berms within the higher topographical areas within the WMD walls on the south western and western side of the WMD. For this reason, water has been pumped up from the ponded water in WMD and discharged into the uncleared area of the high topographical area (see Plate 42). This water ponds behind the internal dams as shown in the aerial photograph (Plate 43)

Plate 42 Fresh water being discharged into uncleared area of the WMD to aid evaporation.
