# Independent Monitor Community Report 2008 Operational Period

Community Report by the Independent Monitor for the Period  
October 2007 to September 2008

Welcome to the second Annual Community Report by the Independent Monitor of the McArthur River Mine (for the period from October 2007 to September 2008)

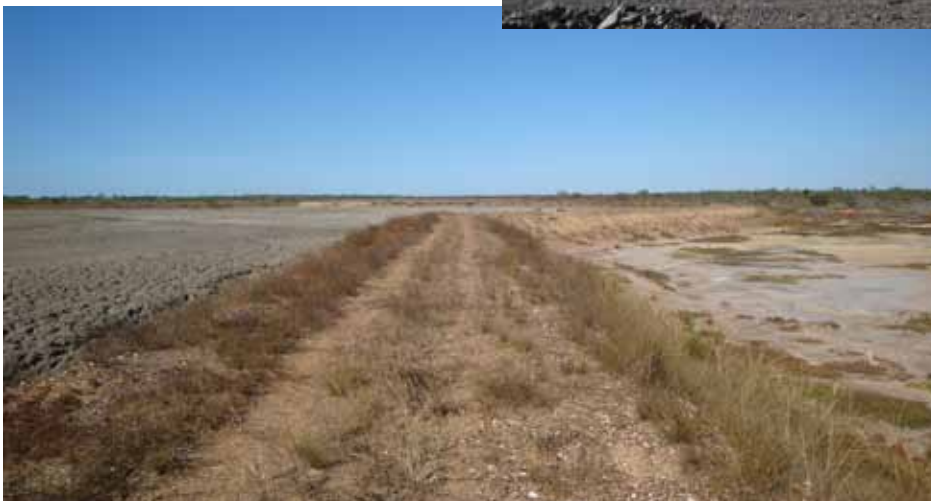
to saline seepage from the ponds that contain dredge material at the Bing Bong Port facility. During the June 2009 site inspection, the Independent Monitor noted significant vegetation die-back and salt crystallisation immediately outside of the dredge pond walls, indicating that saline seepage is migrating through the degraded dredge pond walls. The pond walls and drain design are required to be remediated to ensure that saline seepage does not continue to affect the surrounding land, as shown in the photograph below.

Dredge soil pond wall separating the dredge material (left) from the surrounding land.

The Independent Monitor recommended that MRM review the future use of the dredge spoil ponds so that this facility can be remediated to meet its environmental and engineering performance objectives in line with generally acceptable industry standards. It was also advised that a Management Plan be developed to include regular environmental and geotechnical inspections and monitoring.

reconstruct drains and spillways to divert saline seepage back to sea prior to the next dredging event. The Independent Monitor will review the progress and effectiveness of these and other related mitigation works as part of next year's audit.

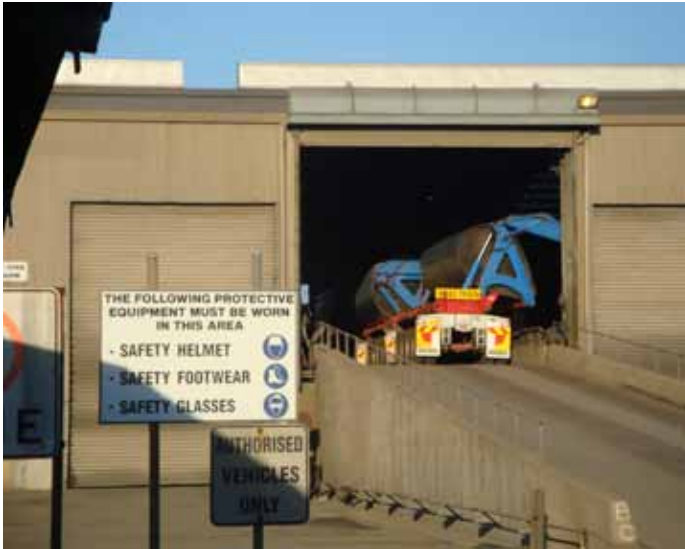
A truck depositing concentrate within the Bing Bong Port storage shed (Photo June 2009, Independent Monitor).

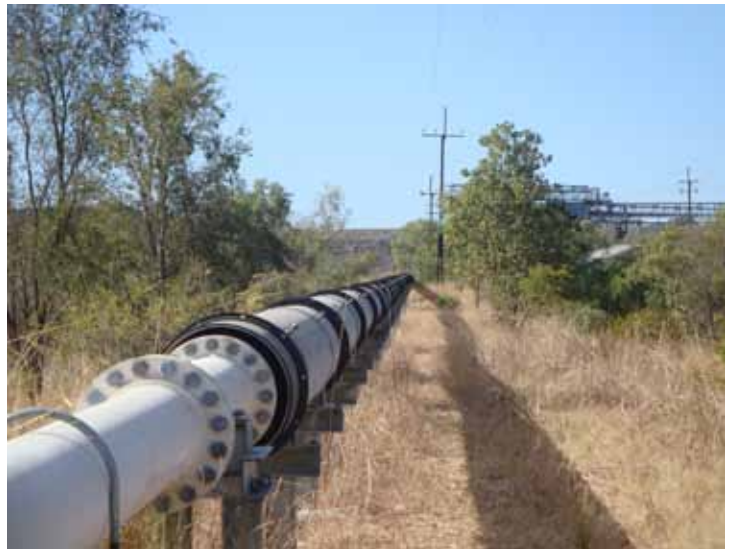
Pipeline that carries the tailings slurry from the processing plant to the Tailings Storage Facility (Photo June 2009, Independent Monitor).

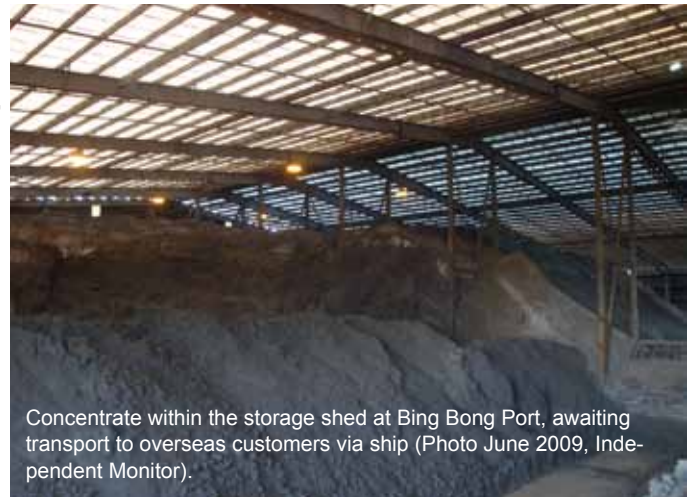
marine sediments and terrestrial soils. Unfortunately, the doors to the concentrate shed must remain open so that dangerous gases do not build up within the shed, however this requirement increases the potential for dust to escape.

Concentrate within the storage shed at Bing Bong Port, awaiting transport to overseas customers via ship (Photo June 2009, Independent Monitor).

the Bing Bong facility to limit the potential for dusts to blow from the site. However, the Independent Monitor recommends that a detailed
