Independent Monitor ENVIRONMENTAL PERFORMANCE ANNUAL REPORT 2017-2018

McARTHUR RIVER MINE

SEPTEMBER 2018
Report No. 01164F_1_v2

**Independent Monitor
Environmental Performance Annual Report
2017-2018**

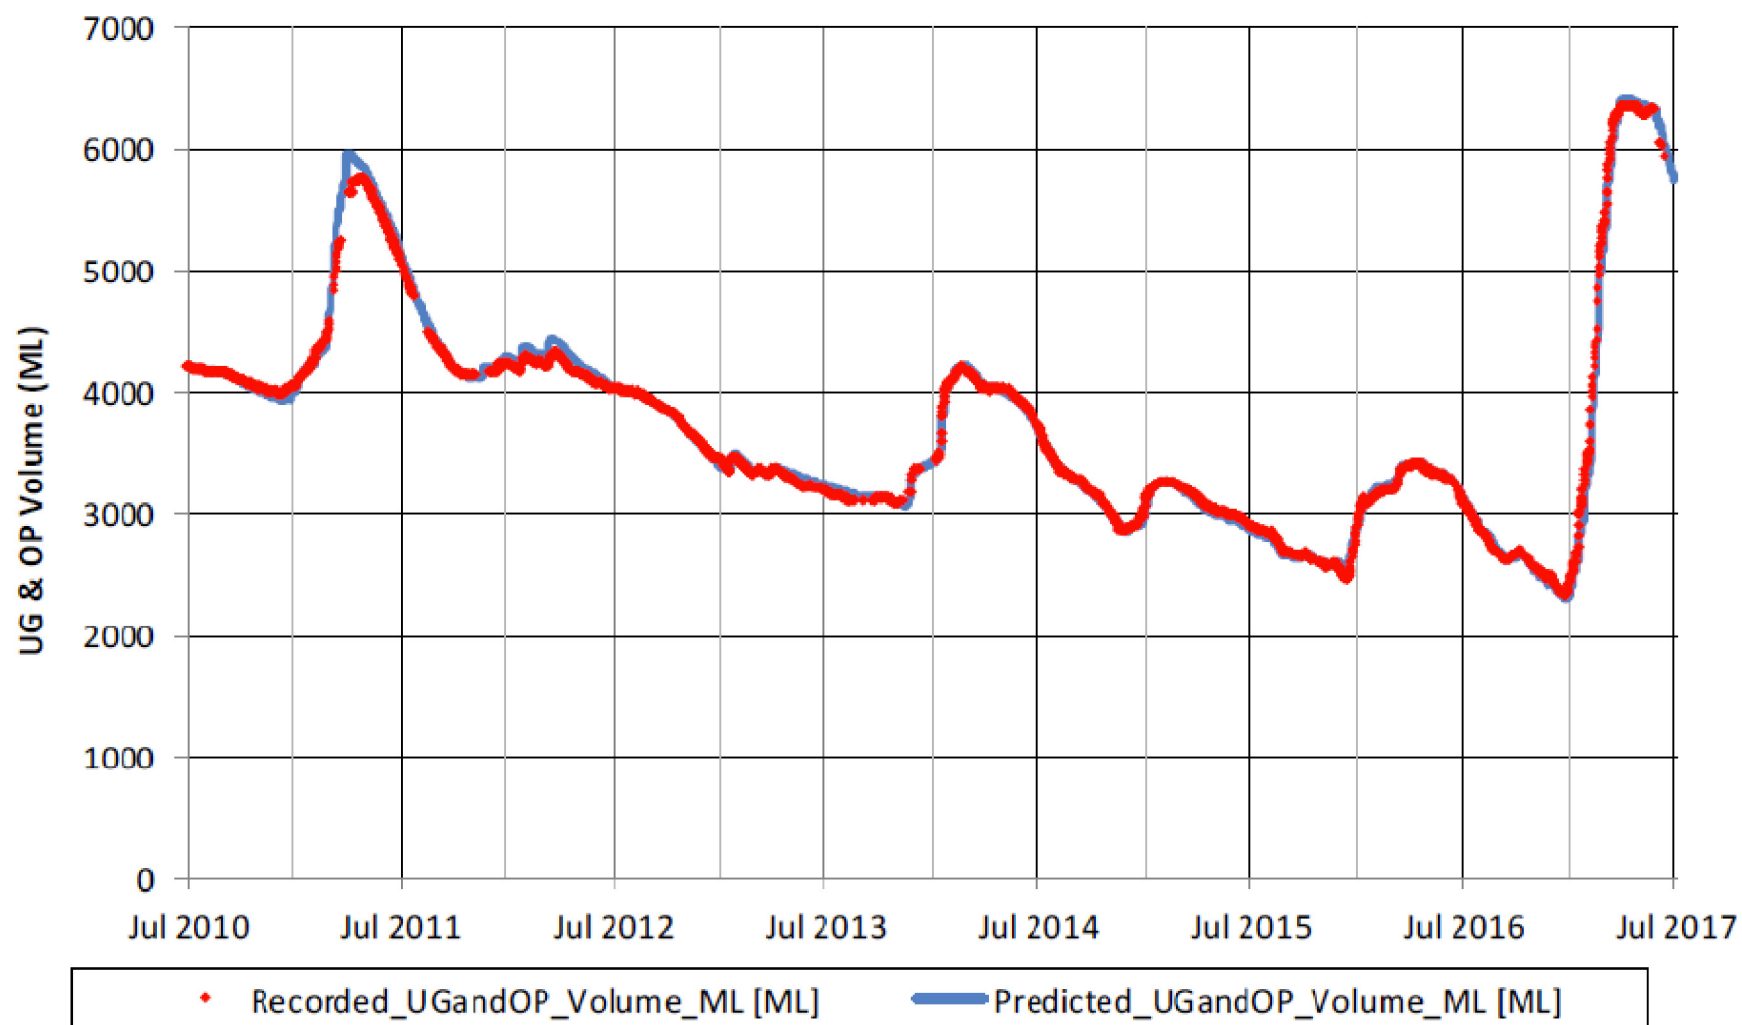
FIGURE 4.1

Figure 4.1 shows a chart presented in the 2017-2018 OPR as an example of the predictive ability of the water balance model (a similar chart is also presented in the 2016-2017 OPR). The commentary in the 2017-18 water balance report (WRM, 2018a) describes how the

almost perfect fit is due to the groundwater inflows being derived (by difference) from the measured pumped outflows and the UG&OP stage storage curve. That is, the calculated groundwater inflow is the integration of ground water inflow and any error in inflow/outflow errors. Therefore, groundwater inflow acts as a 'fudge factor' with the model fit always being almost perfect. The results shown in Figure 4.1 are a weak test of model performance and a misrepresentation of the models accuracy. The 2017-2018 water balance report (WRM, 2018a) provides numerous additional charts that show poorer fits between the modelled and observed data. These additional charts are more representative of model performance. It is recommended that Figure 4.1 (or figures derived with similar data) not be used in future OPRs.

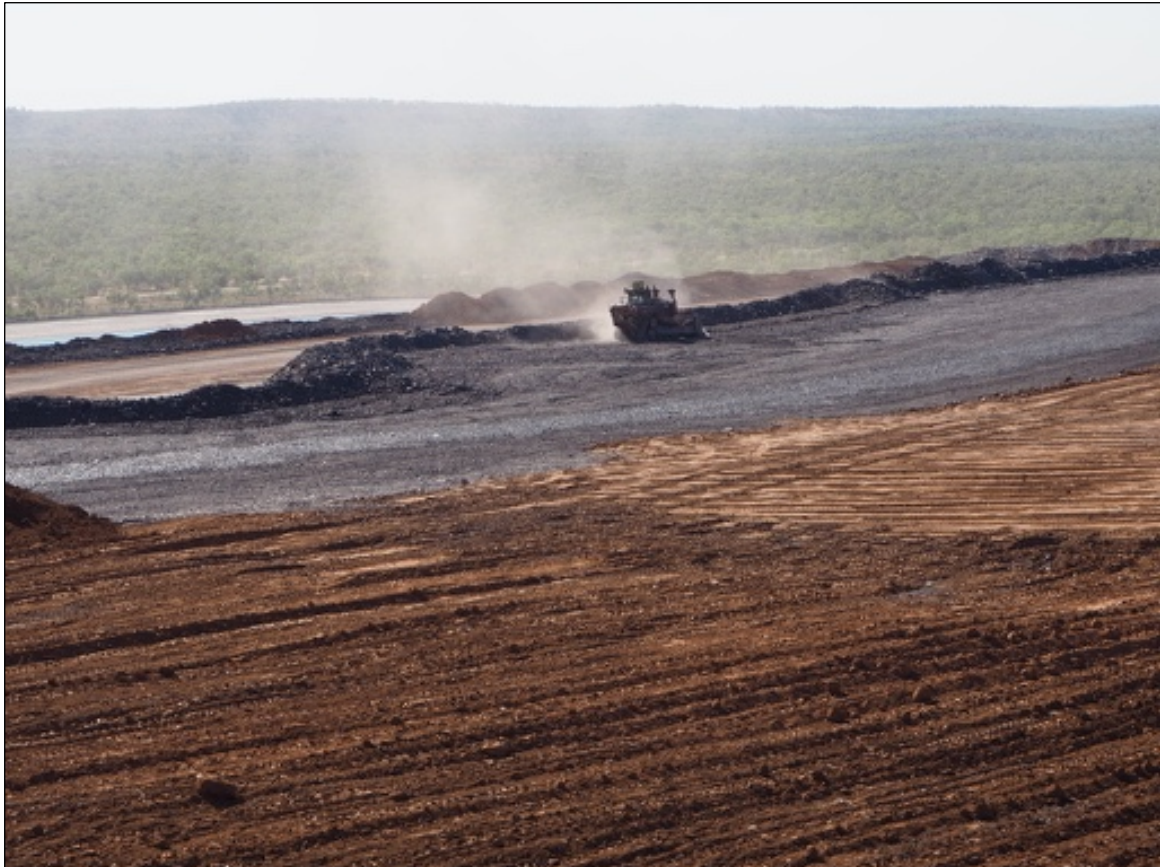
Plate 4.1 – Example of Dozing PAF Cell Placement in CW Stage of the NOEF

Waste rock was primarily being placed in the CW stage of the NOEF during the 2018 IM site visit, with PAF(HC) and PAF(RE) materials being end tipped in 2-m lifts, dozed flat (Plate 4.1) and traffic compacted, as per previous activities. The end tip profile was examined during the IM site visit, and it was clear there was no significant segregation at a 2-m lift height, with the materials relatively well graded (Plate 4.2). However, the materials do include blocky portions, and significant segregation may occur at the higher tip heads proposed for PAF(HC) in the Draft OMP EIS (MRM, 2017a).

McArthur River Mining proposes to continue placement of PAF(RE) materials in 2-m lifts, but PAF(HC) materials would be placed in up to 7.5-m lifts (2-m base followed by 5.5-m tip head). The IM still has concerns with the proposed 7.5-m lifts for PAF(HC) materials, which are unlikely to result in spontaneous combustion but could still cause high convective oxidation rates and generation of AMD. Given the highly pyritic nature of PAF(HC) materials (median S values of around 8%S), it is recommended that the PAF(HC) materials also be placed in 2-m lifts to

minimise AMD loadings and reduce liabilities during all stages of dump construction, and in case the proposed final cover system is not fully successful.

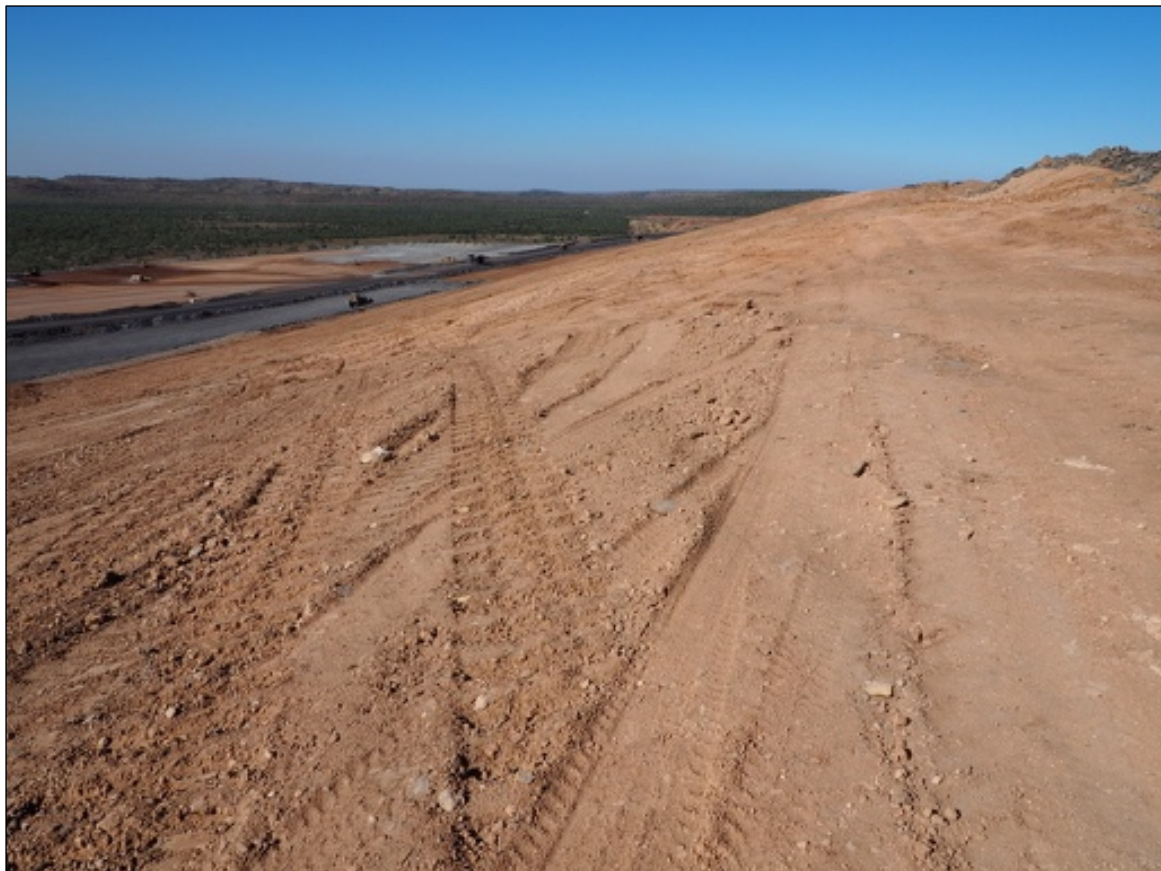
Plate 4.3 – Interim 0.5 m Advection Barrier Between the Older NOEF Dump Area and CW Stage

Advection control measures continued to be implemented at the NOEF, with focus on installation of an interim advection barrier on the northern batter between the older dump areas and the CW stage (Plate 4.3), which is appropriate to help reduce extreme oxidation rates in the older end-tipped portions of the dump. A number of levels of advection control are being carried out:

that the older PAF areas will continue to contribute high AMD loadings into seepage during operations until infiltration is controlled. The high temperature zones are not expected to directly affect the alluvium advection barriers. Note that there are still very high temperature zones in the NOEF, and this could potentially cause differential settlement which may affect the integrity of the cover through desiccation effects, but the existing temperature gradient will tend to encourage convective pathways and continued high rates of pyrite oxidation. These advection layers are suitable as an interim measure to control extreme spontaneous combustion, but final control of AMD effects relies on limiting infiltration and transport. Spontaneous combustion was not observed during the site visit, whereas isolated occurrences were observed in the 2017 visit.

- ♦ Interim 0.1-m thick alluvium layers on each PAF lift.
- ♦ Interim 0.5-m thick alluvium layers on older PAF dump areas that will be covered by other dump stages or a 5- to 20-m true thickness halo zones (thinner in the plateau zone) within six months.
- ♦ Interim 0.5- to 1.2-m thick alluvium layers (thinner in the plateau zone), followed by a 0.2- to 1.5-m thick MS-NAF protection layer (thinner in the plateau zone) with on older PAF dump areas that will be exposed for more than six months.
- ♦ Final 5- to 20-m true thickness halo zones (thinner in the plateau zone).

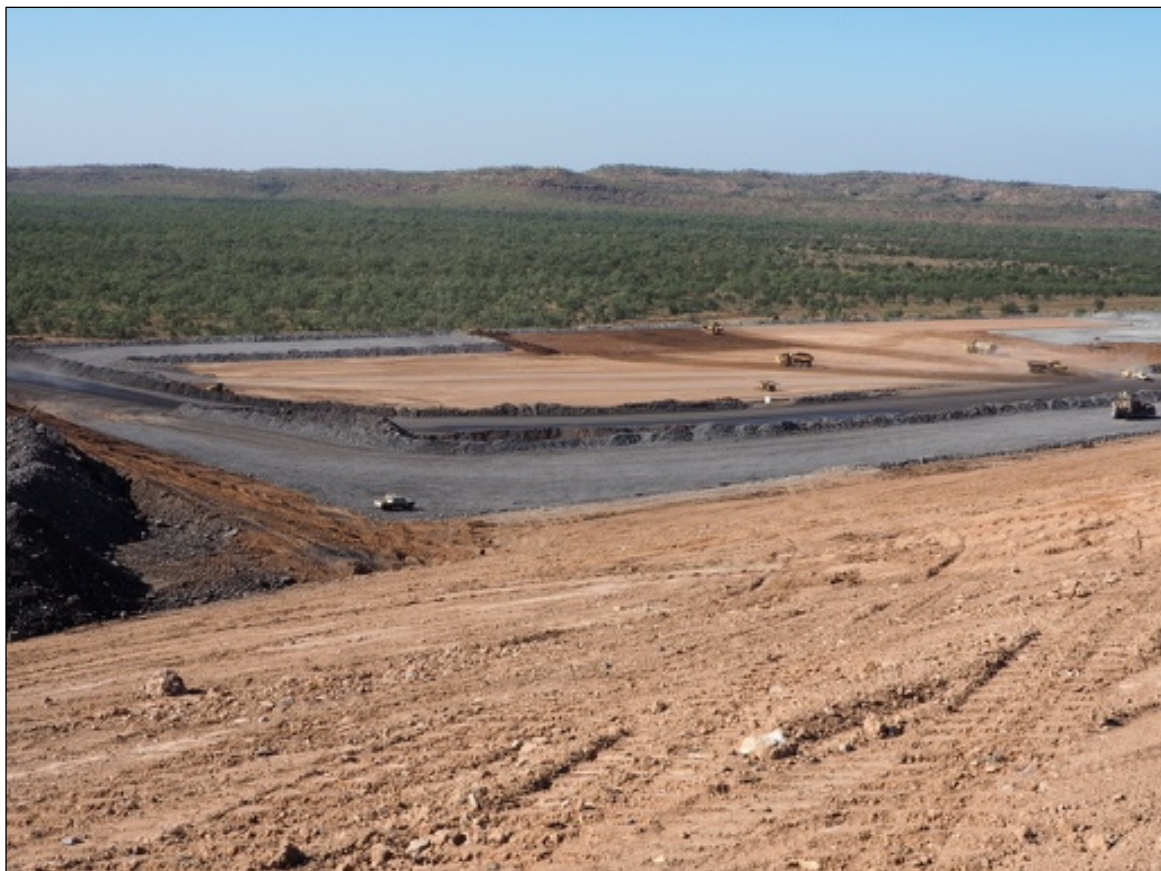
Plate 4.4 – Construction Activities for the Various Components of the CW Stage

As with the previous site visit, it was apparent that the identification and stockpiling of materials suitable for the CCLs and advection barriers was well organised, along with staging the various components of the NOEF construction, including NAF wedge, CCL base, PAF cells, MS-NAF haloes, and advection barriers (Plate 4.4).

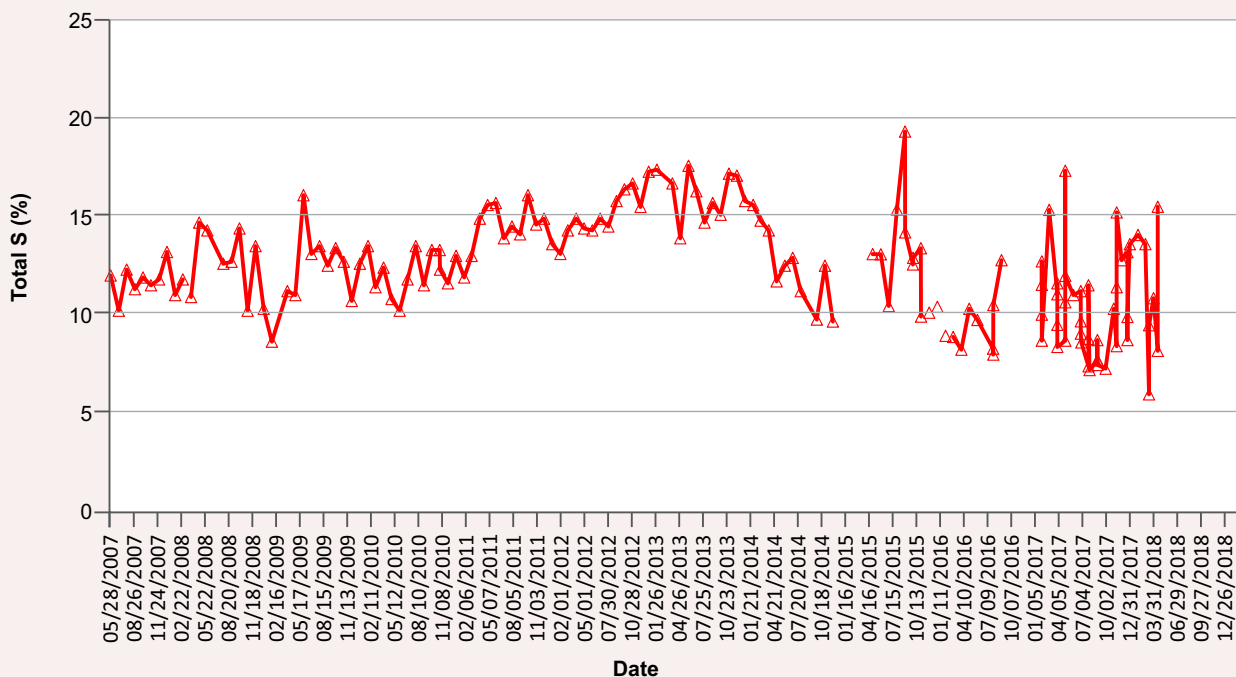
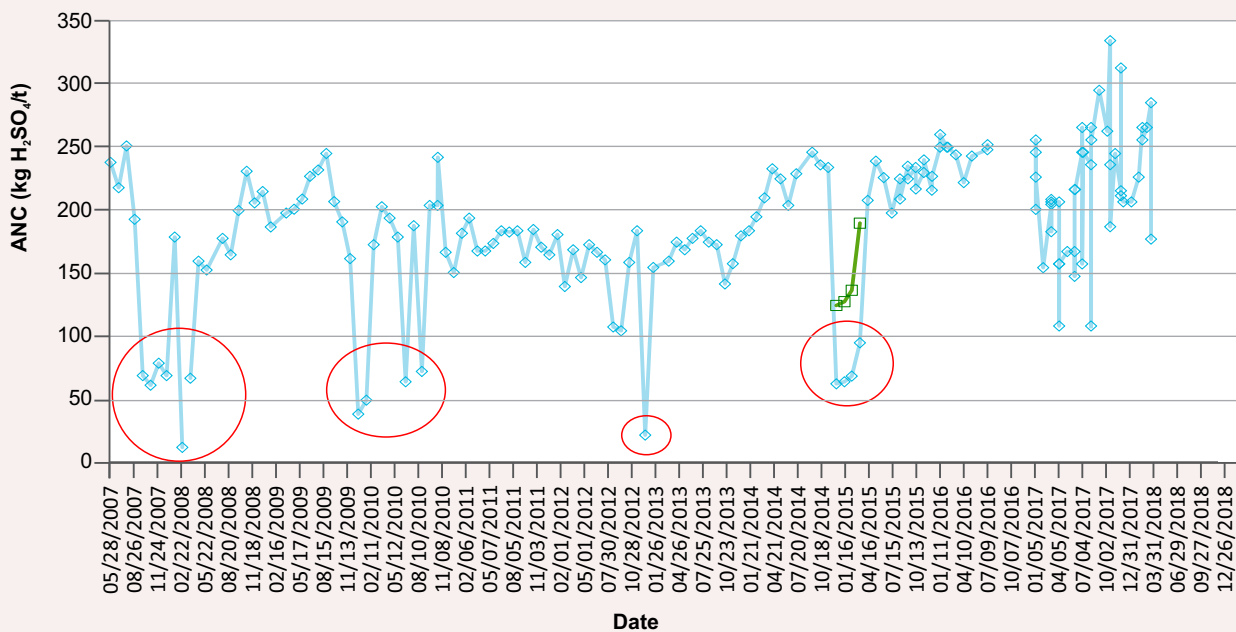
FIGURE 4.26

Tailings S and ANC results provided by MRM from May 2007 to April 2018 are shown in Figure 4.26, and the results from the current IM review period continue to show that the tailings are PAF with very high acid generating capacity, but generally with high ANC, and a lag would be expected before acid conditions develop after exposure to atmospheric oxidation conditions. The lower ANC values for tailings collected in December 2014 to March 2015 were confirmed as anomalous, with the majority of tailings samples having high ANC of greater than 150 kg H₂SO₄/t.

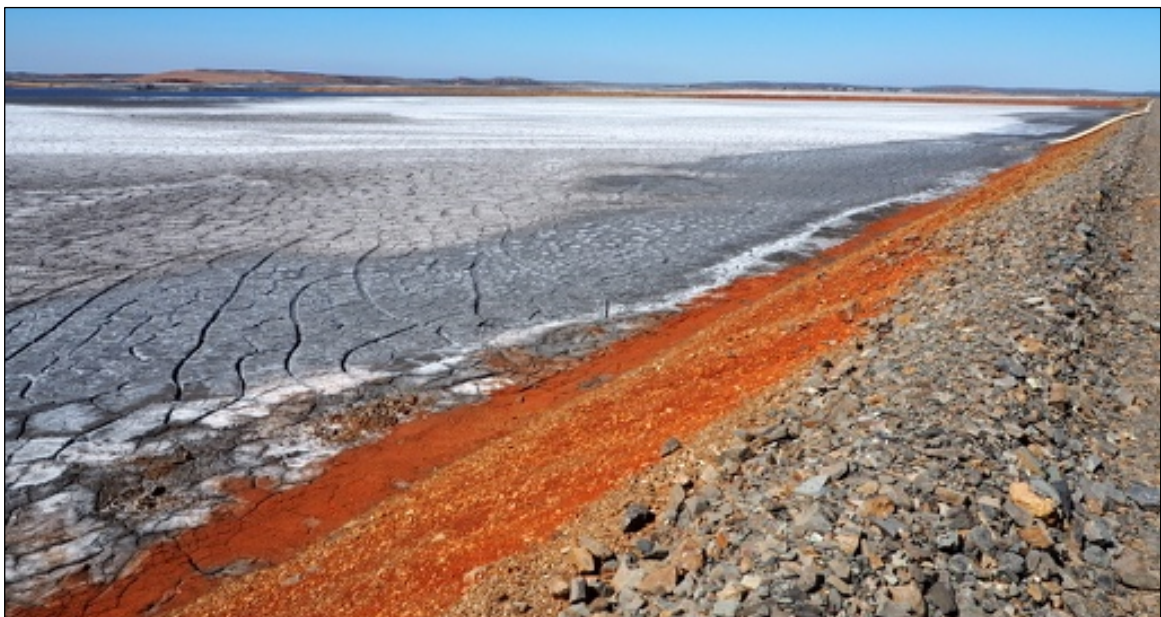
Plate 4.6 – TSF Cell 2 Showing Salt Crusting on Surface

White salts were commonly observed on the tailings beaches during the IM site visit (Plate 4.6), more so than the previous visit, which are primarily expected to be due to drying out of process water. A DPIR site inspection report also noted extensive dry tailings surfaces and dust being generated in September 2017 (DPIR, 2017), and MRM advised that this was temporary while spigots were off line. These observations suggest that the TSF surface is regularly dry, and some surface oxidation of the highly pyritic tailings is undoubtedly occurring. However, results of review and oxygen penetration test work carried out in 2016 and 2017 (Earth Systems 2016a; 2016b; 2017a) and reported in the previous IM report indicate that acid conditions are unlikely to develop within tailings pore water during operations in which only partial surface drying of tailings occurs due to spigot cycling, and maintenance of 80% to 90% saturation.

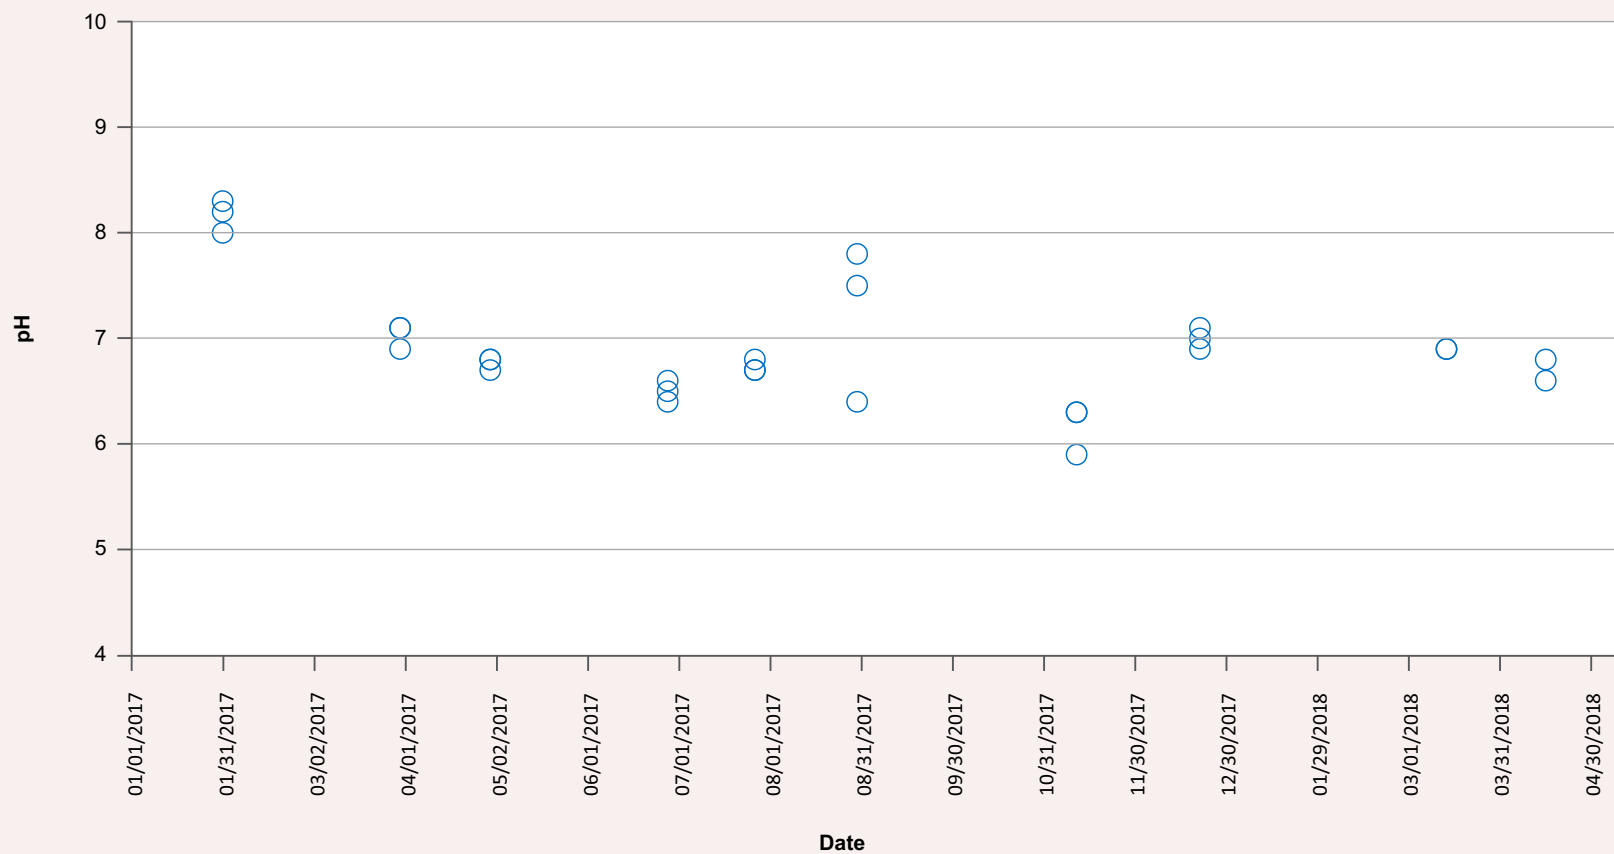
FIGURE 4.27

Surface sampling of deposited dry tailings close to spigot locations was carried out for water extraction testing as per IM recommendations. Figure 4.27 is a plot of saturated paste pH by date, which shows generally circum-neutral pH, except for one sample with a slightly acidic pH of 5.9. These results confirm the lack of significant acid generation from oxidising tailings at the locations sampled. Further clarification of the relative contribution of tailings sulfide oxidation and acid generation to AMD loadings from the TSF is recommended. The surface sampling should continue, and include targeted sampling of TSF surfaces that have been exposed for extended periods with strong salt generation. Sample descriptions would assist interpretation of results. The relative contribution of tailings sulfide oxidation and acid generation will be further addressed in a proposed work program by Earth Systems (2017b).

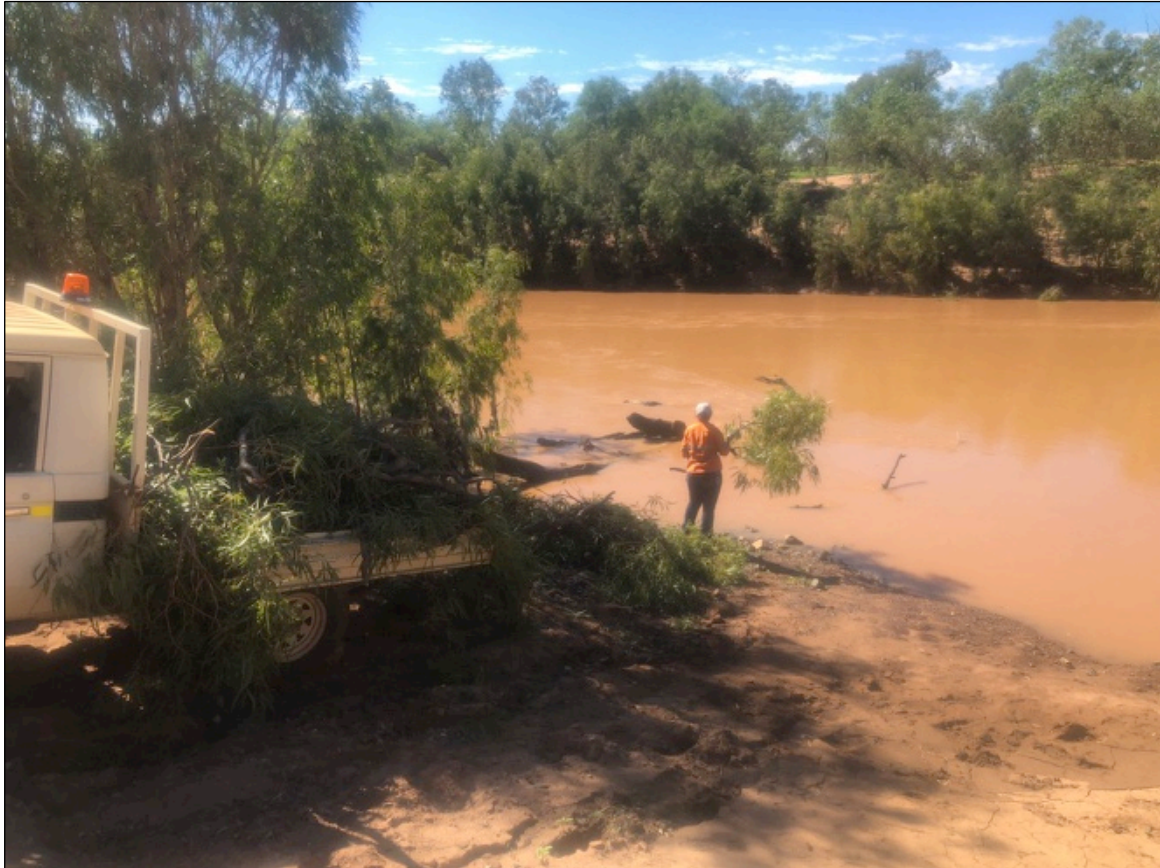
Plate 4.7 – Small Woody Debris Being Placed into the McArthur River Diversion Channel

McArthur River and Barney Creek diversion channels at the end of the wet season. It is hoped that the SWD will be retained in the channel along the banks and behind existing LWD piles to create more complex habitats for small fish and macroinvertebrates.

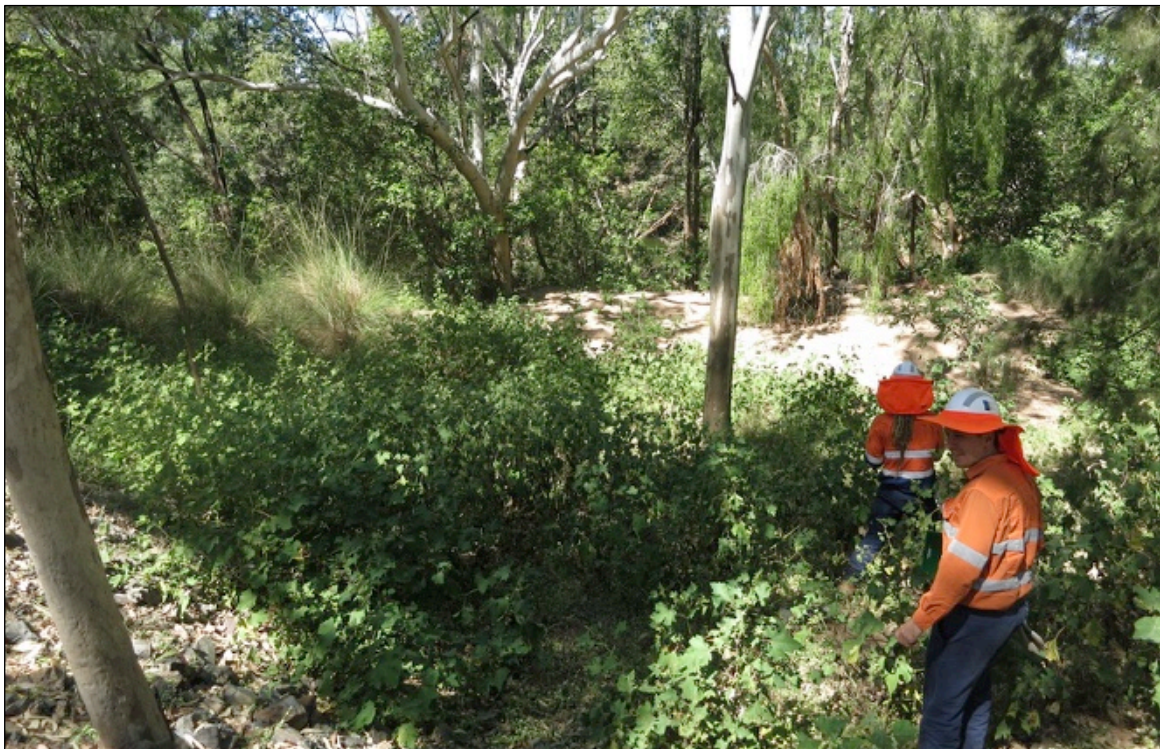
Plate 4.11 – Noogoora Burr Infestation Observed at Djirrinmini Waterhole During the 2018 IM Site Visit

Noogoora burr is still a significant issue at the McArthur River Mine, despite intensive weed control by MRM. Significant stands of this weed were observed during the site visit particularly at Djirrinmini Waterhole (Plate 4.11).

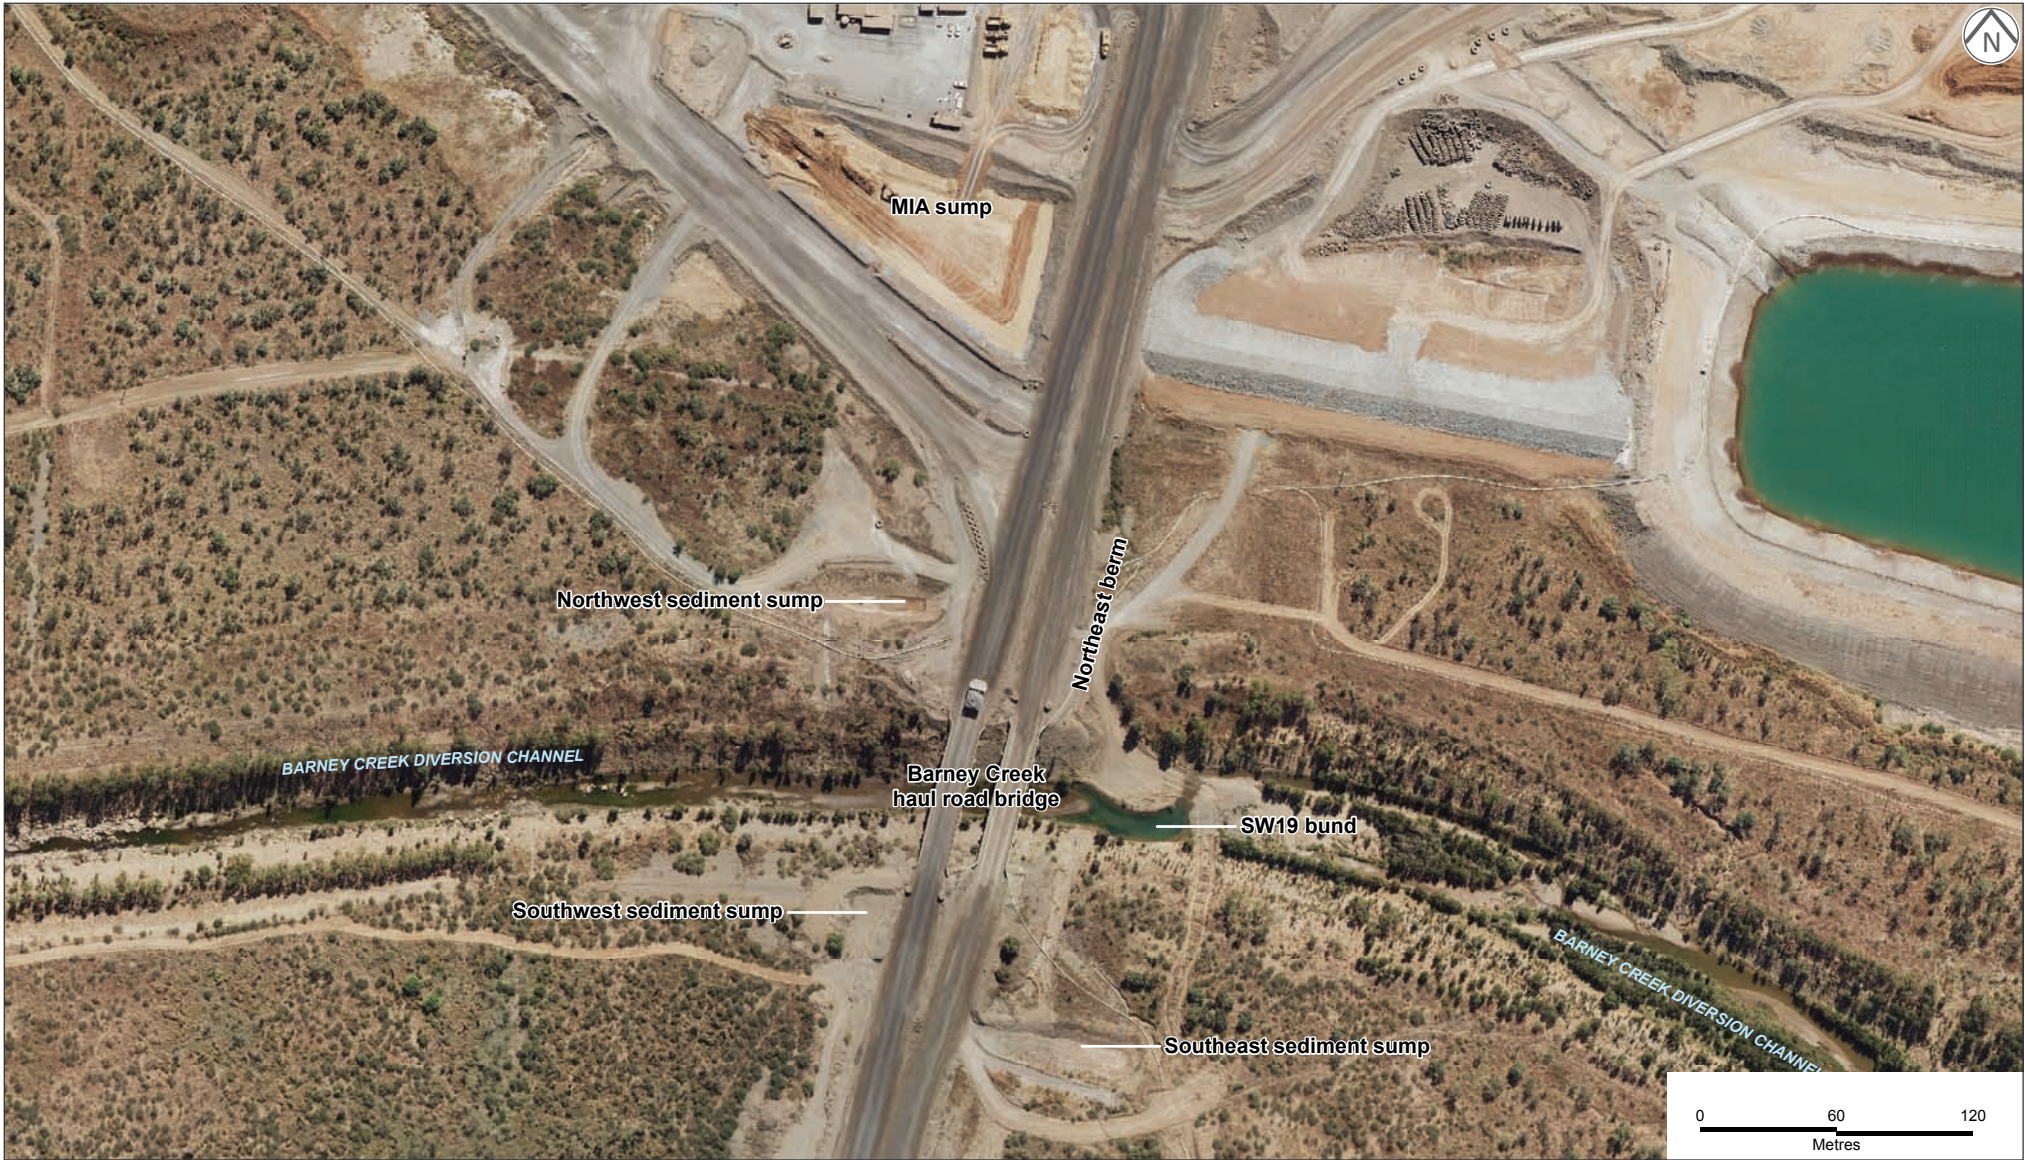
FIGURE 4.43

As indicated in Figure 4.43, additional controls that are specific to fluvial sediments (and reducing input of contaminated sediment) near Barney Creek haul road bridge include:

- ♦ Northeast of the bridge – a berm along the eastern side of the haul road that is maintained to direct runoff across the bridge towards the southeast sediment basin. This, combined with the topography of this quadrant, minimises sediment runoff towards the diversion channel. Recent works in this area are described in Section 4.12.3.2 – New Controls.
- ♦ Immediately downstream of the bridge at FS19/SW19 – a bund/small dam constructed within the Barney Creek diversion channel during the 2014 operational year to capture contaminated water and sediment (although flow still occurs to varying degrees in all but the driest months).

- ♦ To the northwest of FS19, the MIA (Mine Infrastructure Area) sump (see Figure 4.43) was under construction during the 2017 and 2018 site visits. This new sump is designed to capture sediment and contaminated runoff from adjacent haul roads, and particularly the roads to the south/southwest of the NOEF. It is designed for a 1-in-10 year 36-hour rainfall event (MRM, 2017b) and is expected to reduce inputs to the existing sediment sump northwest of the haul road bridge. The MIA sump has been constructed with a compacted clay liner and an HDPE liner. While construction of the sump itself was completed during 2017, completion of the associated inlet culvert and drainage works is expected during the 2018 dry season (i.e., before November 2018).

- ♦ Sediment containment structures to the northwest (NW), southwest (SW) and southeast (SE) of Barney Creek haul road bridge, along with water diversion structures to the northeast of the bridge, were assessed and upgraded during 2017 (MRM, 2018b), as follows (see Figure 4.43):

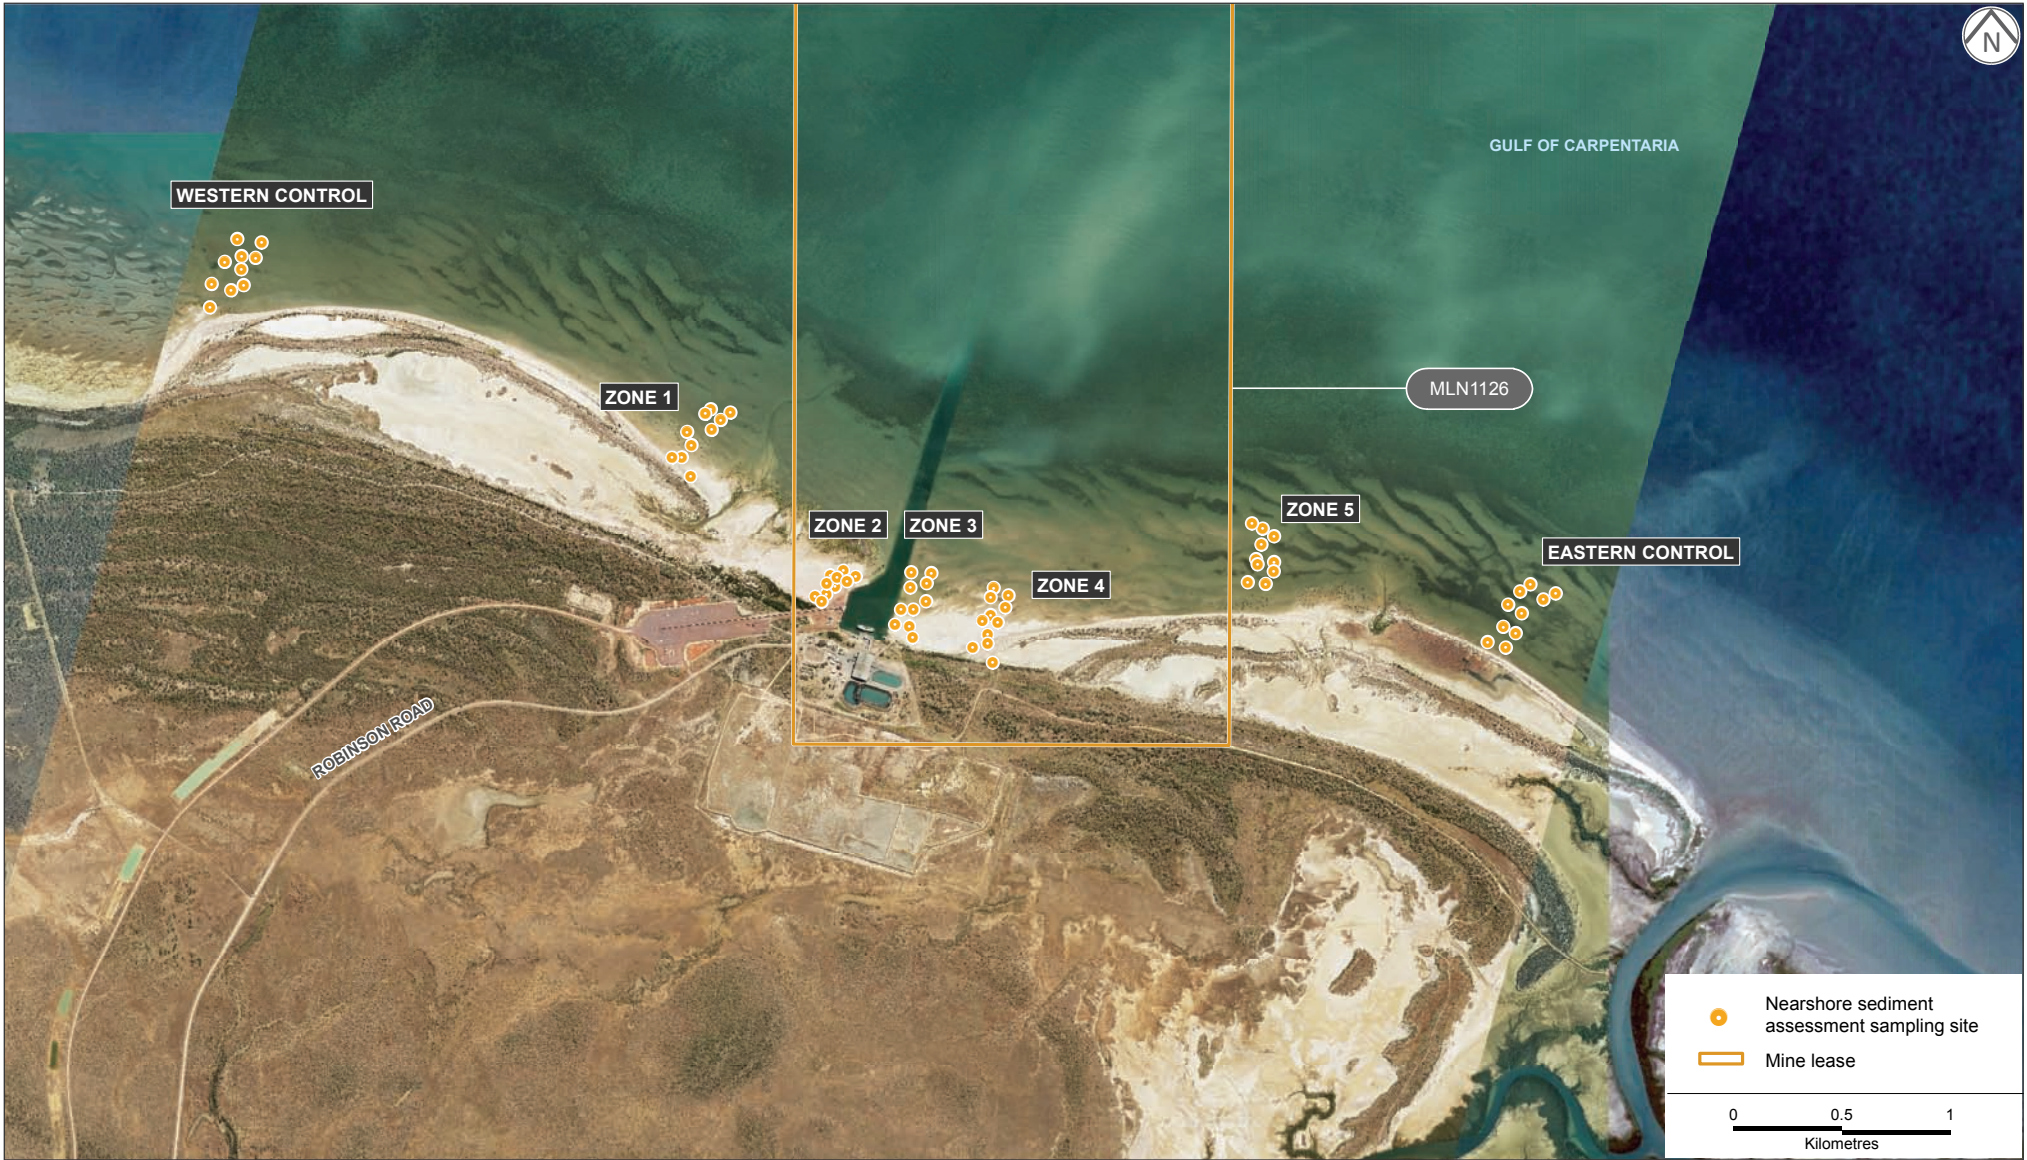
FIGURE 4.45

In Zone 2, immediately to the west of the swing basin (see Figure 4.45), one site (Z2-3) had minor exceedances of Pb and Zn SQGVs, and somewhat elevated Cd and Cu, while all other results in this zone remained low. Indo-Pacific Environmental (IPE, 2018b) notes that these localised elevated results were likely due to dust deposition from MRM's activities at Bing Bong Loading Facility, combined with limited flushing of the inshore section of Zone 2. Specifically, dust emissions from the concentrate storage shed and/or dust generated during loading of concentrate onto the MV Aburri may have contributed to nearshore sediment contamination near the swing basin.

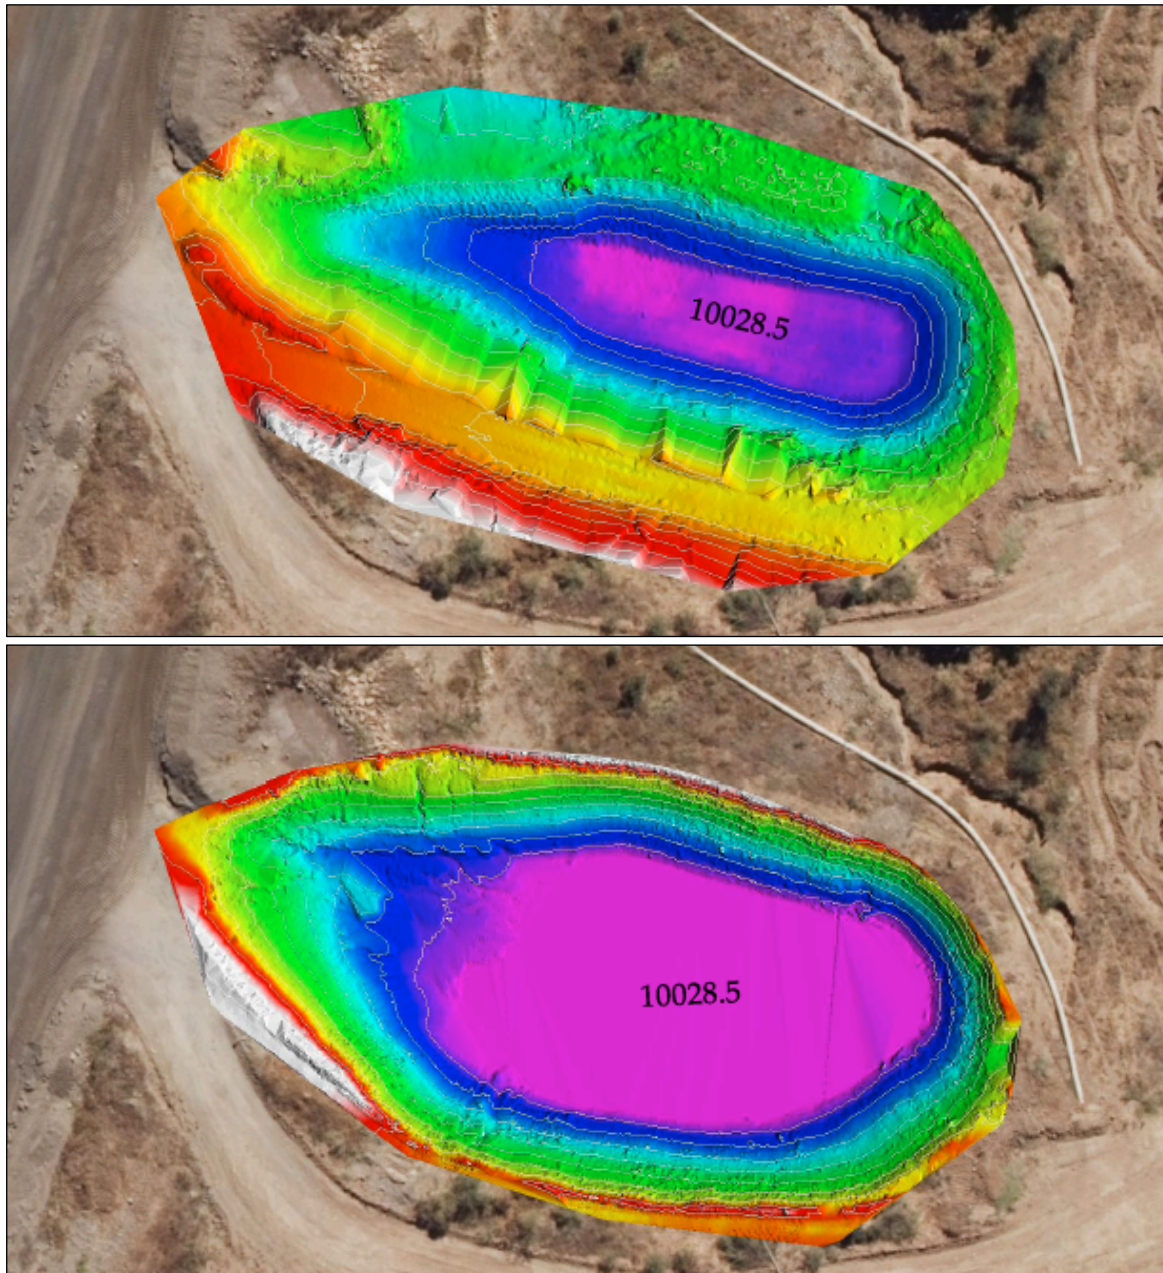
- Based on the above assessment, SE sump was expanded towards the south to meet the increased capacity requirement (Plate 4.12). Land to the south of SE sump was filled/raised, and the sump bunded, with a drain to divert clean runoff directly to Barney Creek diversion channel. The sump spillway was moved from the north to the east to reduce erosion/stability risks from floodwaters.

Plate 4.12 – Upgrades to Haul Road Bridge Southeast Sump (Before/After)

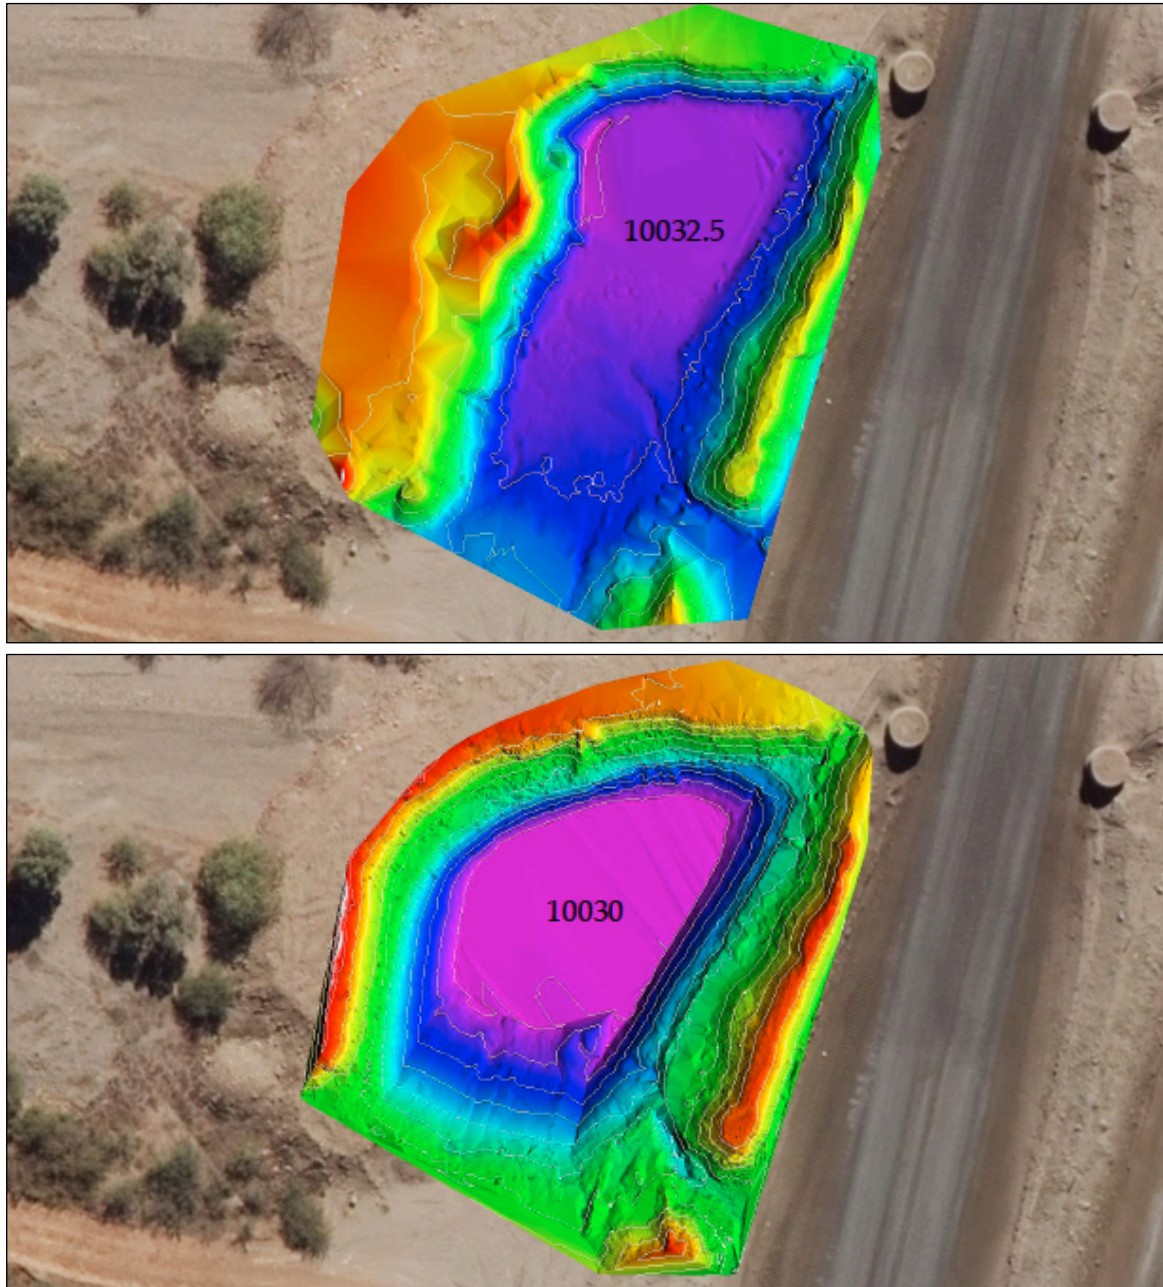
- The SW sump was deepened and expanded towards the west (Plate 4.13).
- Works were undertaken to prevent clean runoff from entering NW sump. The sump was expanded to the north (Plate 4.14).
- The upgraded sumps are designed to have capacity for up to 1-in-10 year floods.
- Following construction of new sump pumps/electrical infrastructure to the northeast of the bridge, the associated new access point had potential to divert impacted runoff from

Plate 4.13 – Upgrades to Haul Road Bridge Southwest Sump (Before/After)

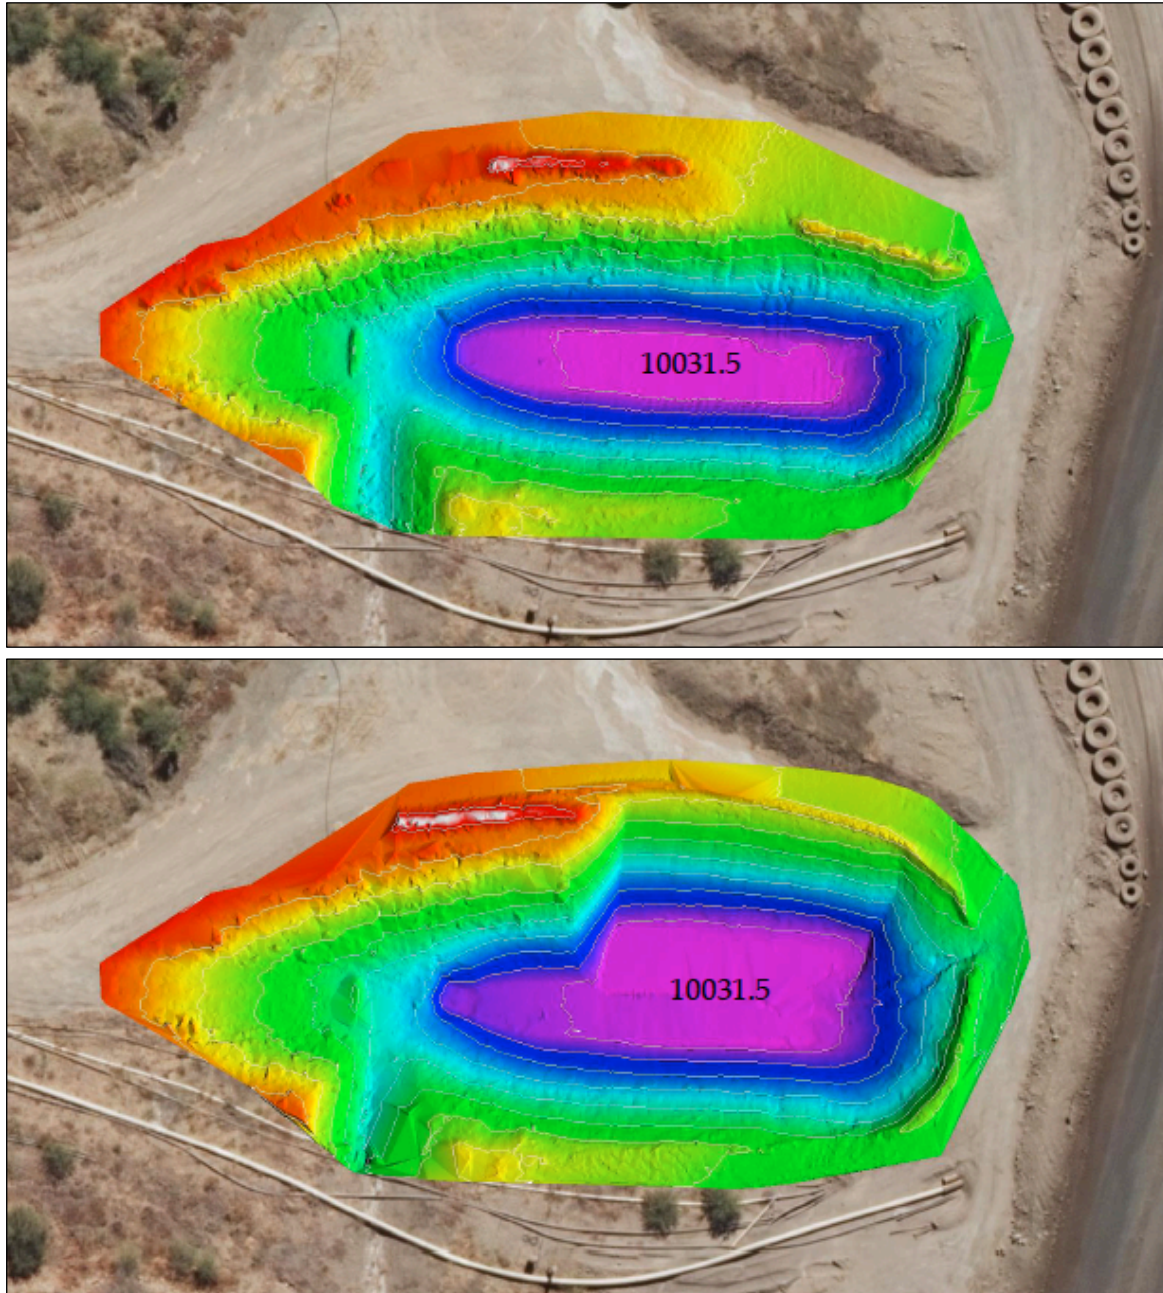
Plate 4.14 – Upgrades to Haul Road Bridge Northwest Sump (Before/After)
