Independent Monitor ENVIRONMENTAL PERFORMANCE ANNUAL REPORT 2017-2018

McARTHUR RIVER MINE

SEPTEMBER 2018
Report No. 01164F_1_v2

**Independent Monitor
Environmental Performance Annual Report
2017-2018**

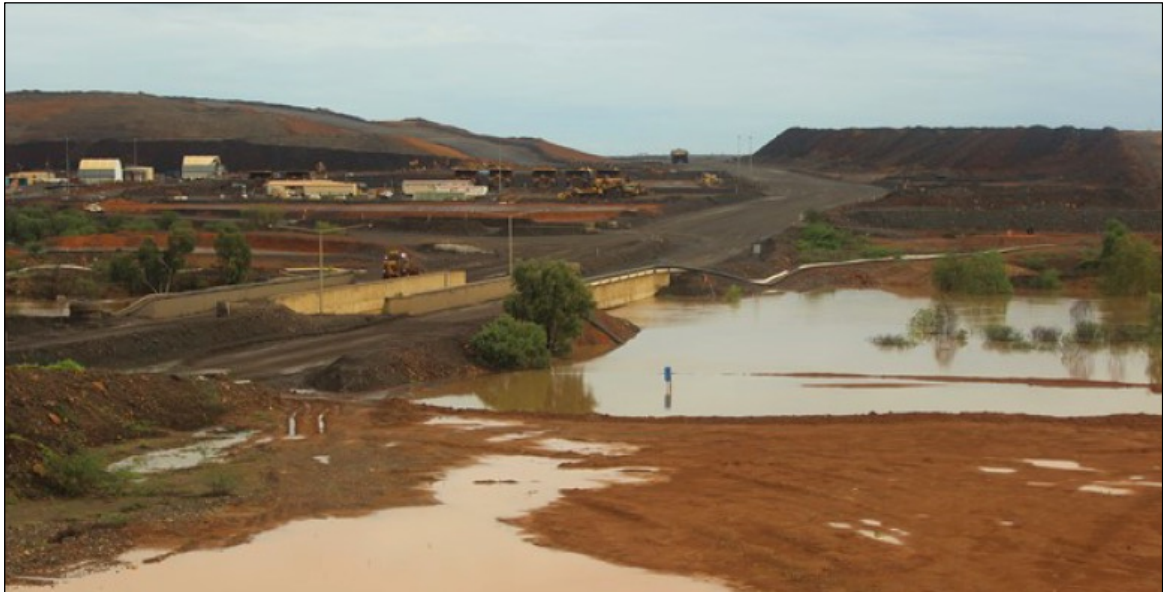
Given that the sumps are designed for a 1-in-10 year flood and are known to be completely submerged during significant flood events (Plate 4.15), the IM commends the above update to MRM's position, and considers that at least annual cleanout of these sumps is essential, along with monitoring of sediment levels after significant rainfall/runoff events.

Plate 4.15 – Flooding Below Barney Creek Haul Road Bridge, 27 January 2018

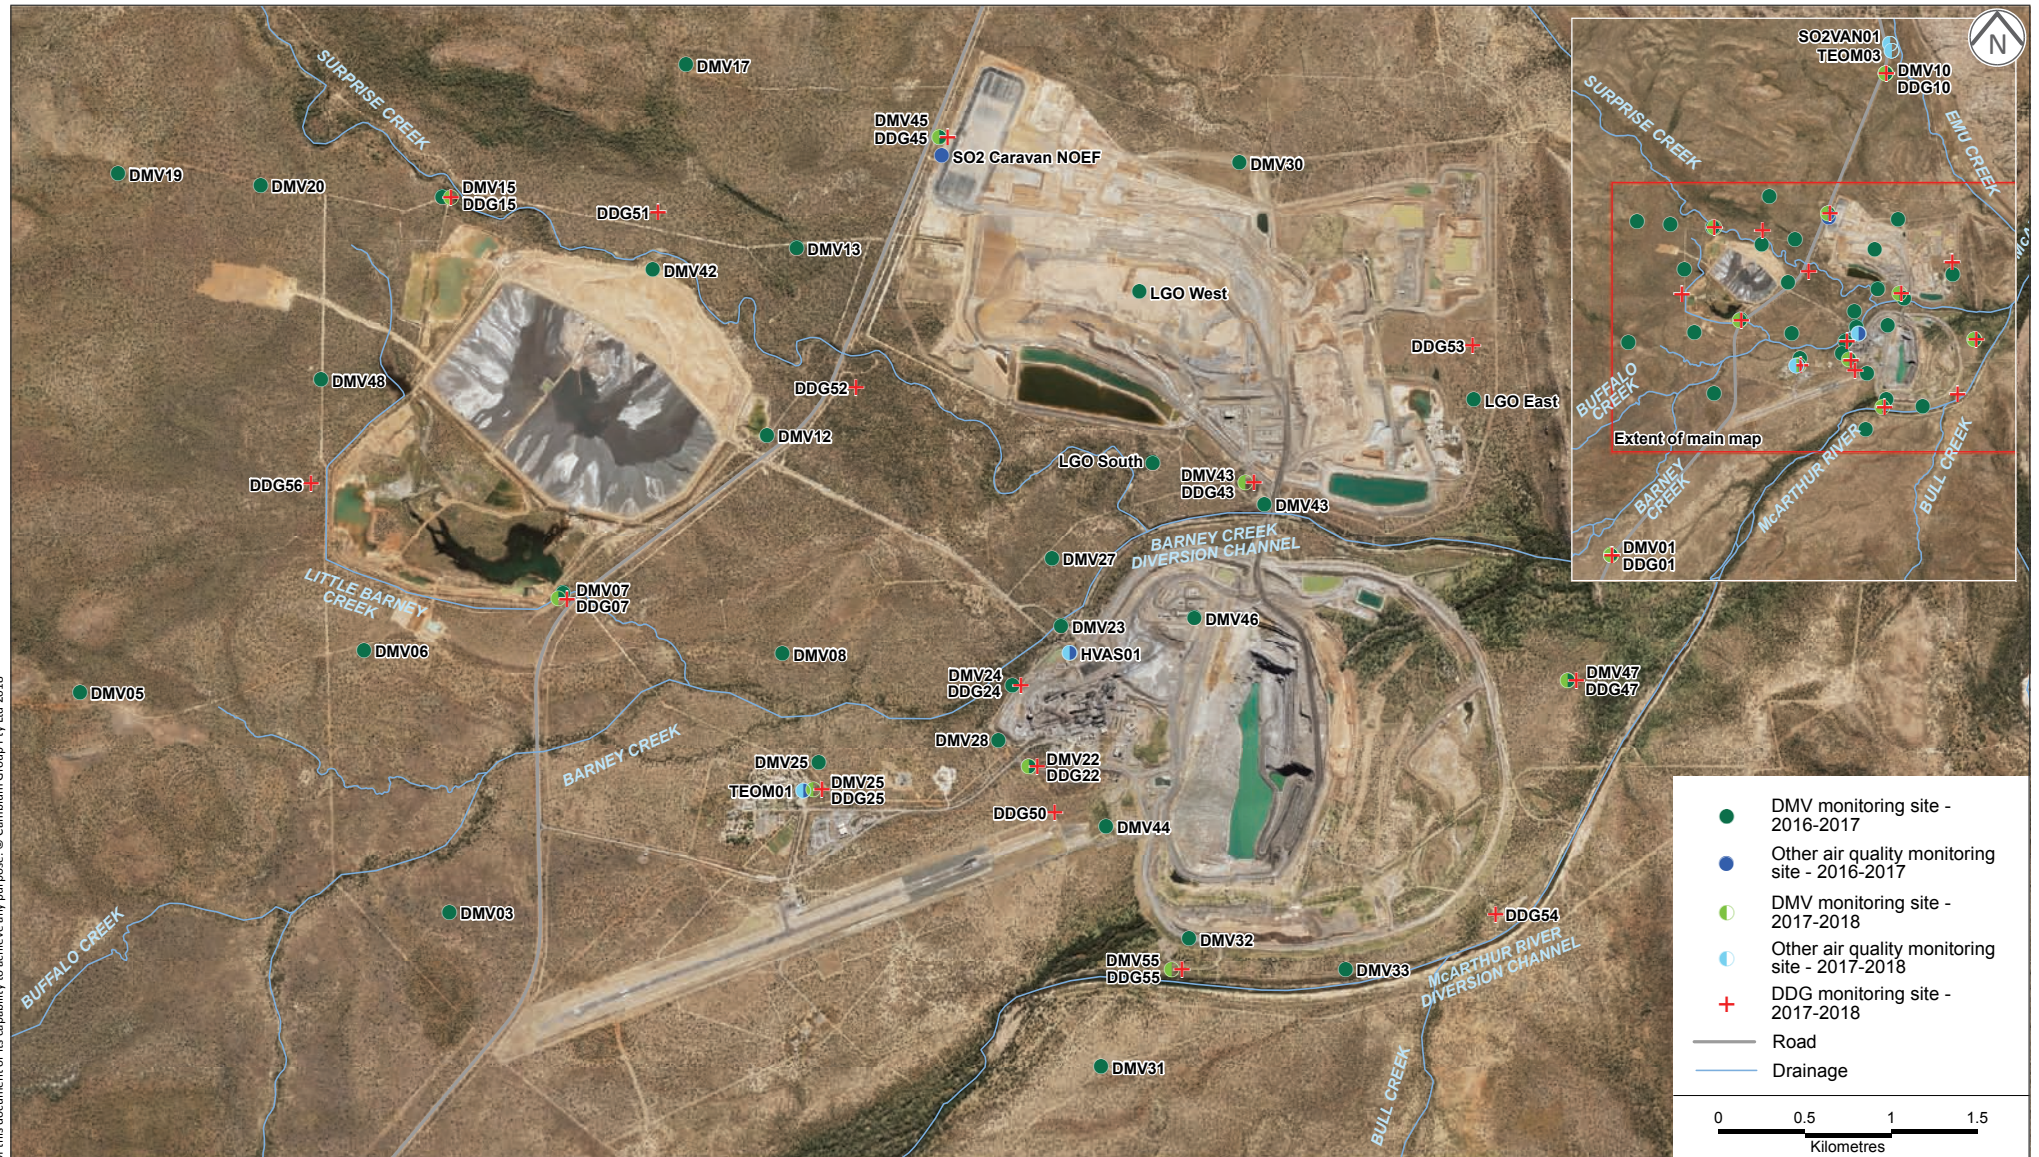
FIGURE 4.47

- ♦ Between April 2017 and March 2018, 14 DMV sites in the vicinity of the mine were decommissioned, while 10 DMV sites were moved or replaced with another site within approximately 700 m of their previous location (TAS, 2018) (see Figure 4.47, Table 4.64). Section 7.1.5 (Figure 7-4) of TAS (2018) implies that the retained DMV sites include those with the most noteworthy exceedances in recent years.
- ♦ While there are now fewer DMV sites (10 in total), the sampling frequency of these monitors has increased from 24 hours once per month to approximately once every 12 days (TAS, 2018).
- ♦ Previous monitoring has demonstrated that while metals other than Pb and Zn (e.g., Cd, As and Hg) may be present as a component of particulate matter emissions at the mine site, the emissions of these metals are consistently further below their applicable criteria. As such,

- ♦ The maximum Pb concentration standard of 0.5 µg/m³ was again exceeded during individual 24-hour periods⁴ at three sites within 1 km to the west or southwest of the processing plant (DMV22, 24 and 28; see Figure 4.47, Table 4.66). Ore/concentrate materials processed by the facilities in this vicinity are likely to be the source of these dust exceedances. While eight exceedances (out of 34 sampling events (24%)) were recorded at these three sites in the previous reporting period, there were 17 (out of 42 (40%)) in the current period.
