# Independent Monitor **COMMUNITY REPORT**

McARTHUR RIVER MINE

November 2016

## Environmental Performance 2015

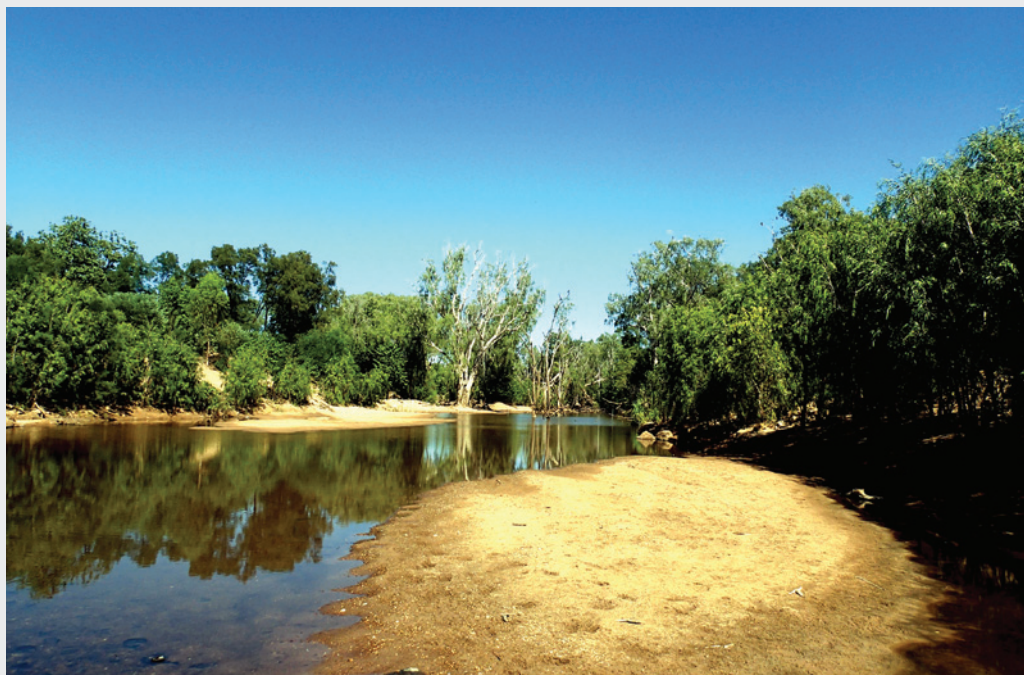
McArthur River diversion channel (upper) looking towards main river

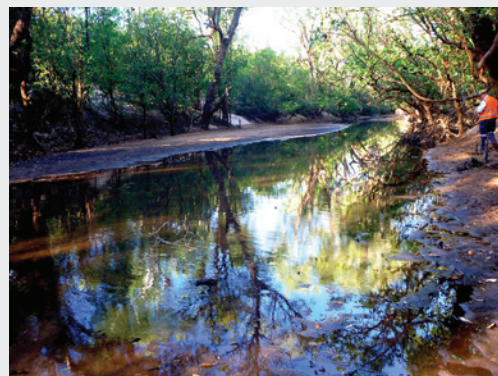
- The surface water monitoring program should be reviewed on an ongoing basis to ensure that sufficient early warning is provided of potential impacts on water quality from runoff or leachate from mine facilities.
- In the McArthur River just downstream of the mine, elevated sulfate concentrations and conductivity levels have been identified – MRM should undertake a risk assessment identifying likely causes, possible implications, and mitigation measures if appropriate.

McArthur River at the compliance point downstream of the mine site

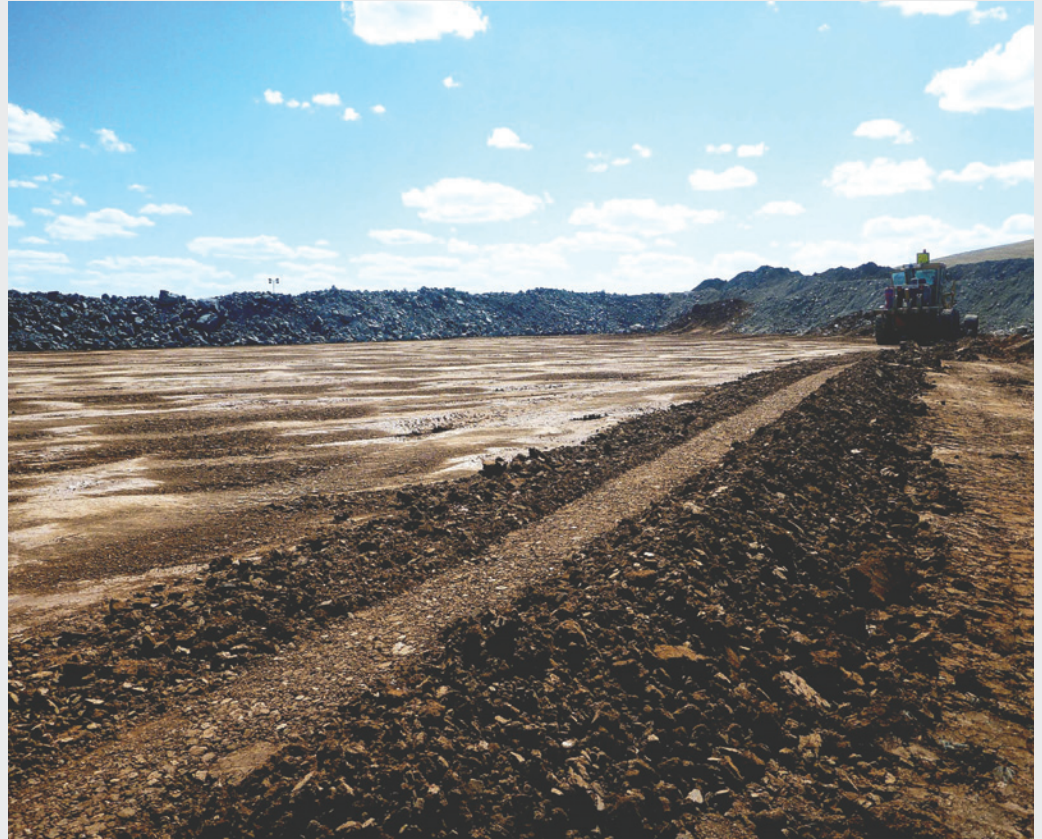
*NOEF compacted base with waste rock placed over top*

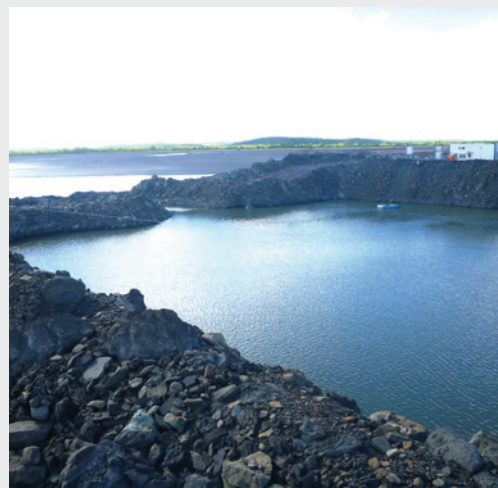
MRM has continued to avoid storing excess water at the TSF – a safer method of operation that minimises risks of bank failure, seepage and/or overtopping. Excess water is now being reclaimed and reused for ore processing activities.

*Water reclamation from the TSF*

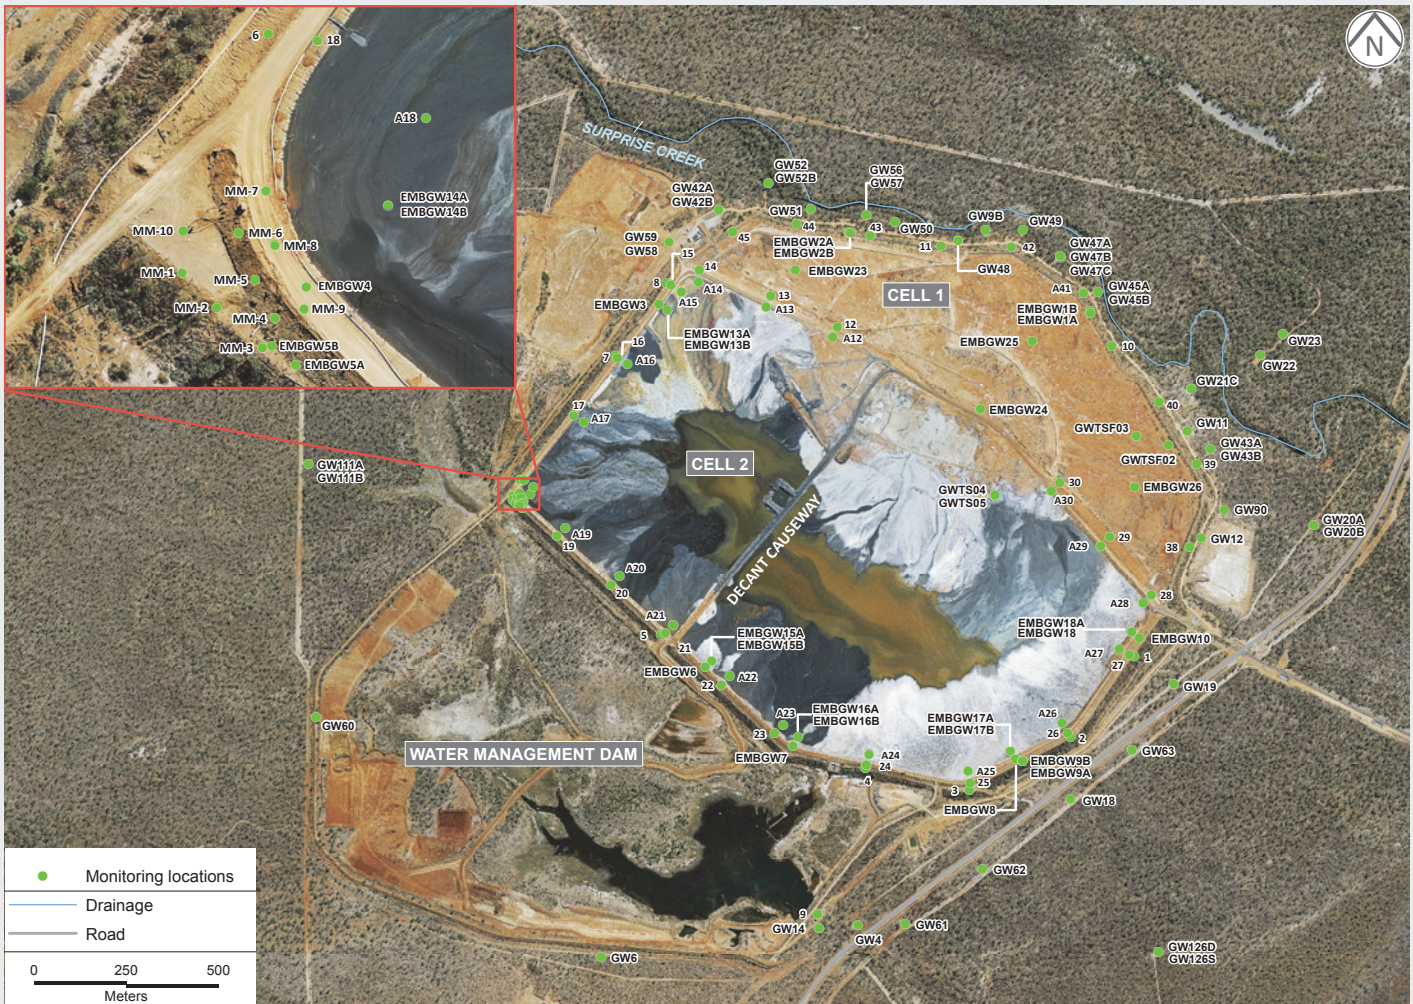
Overview of TSF showing locations of monitoring sites

- Capping is eroded in places, and ongoing repairs are localised. As such, runoff sometimes comes into contact with tailings below the cap, contaminating that water. The IM recommends that MRM install an improved cover that withstands erosion and prevents water infiltration.
- Seepage towards Surprise Creek appears to have reduced during 2015 (which was a dry year), however it is an ongoing issue, which existing measures are not adequately controlling. The IM recommends that MRM review the strategy for managing water and seepage.

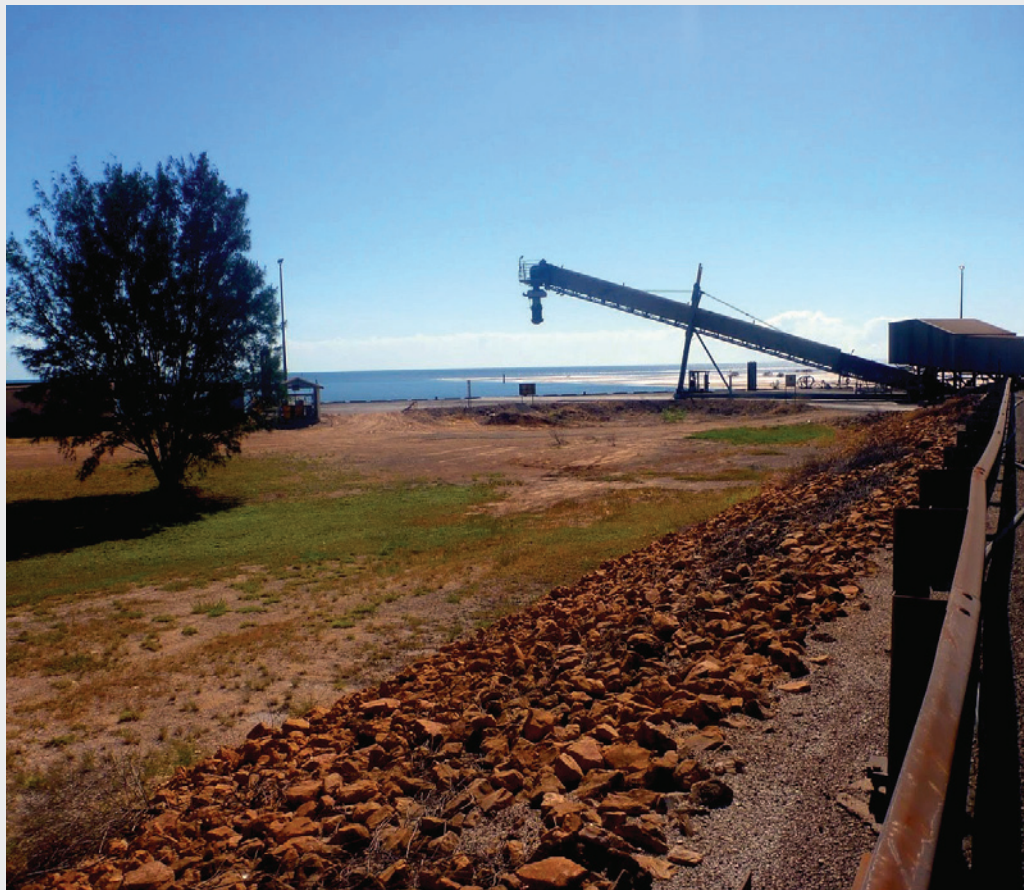
At Bing Bong Loading Facility, management of dust resulting from MRM's activities is an ongoing issue. However, environmental impacts of the facility are limited.

*Ship loader at Bing Bong Loading Facility*

- The bitumen surface surrounding the loading facility should be repaired to avoid dust and potential for contamination of underlying soils – MRM plan to do this during 2016.
- The doors of the concentrate shed have not been able to be closed for at least the past three years. This is a likely cause of dust issues in the local area, and the IM recommends they be repaired as soon as possible.

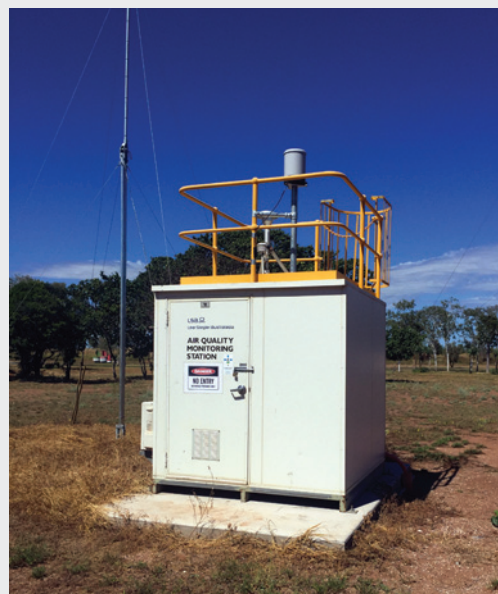
- Despite the past 14 months having been drier than usual, less dust was present around the facility compared to 2015.
- The dust extraction system in the concentrate shed has been repaired.
- During 2015, MRM installed a more permanent dust monitoring station. Results from this will be reported next year.

*Air quality monitoring station at Bing Bong Loading Facility*
