RUM JUNGLE Rehabilitation Project

Report prepared by T.J.Verhoeven for the Australian Mining Industry Council International Environmental Workshop

Darwin September 1988 The Rum Jungle Rehabilitation Project was a Commonwealth funded project managed by the Northern Territory Government. It was aimed at substantially reducing the adverse environmental effects of the mining and milling of uranium and other metals at Rum Jungle between 1952 and 1971. The Project's civil works were completed between 1982 and 1986, and an ongoing monitoring and preventative maintenance program has been conducted to August 1988.

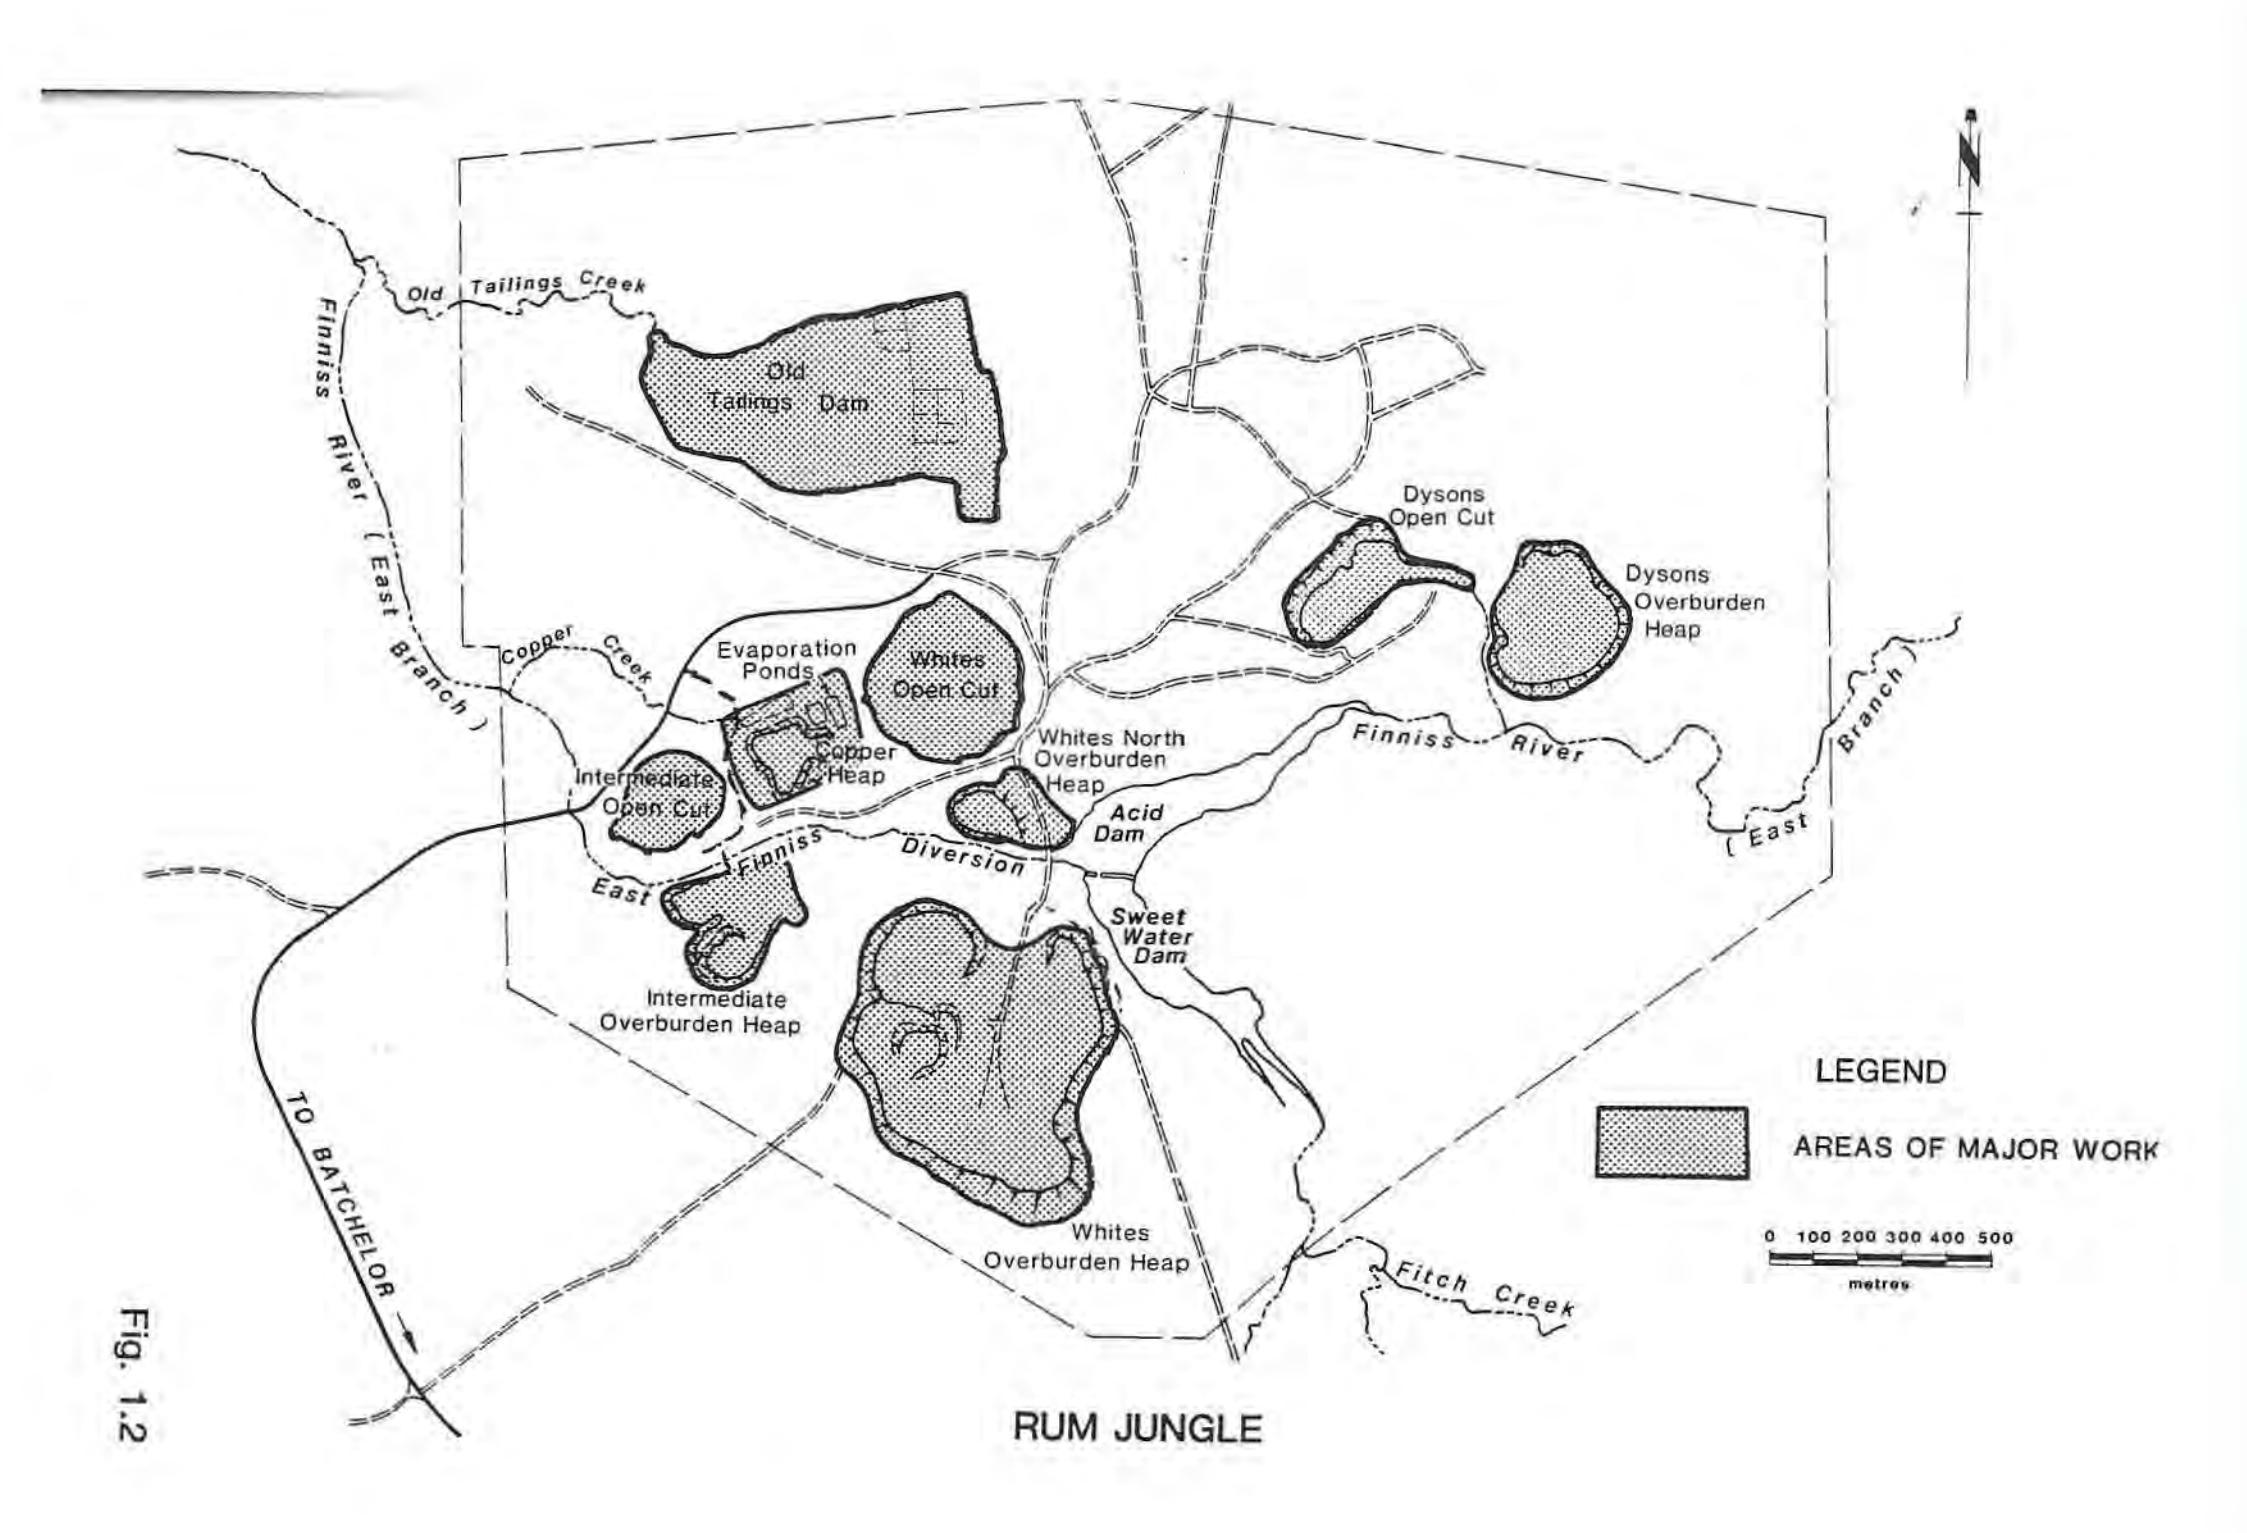
Territory Enterprises, a subsidiary of Consolidated Zinc Pty Ltd (now CRA Limited) commenced mining and exploration at Rum Jungle on behalf of the Australian Government. Mining was initially by underground methods, followed in 1954 by the development of Whites Open Cut. Mining continued until 1969; the sequence is summarised in Table 1.2, and shown on a plan of the site as Figure 1.2.

The principal sources of pollution (shown in Figure 1.2) were:

- The Copper Heap Leach Pile and four overburden heaps - Whites, Whites North, Intermediate and Dysons - were oxidising producing acid mine drainage, which was the most serious form of pollution of the surface water and groundwater systems.
- . Three open cut pits Whites, Intermediate and Dysons - were filled with wastes and acidic water, polluting the water environment and proving hazardous to public health.
 - The tailings dam, which was being eroded, had already contributed 150,000 tonnes of acidic wastes containing heavy metals and low levels of radioactivity to the river. It was aesthetically disasterous.

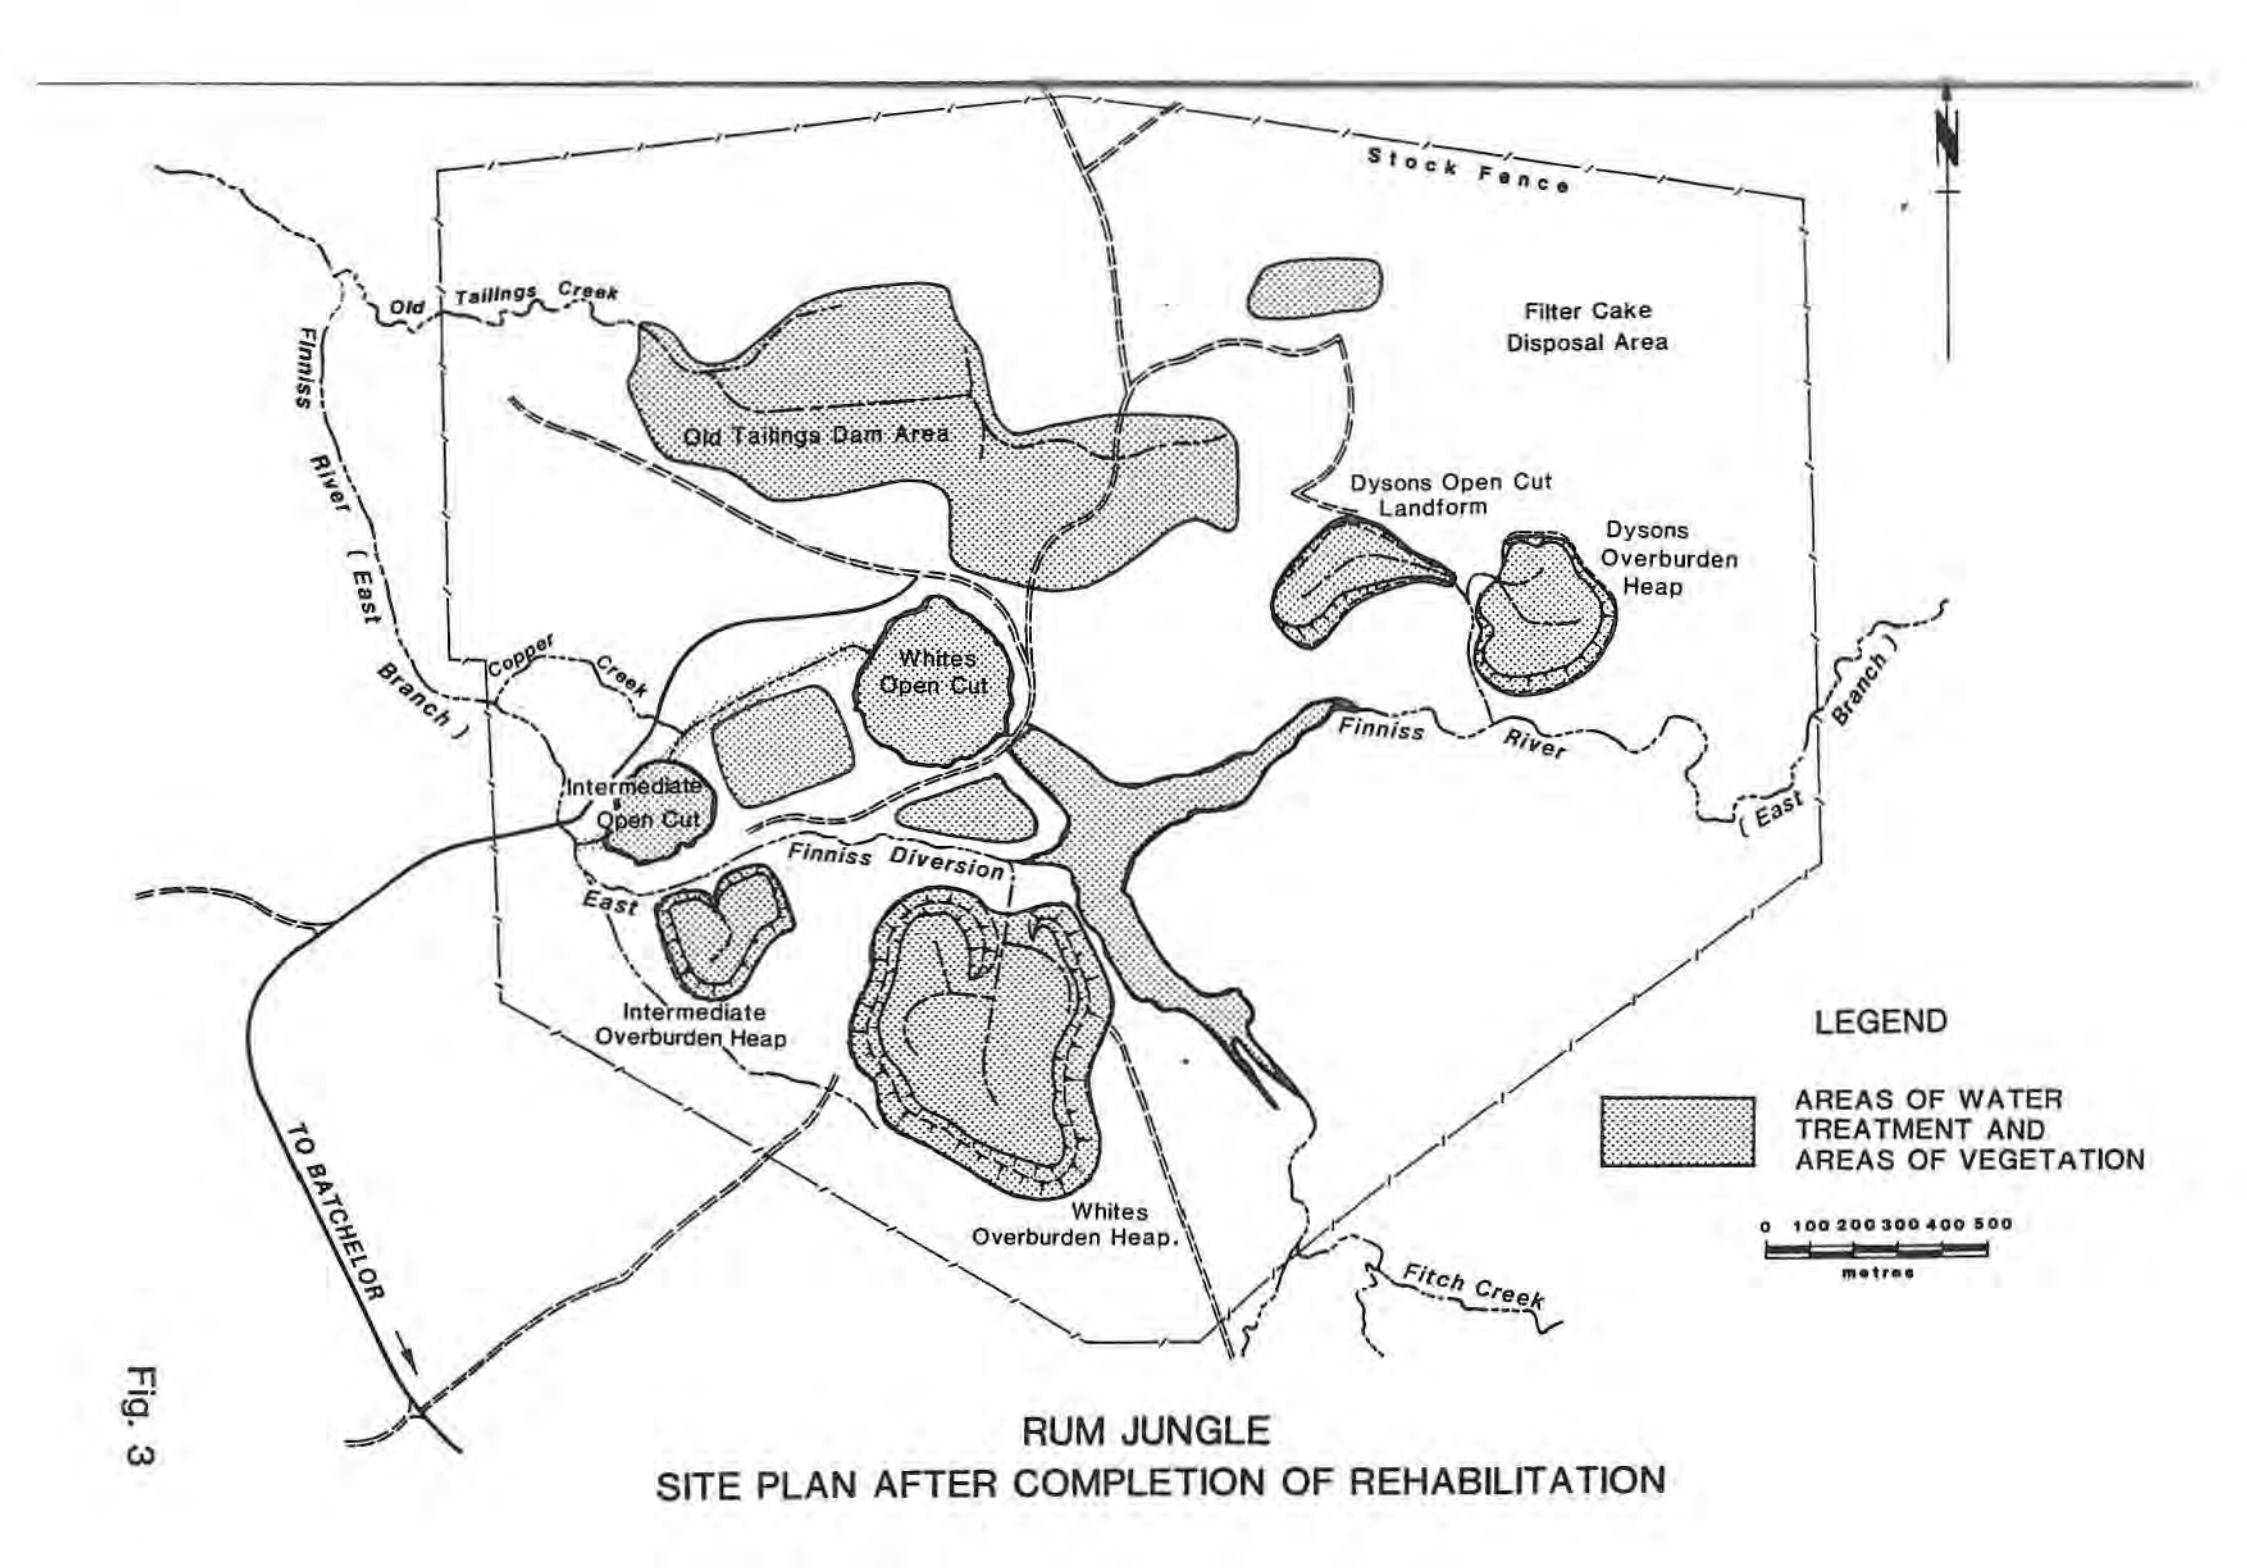
Rehabilitation works completed (scope shown in Figure 3) include:

- Removal of Whites North Overburden Heap to Whites Overburden Heap.
- Reshaping of Whites, Intermediate and Dysons Overburden Heaps, construction of low permeability cover systems, construction of drainage, vegetation of the covers (Section 3.1).

- Burial in Dysons Open Cut of tailings and affected subsoils (from Tailings Dam), together with the Copper Heap Leach Pile and associated subsoils. Cover of the land fill, construction of drainage, vegetation of the cover (Section 3.2). Rehabilitation of the Tailings Dam and Copper Heap Leach Pile areas.

- Construction of a water treatment plant to treat polluted water in Whites and Intermediate Open Cuts. After completion of treatment, the East Branch of the Finniss River was rediverted through the open cuts (Section 3.3).

- Clean up and/or revegetation of other areas including the Treatment Plant and Stockpile areas, borrow pits and haul roads, the Acid Dam, and the Sweetwater Dam (Section 3.4).

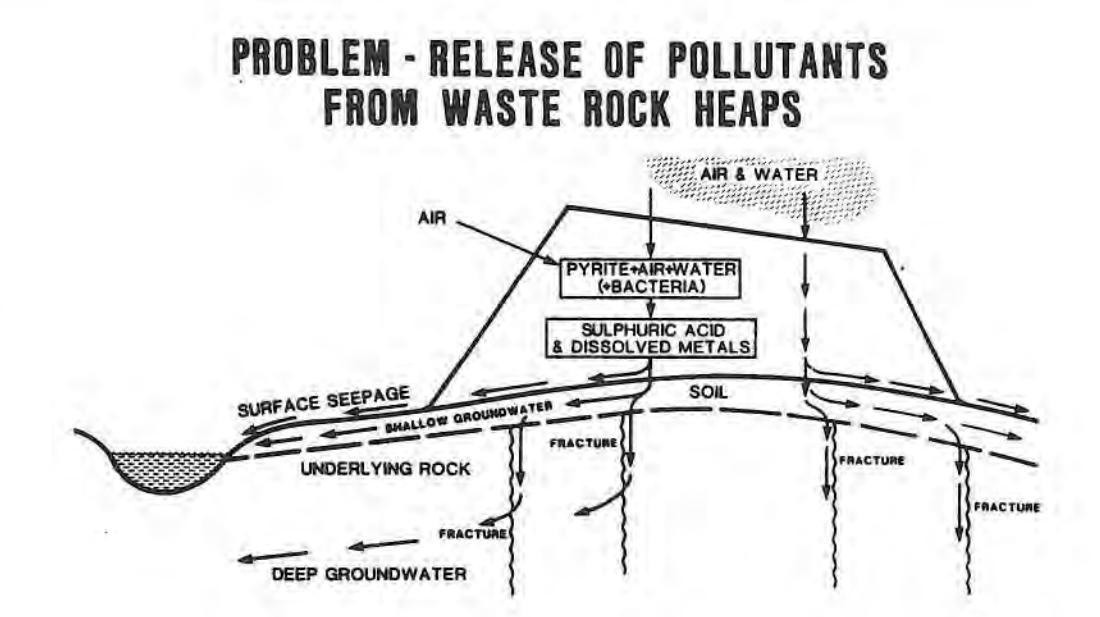
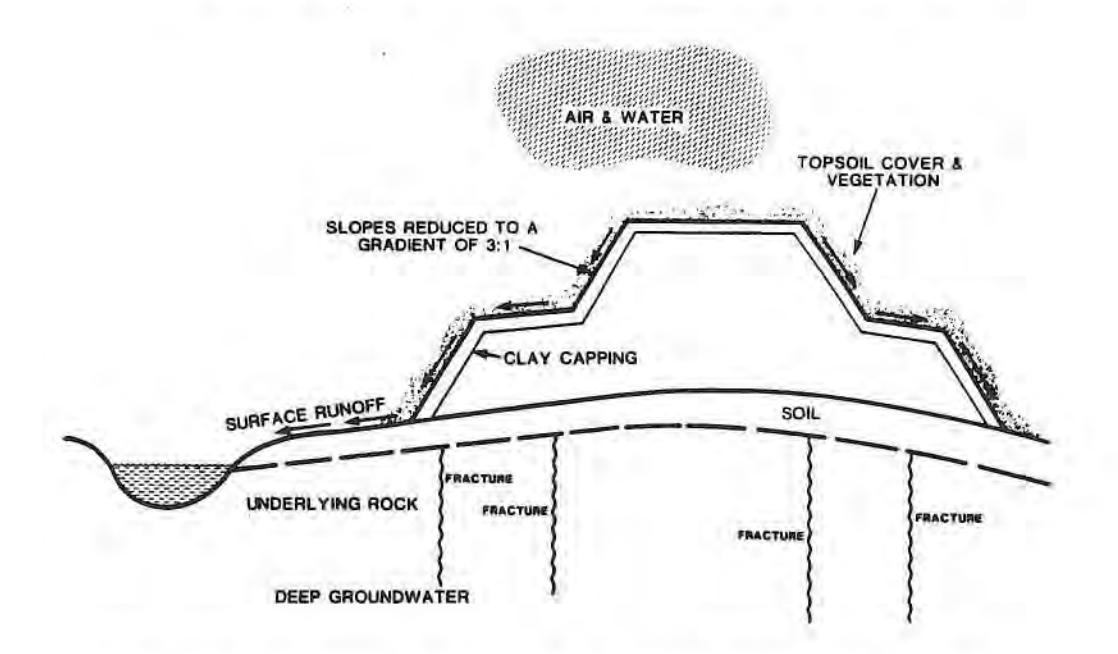
REHABILITATION OF THE OVERBURDEN HEAPS

WASTE ROCK IN THE WASTE ROCK HEAPS CONTAINS ABOUT 5% PYRITE. AN IRON SULPHIDE MINERAL. PYRITE REACTS WITH AIR AND WATER TO FORM A SULPHURIC ACID SOLUTION WHICH ALSO CONTAINS HIGH LEVELS OF IRON, COPPER, ZINC, COBALT AND NICKEL. THIS PROCESS IS GREATLY ACCELERATED BY BACTERIA WHICH EXIST IN THE RUM JUNGLE OVERBURDEN HEAPS.

POLLUTED WATER CAN EMERGE FROM THE WASTE ROCK HEAPS EITHER AS SURFACE SEEPAGE, IN SHALLOW GROUNDWATER, OR WATER CAN PERCOLATE THROUGH FRACTURES IN THE UNDERLYING ROCK AND ENTER DEEP GROUNDWATER. FISH KILLS MAY OCCUR WHEN THIS WATER DRAINS INTO THE FINNISS RIVER.

SOLUTION - RESHAPING, CAPPING WITH COMPACTED CLAY AND REVEGETATION

WASTE ROCK DUMPS AT RUM JUNGLE WERE RESHAPED TO GIVE GENTLE SLOPES AND CONTOURED DRAINAGE CHANNELS. A COMPACTED CLAY CAPPING WAS PLACED OVER THE RESHAPED DUMPS, PREVENTING AIR AND WATER ENTERING THE DUMPS. PRODUCTION OF SULPHURIC ACID IS REDUCED AND WATER QUALITY IN THE FINNISS RIVER WILL IMPROVE.

Each of the overburden heaps contains varying amounts of pyritic ore and various zones within the heaps had been shown to be subject to pyritic oxidation. Briefly, sulphides contained in the pyritic ore oxidised to form sulphuric acid, which further oxidised the sulphides and liberated heavy metals. In the uncompacted overburden heaps, infiltrating rain water provided both a medium for the process and a transport mechanism for carrying the products of the oxidation process to the environment. Oxygen infiltrating the heaps supported the reaction which was catalysed by bacteriologic action (Figure 3.1a).

The general design approach to the rehabilitation of the overburden heaps involved the management of the water budget of the heap, limiting infiltration of rainfall and reducing both the rate of oxidation of the pyrites and the transport of the resultant pollutants to the environment, as shown in Figure 3.1 (a).

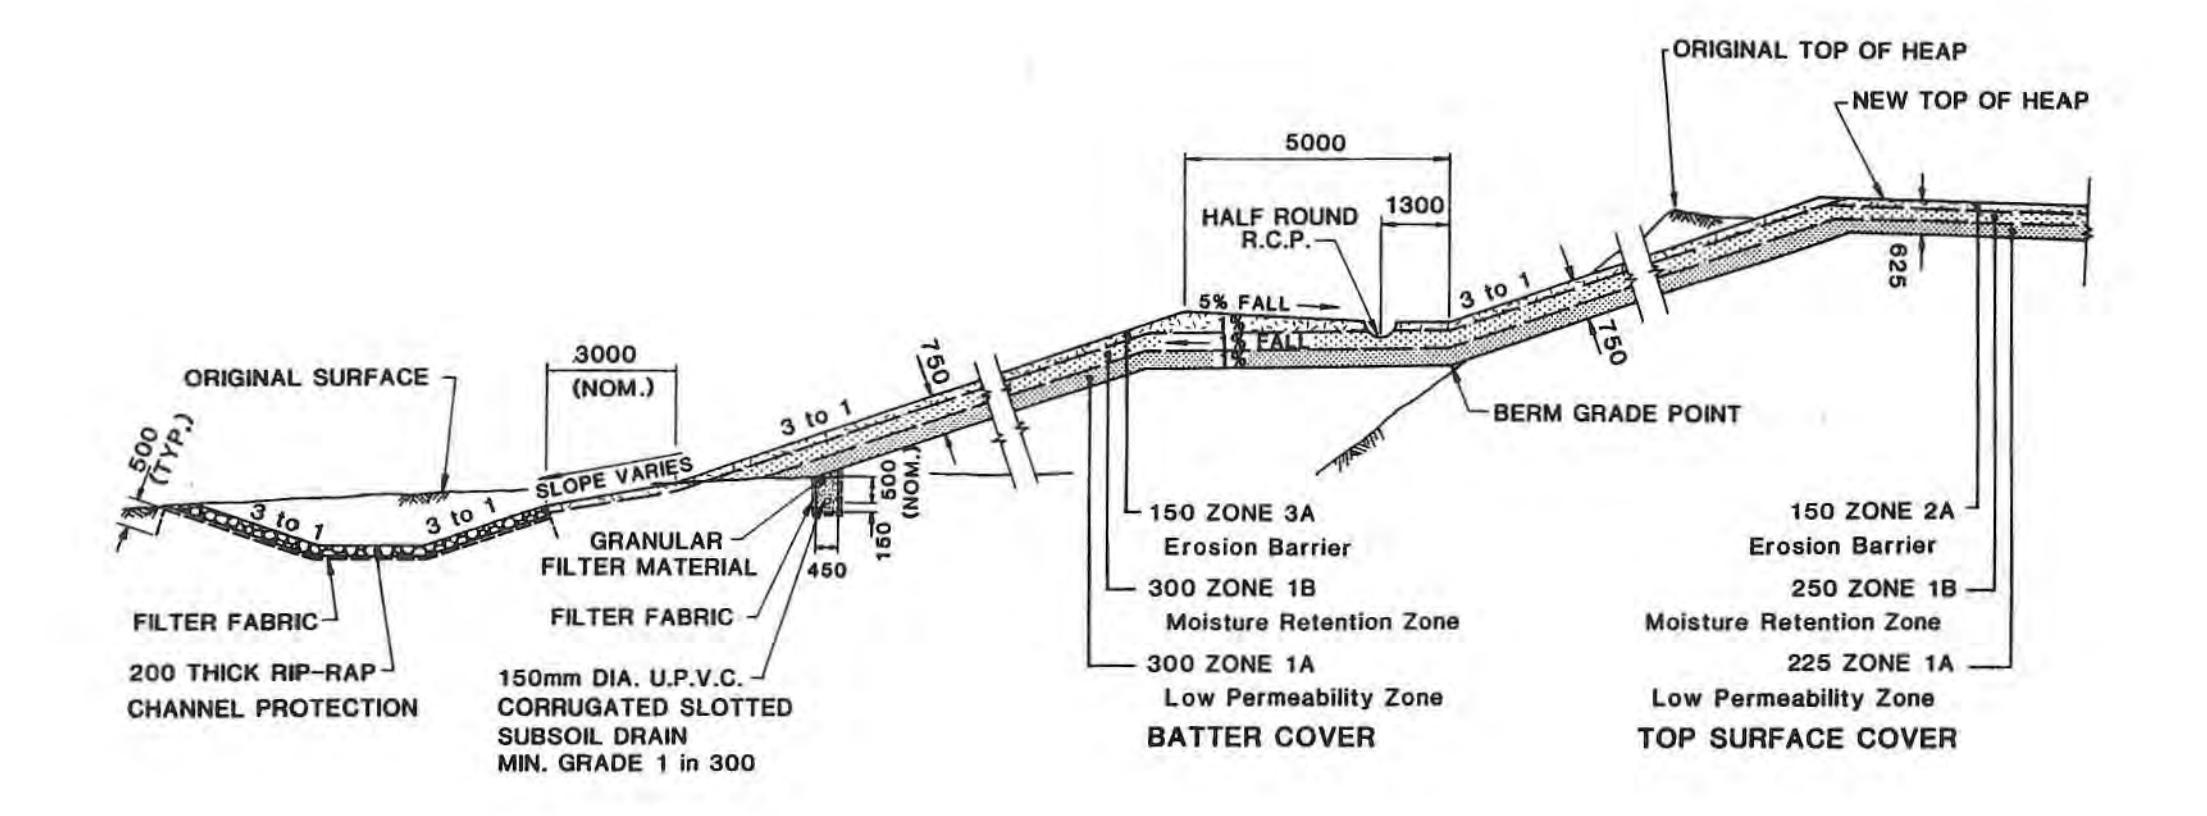
Figure 3.1(b) TYPICAL CROSS SECTION OF REHABILITATED HEAP

- Reshaping each overburden heap to create a stable landform with minimum grades.
- Constructing a three layer cover system on the reshaped heap, the layers being: i) a low permeability sealing zone, ii) a moisture retention zone, iii) an erosion protection zone.
 - Constructing drainage on the heap.
- Vegetation of the resultant landform.

Figure 3.1(b) shows details of a typical cross section of a rehabilitated heap. Figure 3.1(c) shows the change in plan view to Intermediate Overburden Heap as a result of rehabilitation works.

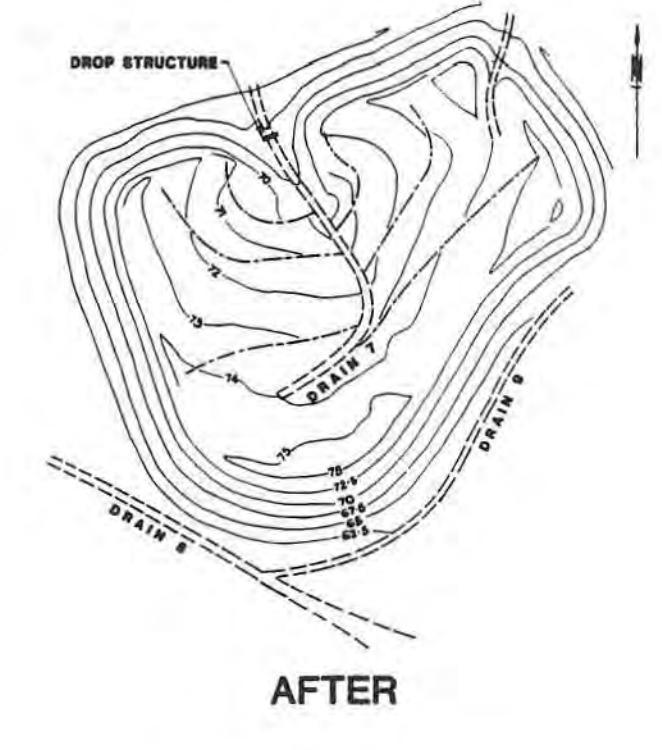
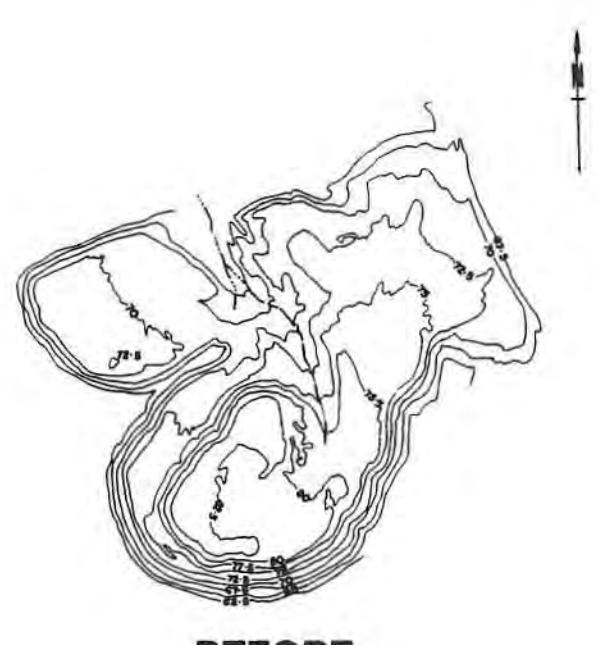
Fig. 3.1(c)

INTERMEDIATE OVERBURDEN HEAP BEFORE AND AFTER REHABILITATION

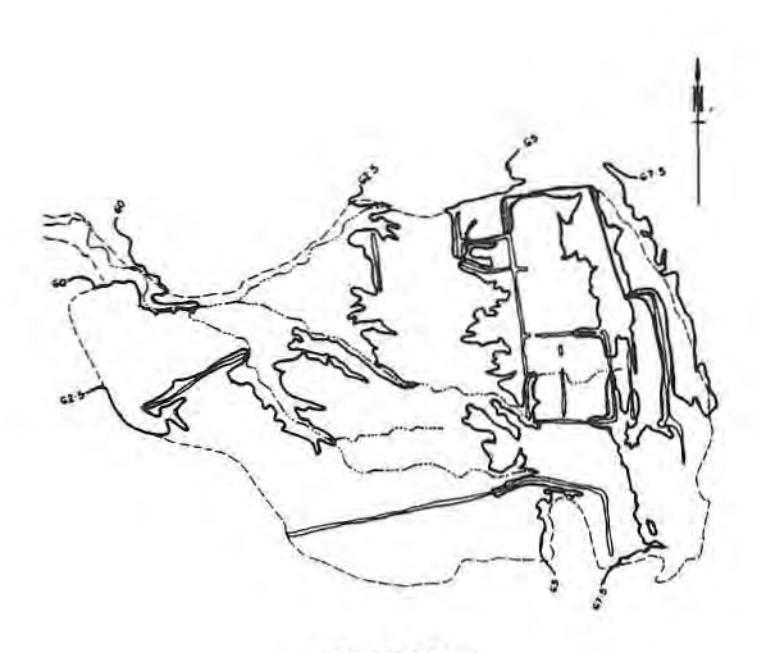
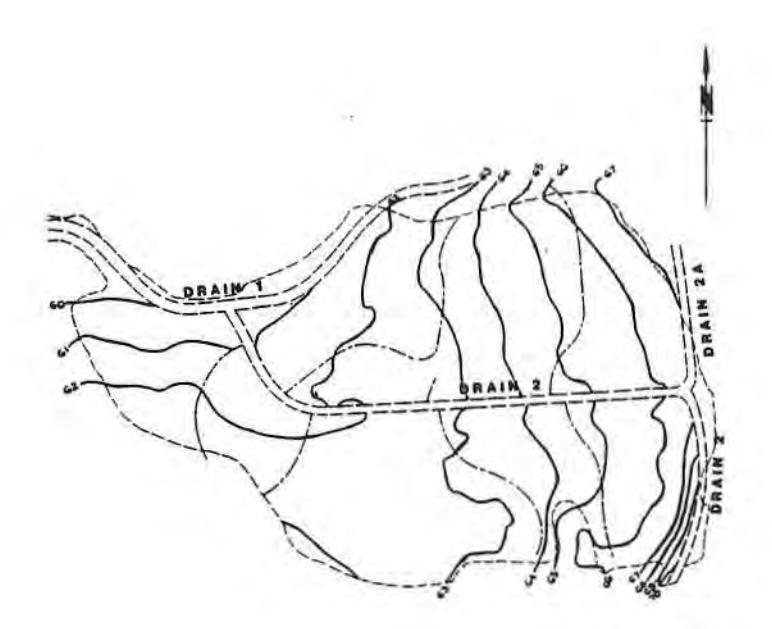
Fig. 3.2(a)

After removal of the tailings and subsoil, the entire area of the Tailings Dam was covered with topsoil, drainage was constructed on the surface and the area was revegetated (Figure 3.2(a)).

TAILINGS DAM AREA BEFORE AND AFTER REHABILITATION

Rehabilitation of the Tailings Dam included removal of the tailings together with affected subsoils, and their placement within Dysons Open Cut. The remainder of Dysons Open Cut was then filled with the material from the Copper Heap Leach Pile, sealed and vegetated.

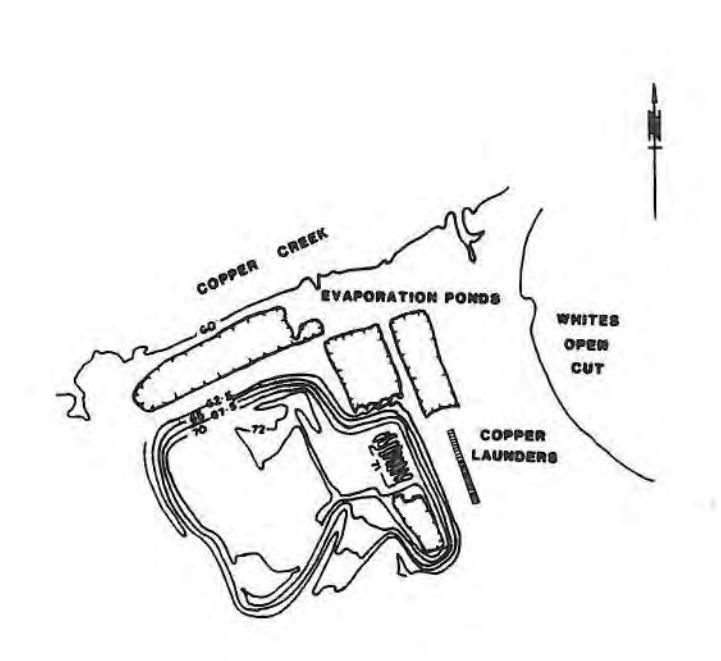
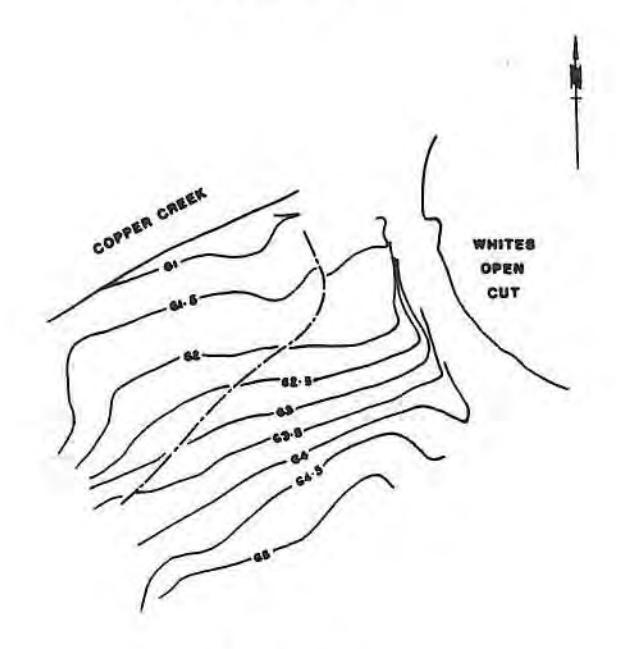
Once the copper heap leach material, subsoil and associated structures had been removed, a system of rubble drains was constructed and the area deep ripped to promote natural leaching of the soil. After leaving for a wet season, the area was covered and revegetated. The change to the area is shown in Figure 3.2 (c).

COPPER HEAP LEACH PILE AREA BEFORE AND AFTER REHABILITATION The flow sheet for the water treatment plant is shown in Figure 3.3(a) and comprised:

Rehabilitation of the Copper Heap Leach Pile included the removal of the pile together with launders, ponds and the worst affected subsoils. Placing these materials in Dysons Open Cut above the tailings from the Tailings Dam served the dual purpose of providing a suitable confinement for the heap leach material as well as an adequate capping for the tailings in the open cut.

To protect the heap leach material from the intrusion of water and thus prevent further oxidation, all placed material was thoroughly compacted and filter layers were constructed directly above the tailings (prior to placing the heap leach material) and on each side of the fill against the original open cut surface and directly beneath the cover system. Figure 3.2(b) shows typical detail. The resultant land form was then covered, drained and revegetated in a similar manner to the overburden heaps.

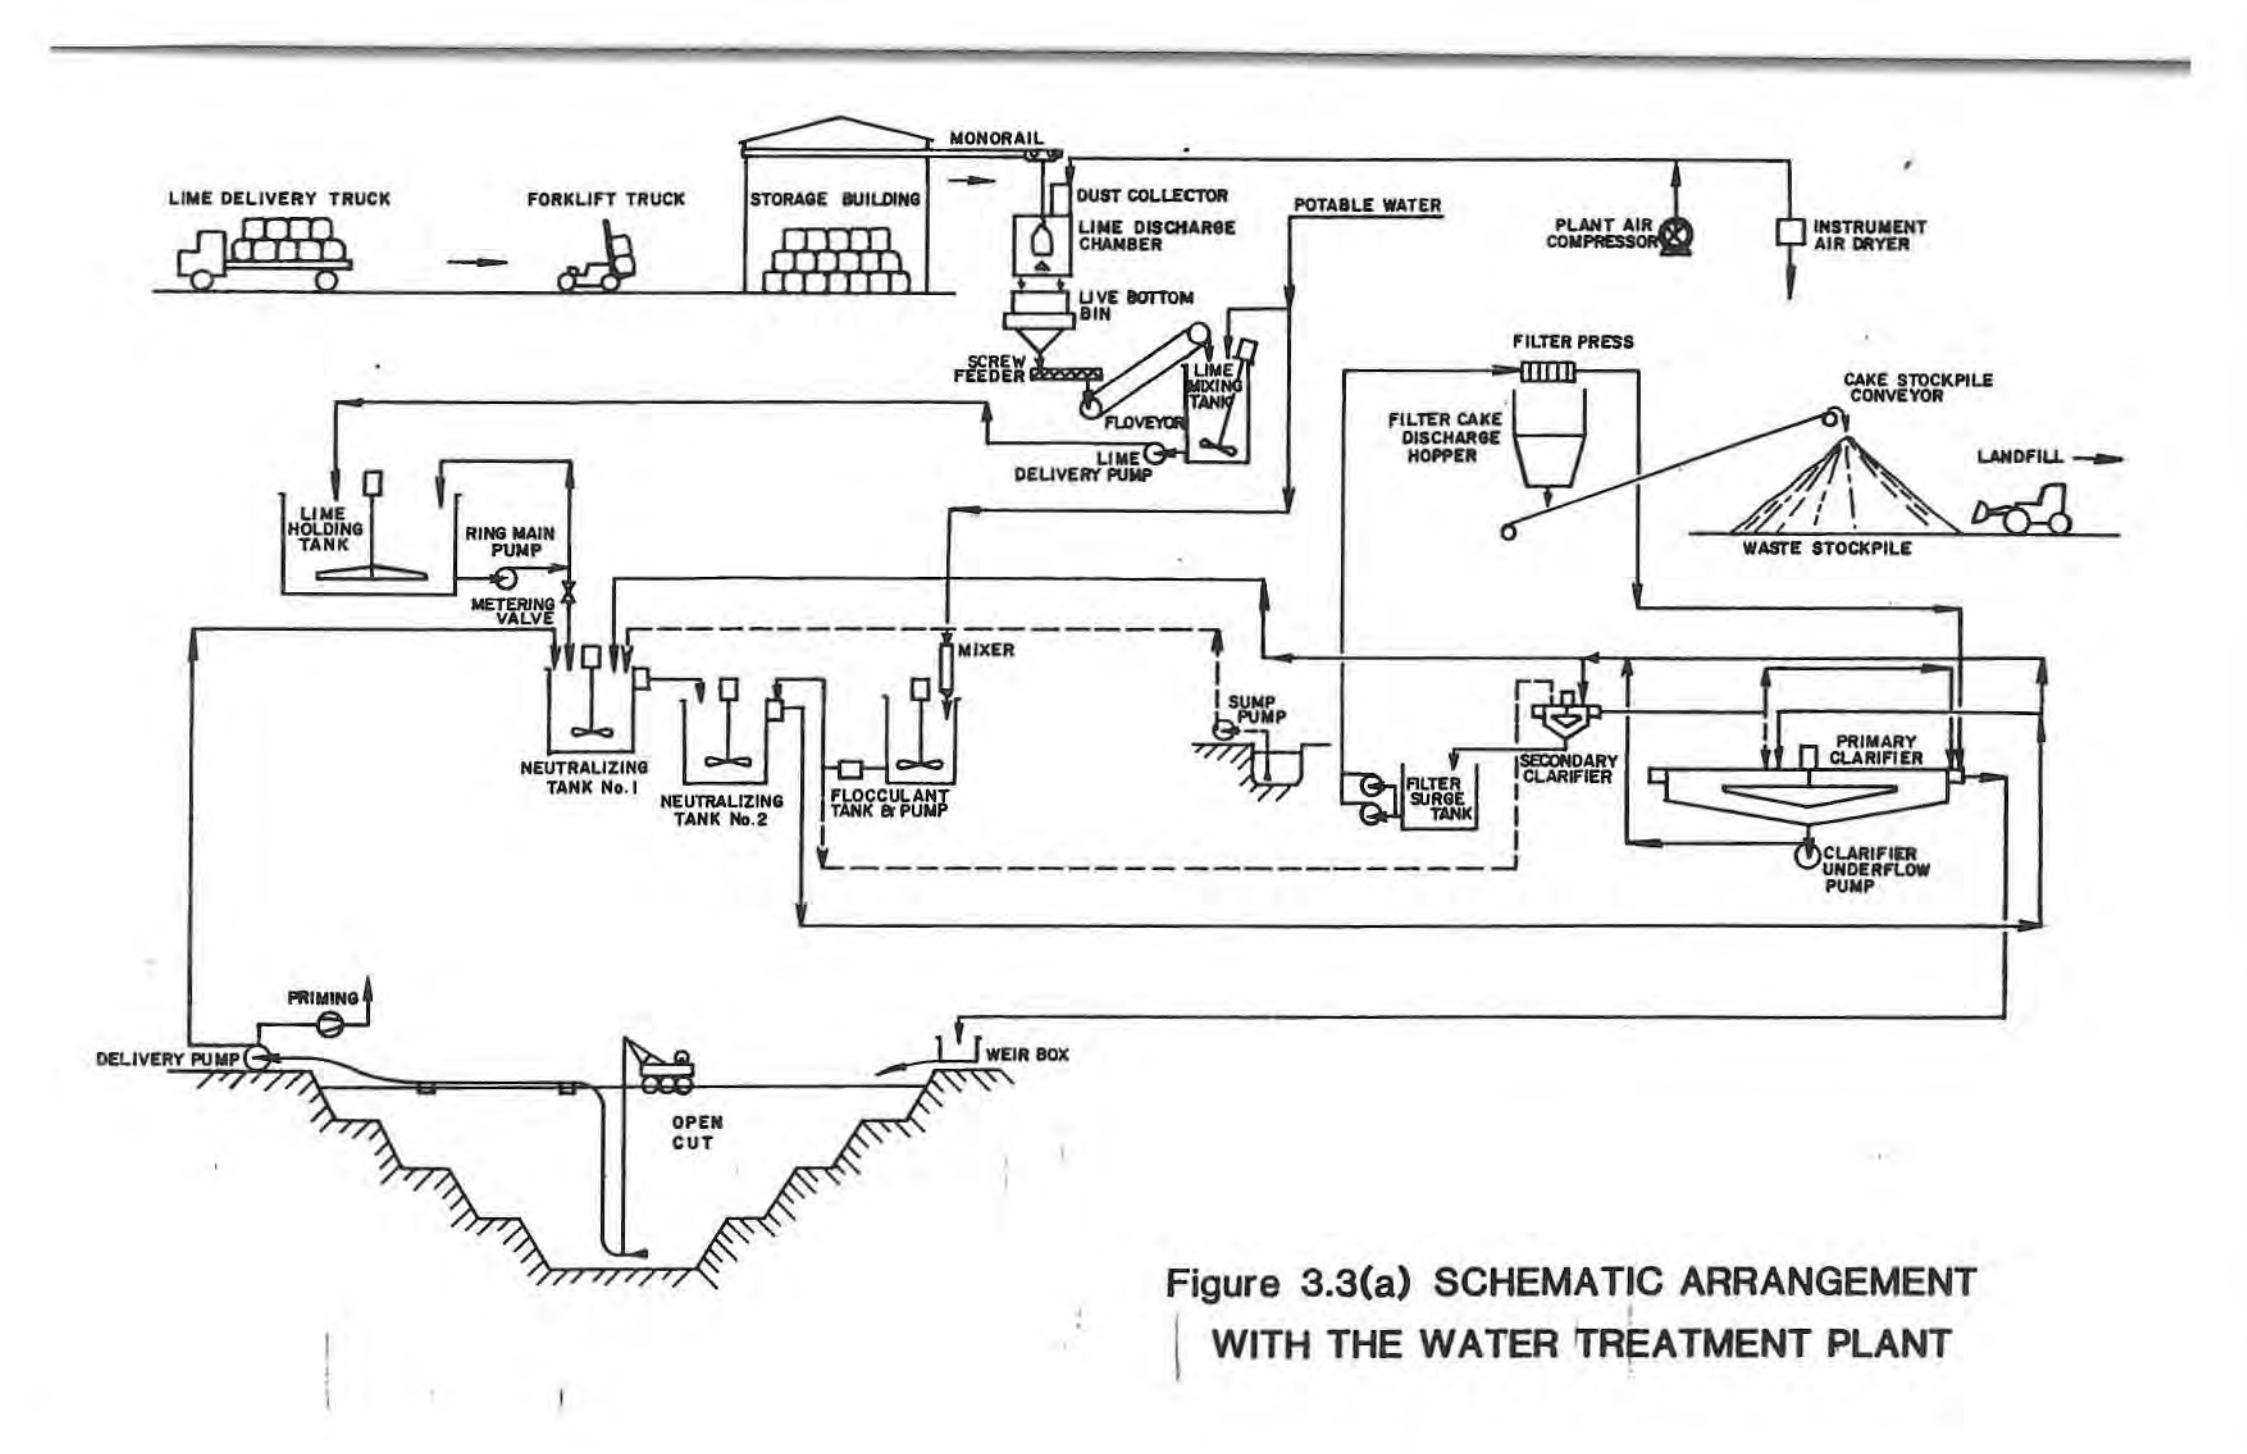
- Raw water was pumped from the open cut via a pontoon mounted suction line with the depth from which the water was taken being controlled by a winch mounted on the pontoon.

- Lime, which had previously been slurried with potable water, was mixed with the raw water in two neutralising tanks.
 - The neutralised water was transferred to a primary clarifier where overflow was returned to the open cut and underflow was transferred to the secondary clarifier.

- Flocculant was added to the neutralised water prior to its entry to the primary clarifier to aid settlement.
 - Overflow from the secondary clarifier was transferred either as recirculating load or to the primary clarifier as overflow and underflow was transferred to the filter press feed surge tank.

- Liquor was transferred from the filter feed surge tank to the filter press where the filtrate was returned to the primary clarifier overflow. The filter cake was transferred to a stockpile for disposal as landfill.
