# RUM JUNGLE MINE CLOSURE REMEDIATION

## East Branch Finniss River - River Reinstatement and Flooding Design Report

SLR Ref: 680.10421.90060-R02  
Version No: -v1.0  
June 2020

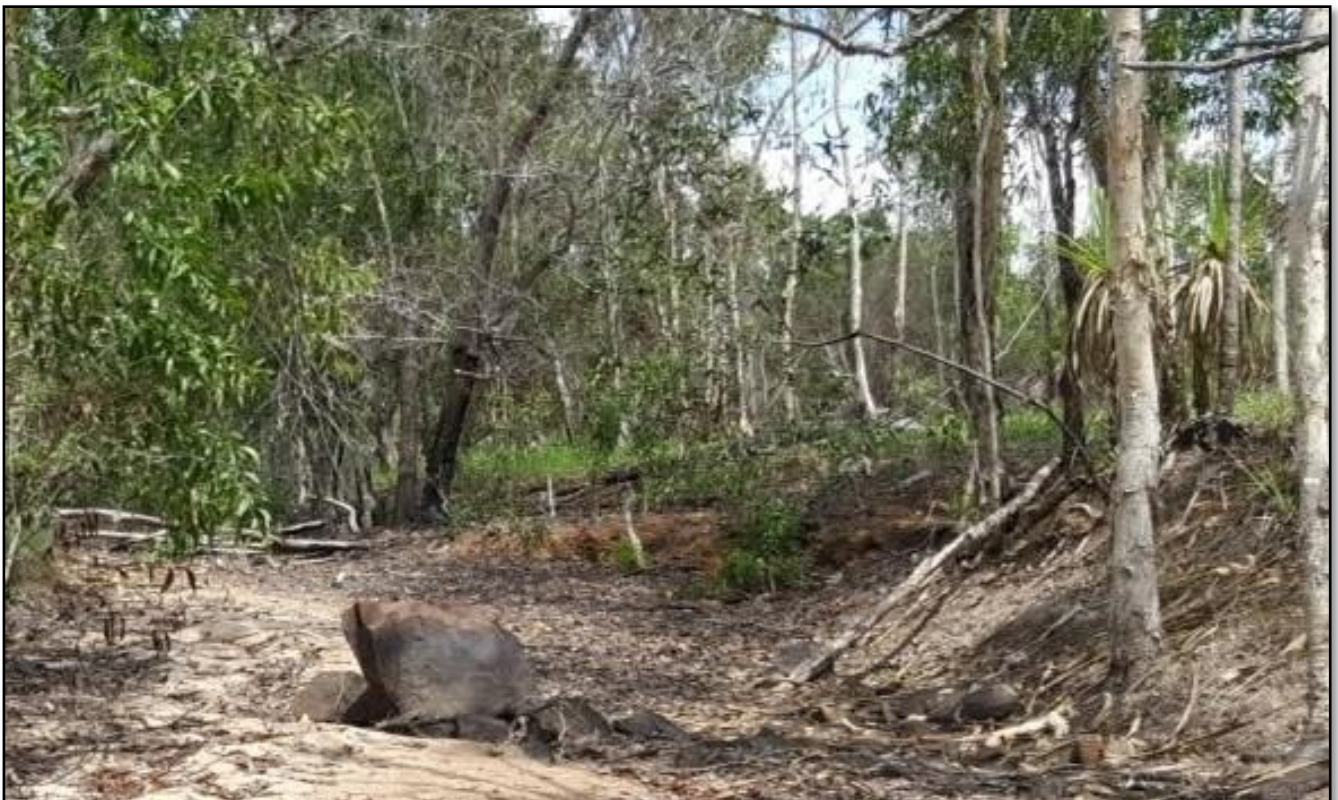
Figure 3 EBFR typical channel sectional profile

**Figure 3** is an example of the unmodified river system upstream of the mine site. It is likely to have been typical of the original EBFR which passed through the pits. The historical flow path of the EBFR pre-mining was estimated from historical photographs and is plotted in **Figure 4** (K. Martin-Stone, 2019).

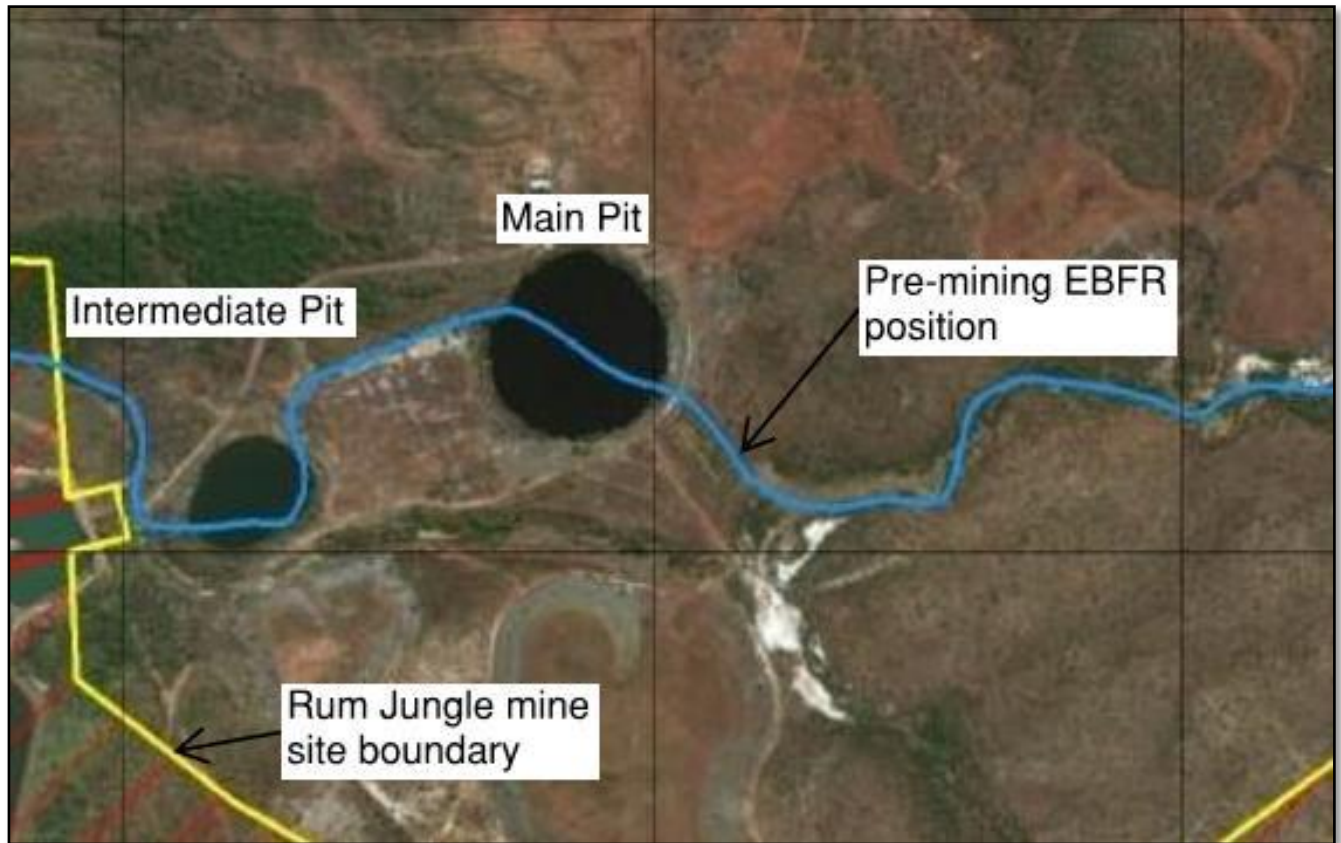
**Figure 4** Original course of the East Branch Finnis River (K. Martin-Stone, 2019)

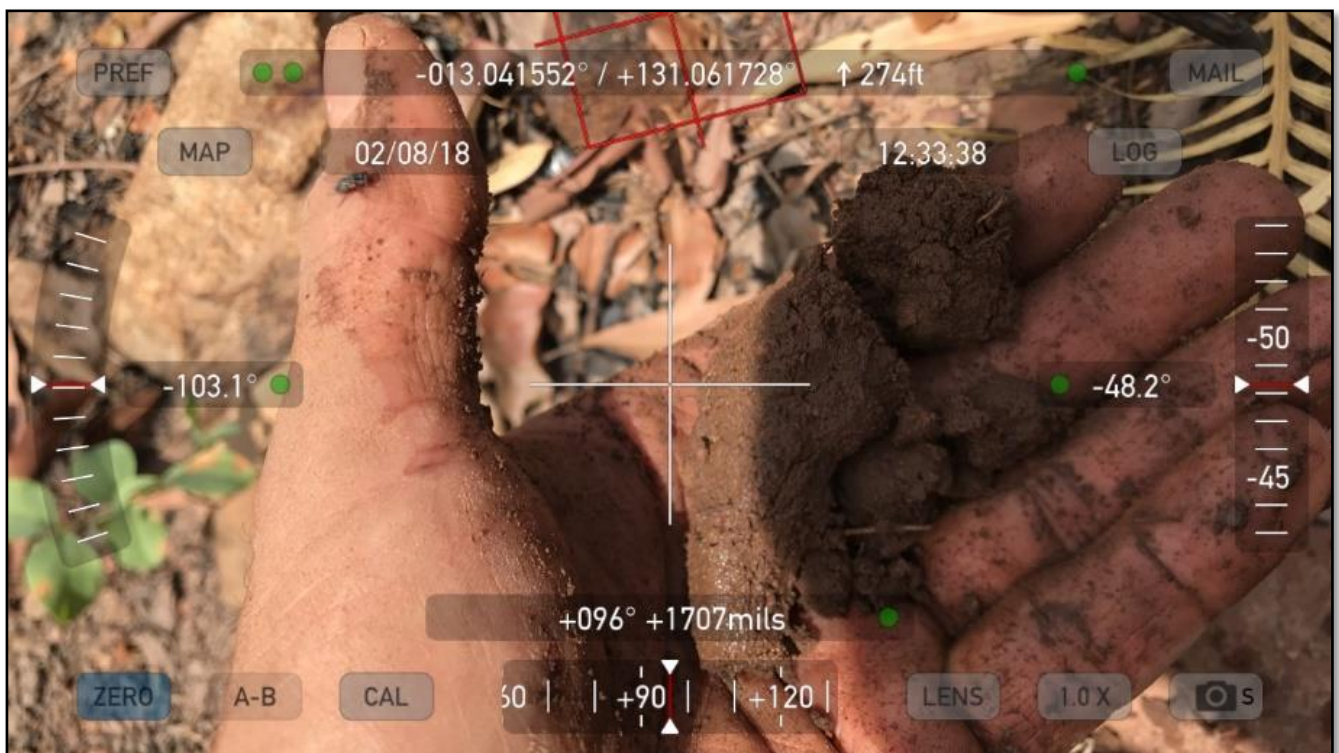
In situ soil samples were analysed at three locations within the upper catchment. A USDA textural classification (Appendix A, (Rawls, W. J., Brakensiek, D. L., & Miller, N., 1983)) at each of the sites showed the upper soil profile to be a sandy clay loam at all three sites, refer Figure 5. Based on the USDA guidelines (Appendix A, (Rawls et al., 1983)) the recommended saturated hydraulic conductivity (akin to continuing loss) would be approximately 3mm/h for a sandy clay loam.

**Figure 5 Sandy clay loamy top soils are consistent throughout the undisturbed catchment**
